Technical Service Bulletin: TSB250191

Fuel Injection Pump Bracket Countermeasure

- QST30 CM552

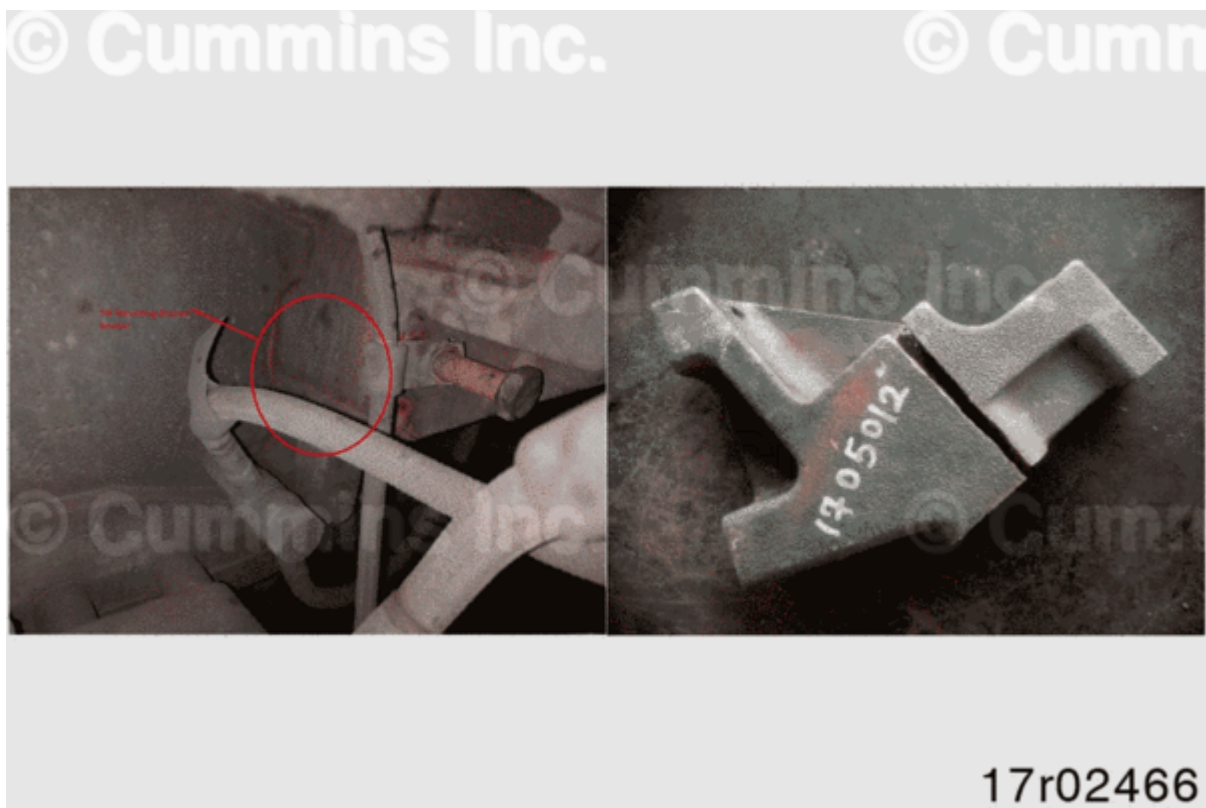
- Fuel injection pump mounting bracket and P-clip capscrew loosens, sometimes leading to fuel injection mounting bracket fracture (see Figure 1).

Figure 1, Example of loosened capscrew and broken fuel injection mounting bracket

- The isolated spot-facing of the fuel injection mounting bracket creates a step that interferes with the P clip seating, leading to bending of the P-clip, progressive preload loss of the joint, capscrew loosening and possible fuel injection mounting bracket fracture.
  - In some instances, some fuel injection mounting brackets have been installed without the washer between the P clip and capscrew head included.

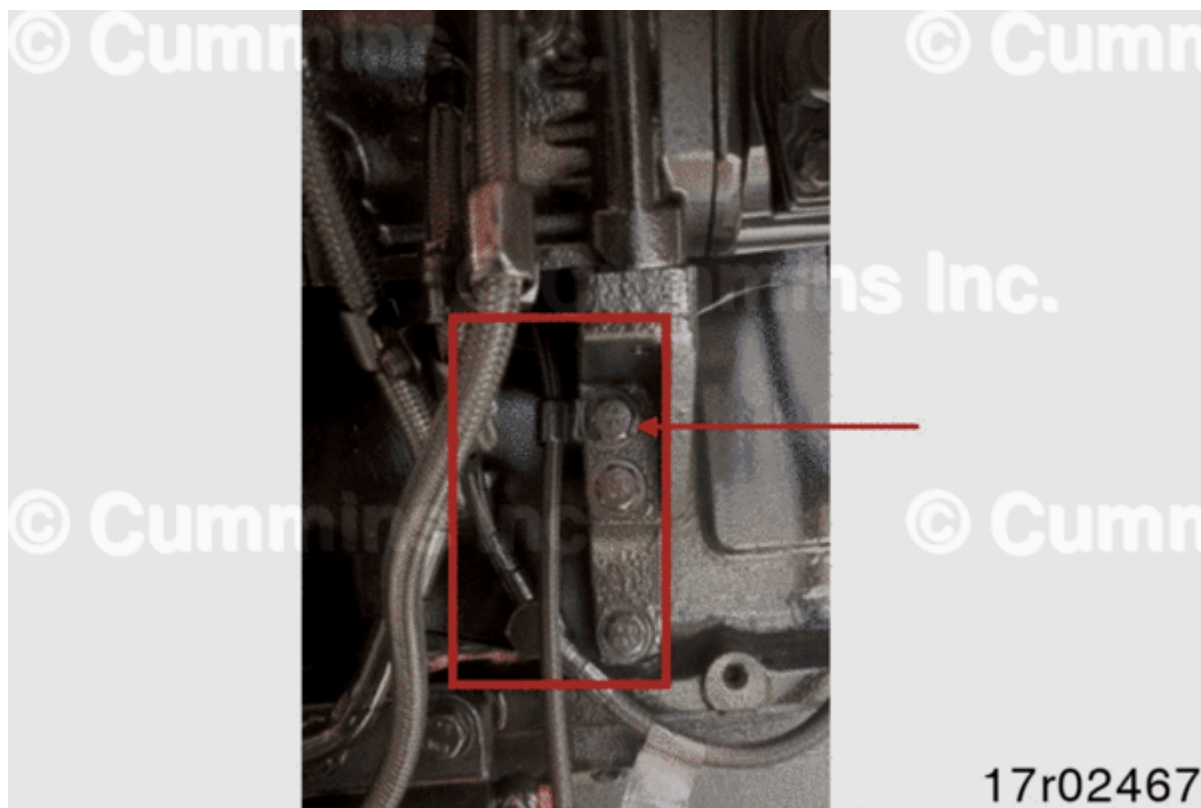
This issue pertains to any engine built with fuel injection mounting bracket Part Number 3093263 with a P-clip mounted in the location shown in Figure 2. This will be found on the left bank side of the engine.

Figure 2, Example of P-clip mounting location

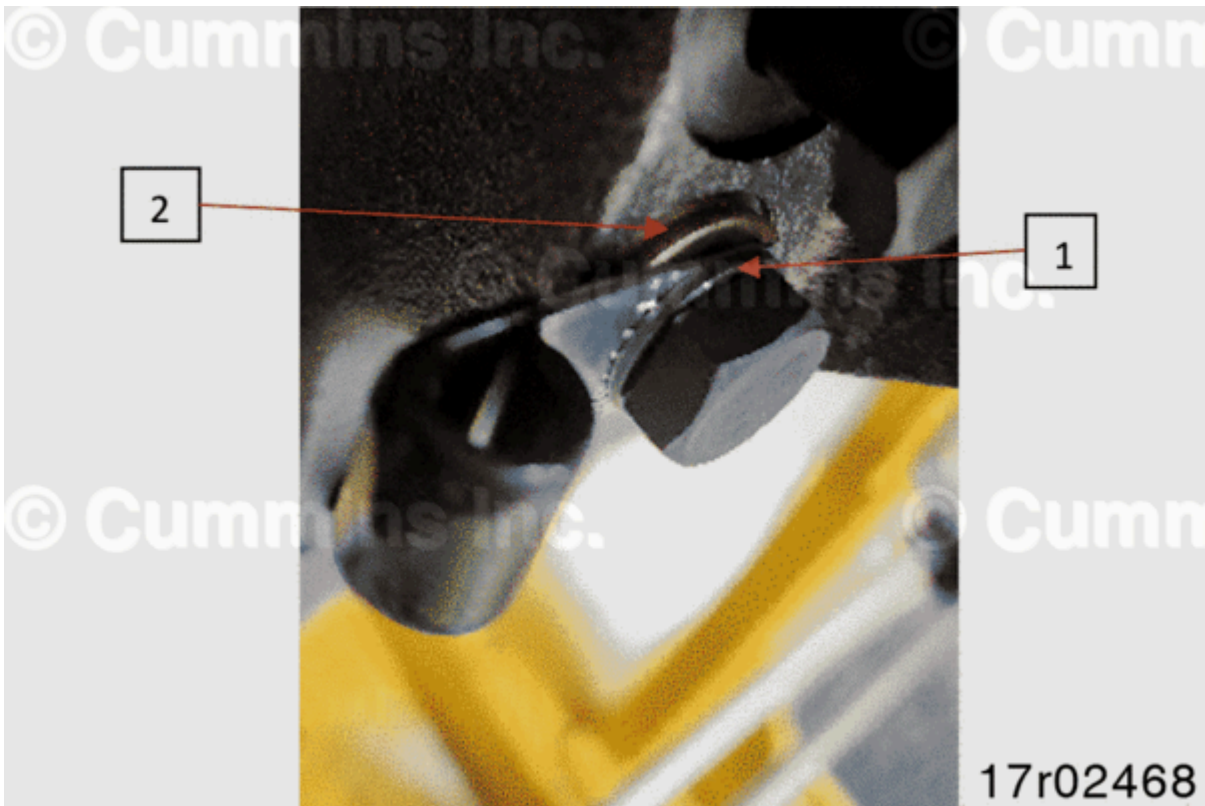
Figure 3, Washer Countermeasure Installation

First, verify there is a washer present between the P-clip and capscrew head. If there is no washer present, washer Part Number 3094024 (1), will need to be installed between the capscrew head and P-clip.

Additionally, washer Part Number 3093799 (2), should be installed between the P-clip and the fuel injection mounting bracket surface, as shown in Figure 3.
