Technical Service Bulletin: TSB250219

Low Temperature Aftercooler (LTA) Water Pump O-ring Oil Leak Countermeasure

QST30 CM552

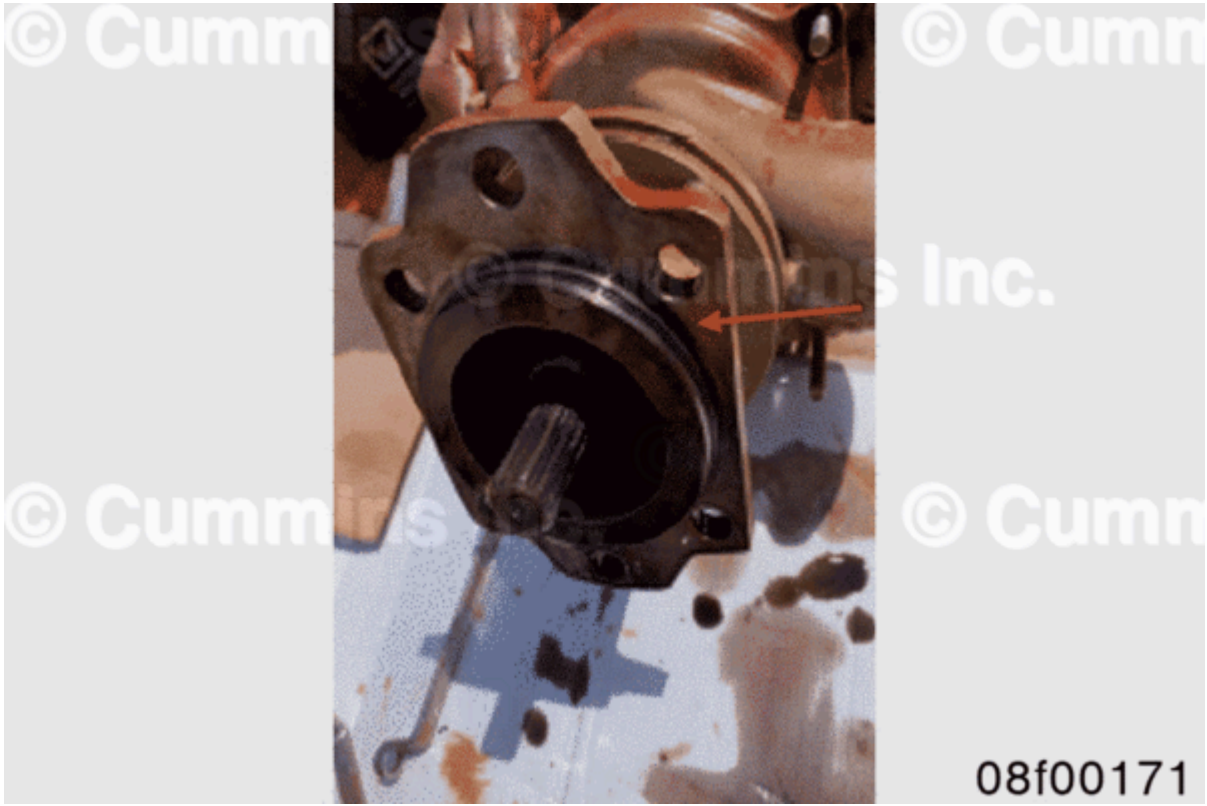
- External oil leak from the LTA water pump-to-accessory drive joint.

- The o-ring seal of this joint experiences temperature exposure beyond its material capabilities.

Figure 1, Example of LTA water pump mounting o-ring seal

As a countermeasure for this issue, replace failed seal part number 4025376 with seal part number 3033248, which has higher temperature exposure capabilities. See image 1 for referenced o-ring seal.
