Mold Inspection & Limited Sampling

**Project:
3705 Indianpipe Circle
Colorado Springs, CO 80918**

November 3, 2017

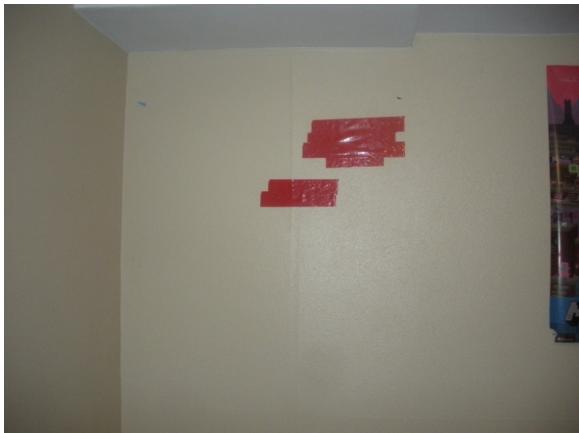
The bedroom door was closed on arrival and had a strong mold type odor upon entering the room.

There are signs of minor water damage on the bedrooms North wall and ceiling area.

A small inspection hole has been previously cut by the Management Company.

There is no visible mold growth either on the surface, on the tack strip, or what was visible inside the wall with a limited view in a boroscope.

Moisture readings were all in a normal range with various readings from 0% to 8.5%.

The bedrooms humidity level was slightly high at 49% Rh. The exterior Rh level was at 23%.

While there is no visible mold growth, there is growth hidden somewhere basement bedroom wall and/or ceiling. In order to locate the source the water damaged sections of the wall and ceiling should have mold remediation work performed.

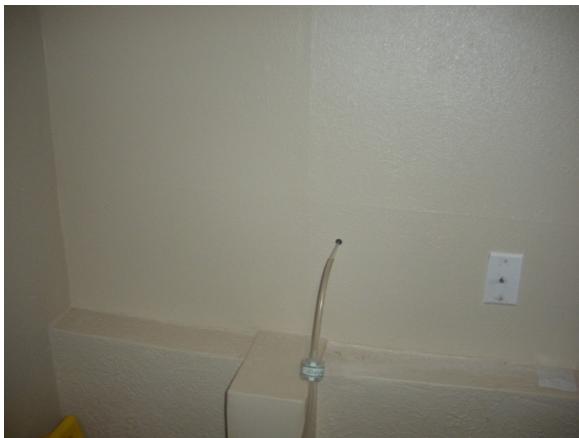
Bedroom Wall Air Sample
#1896380

The air sample taken inside the bedroom wall contained a total of 467 spores per m³.

The sample contained 67 spores of Alternaria mold. **Potential health risk.**

All of the mold remediation work and cleanup should be performed by a certified mold remediation company according to the “IICRC S520 Standards”.
