Limited Asbestos Survey/Inspection

**3705 Indianpipe Circle
Colorado Springs, CO 80918**

November 14, 2017

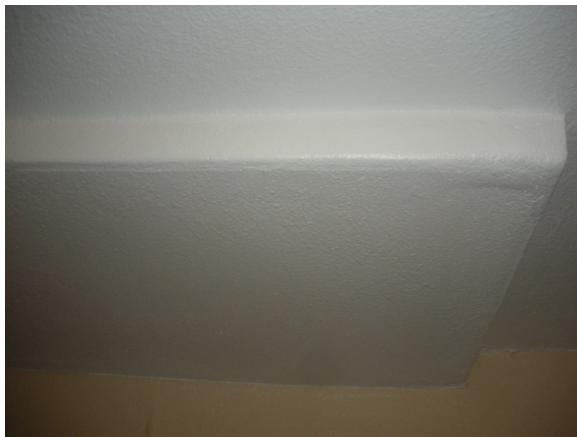
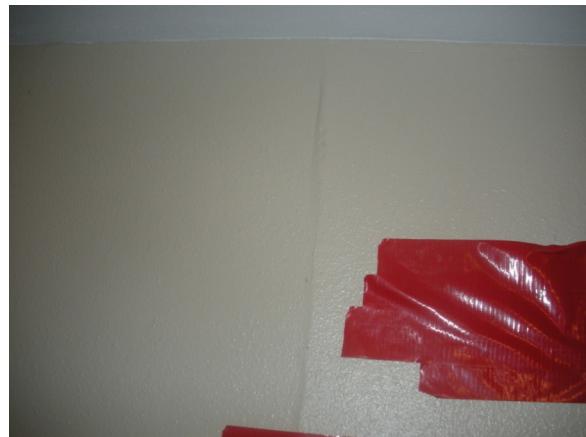
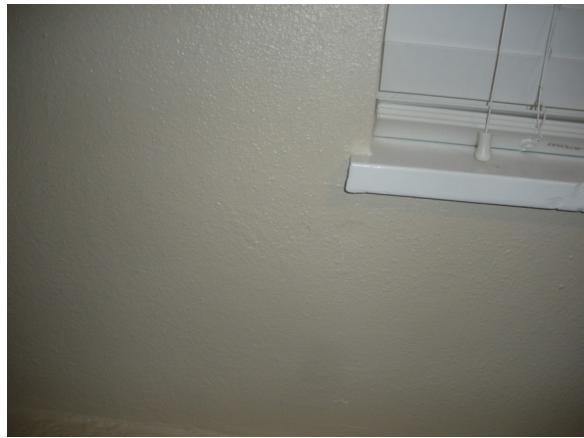
Bedroom

The bedroom has water damage on the ceiling and N/E wall. There is minor water damage on both of lower corners of the window.

The walls and ceiling appear to be of the same build date.

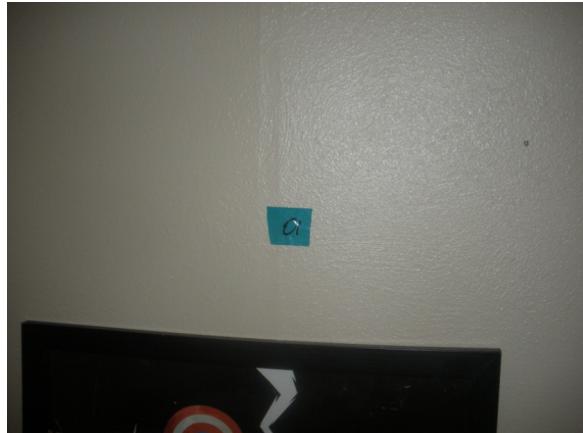
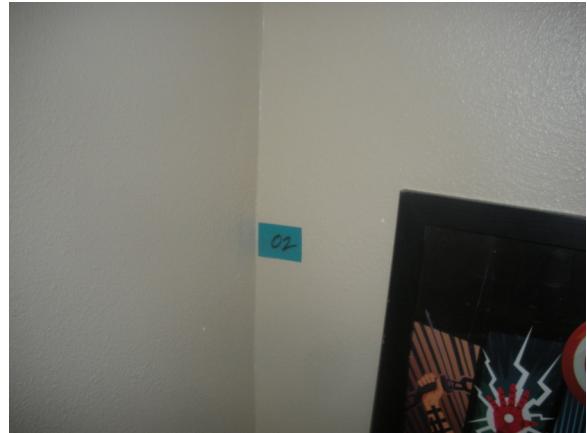
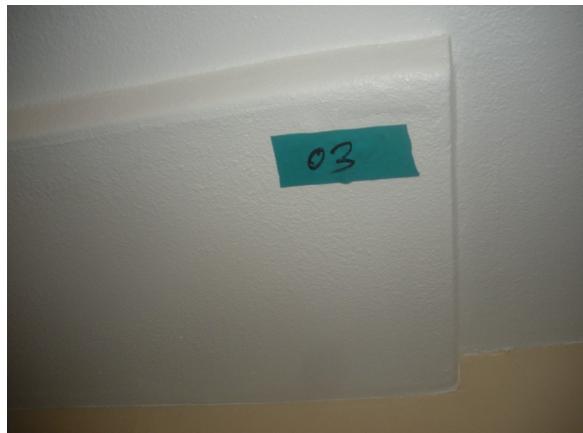
Homogeneous Area #1

Sample BA-3705-01 was positive for asbestos in 2 separate layers. There was a layer of white joint compound with 2% Chrysotile asbestos, and a layer of white texture with tan paint with 2% Chrysotile asbestos.

Sample BA-3705-02 was positive for asbestos in 1 layer. There was a layer of tan texture with white paint at 2% Chrysotile asbestos.

Sample BA-3705-03 taken from the ceiling was negative for asbestos.

With 2 positive samples all of the drywall/gypsum board throughout the room should be considered as positive.

Any materials that are going to be removed in the bedroom must be done by a state certified asbestos abatement company.

Since an abatement company will be removing 1 full wall, part of 2 walls, and a part of the ceiling, I recommend that all of the drywall/gypsum board in the room be removed/abated. This would be the most cost effective and best route for future maintenance and repairs.
