SAMPLE REPORT — NOT A REAL PROPERTY

| PROPERTY | 1240 Example Court, Gurnee, IL 60031 |
| ROOF | Asphalt architectural shingle, approx. 18 years, 6:12 pitch |
| PREPARED BY | Rimantas Podlinevas, Vilkas Inc |

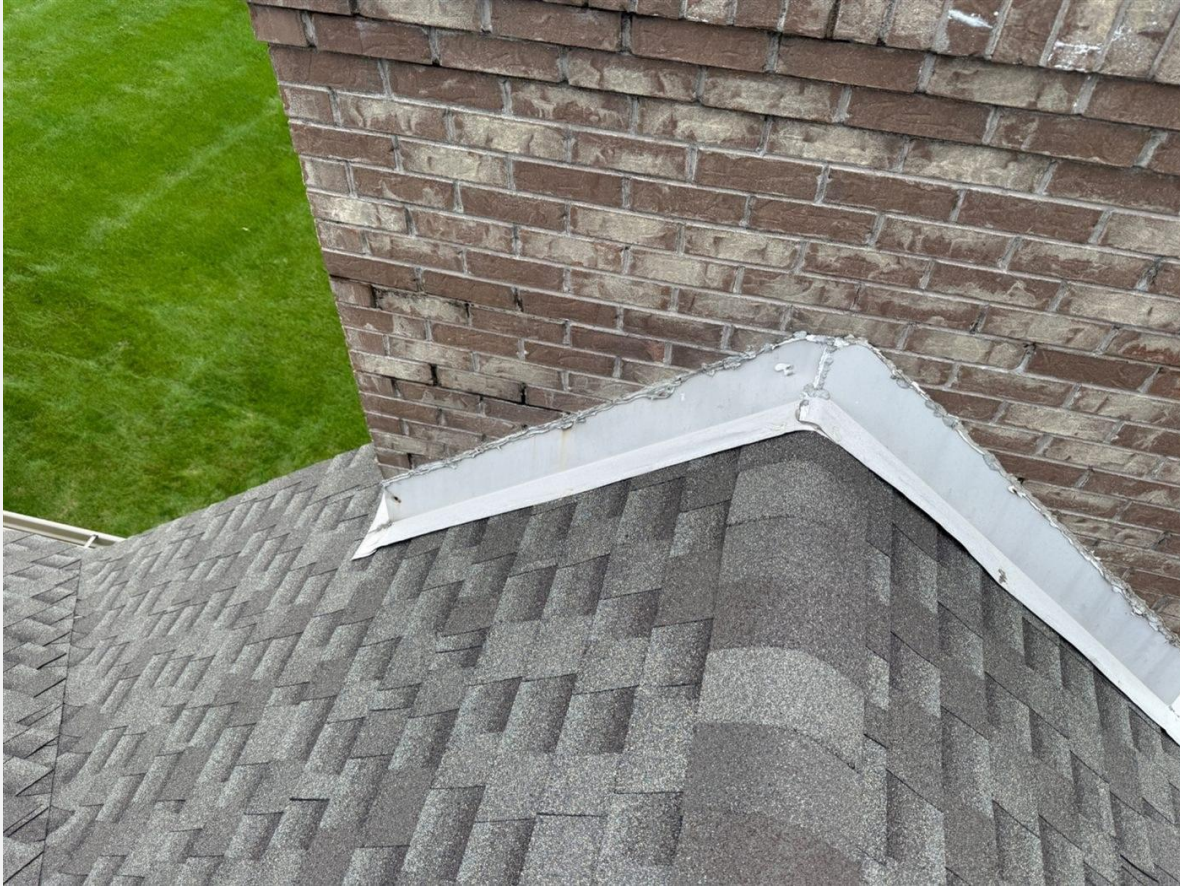
The active leak in the upstairs bedroom has one cause, and it is not the age of the roof. The chimney counterflashing was never let into the masonry — it sits on the face of the brick, held by sealant — and that sealant has failed. Water is entering at the chimney and running down the north slope of the decking, which is where the staining inside lines up.

The counterflashing is surface-mounted and sealed to the face of the brick rather than let into a cut reglet. The sealant bead has shrunk, cracked and pulled away along most of its length, and the step flashing behind it is short at the upcoming corner. This is the point water is entering. A surface-sealed joint of this kind depends entirely on the sealant, so it fails on a schedule rather than by accident, and re-caulking it only restarts that clock.

**Figure 1.** The counterflashing sealed to the face of the brick, the bead cracked and lifted along its length. This is the entry point, not the shingles below it.

**REMEDY** Rebuild the chimney flashing: cut a reglet into the masonry, set new counterflashing into it, and replace the step flashing with the courses woven in.

1. **Rebuild the chimney flashing.** This is the repair that stops the active leak, and it is the only item on this report that is urgent.
2. **Fit the missing exterior vent guard.** Small work now, before weather or nesting creates a larger repair.

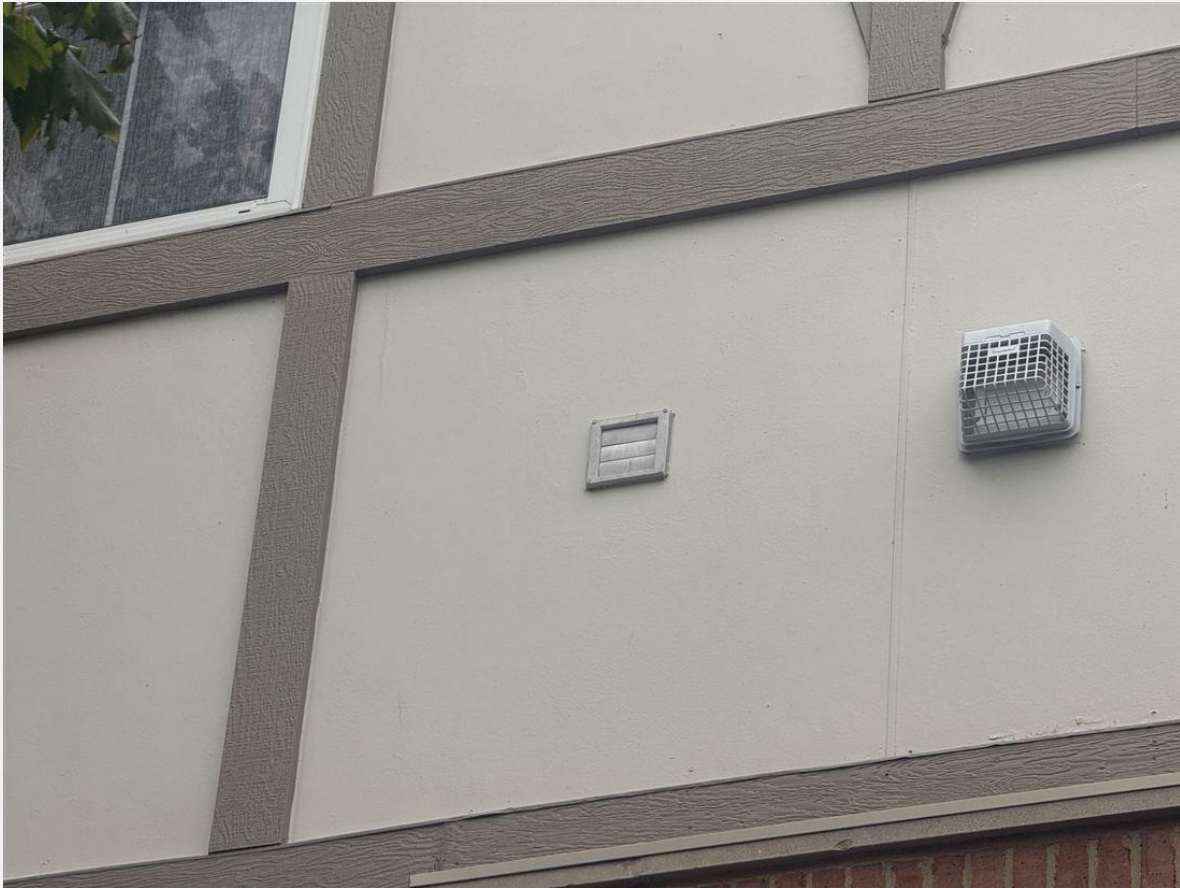
One exterior vent is open where the neighbouring vent carries a guard. The opening admits weather and allows birds or insects to enter. It is recorded as a small correction rather than a roof-system defect.

**Figure 2.** The unguarded vent at left; the neighbouring opening at right shows the protection this one is missing.

**REMEDY** Fit a durable exterior guard that preserves the required airflow.

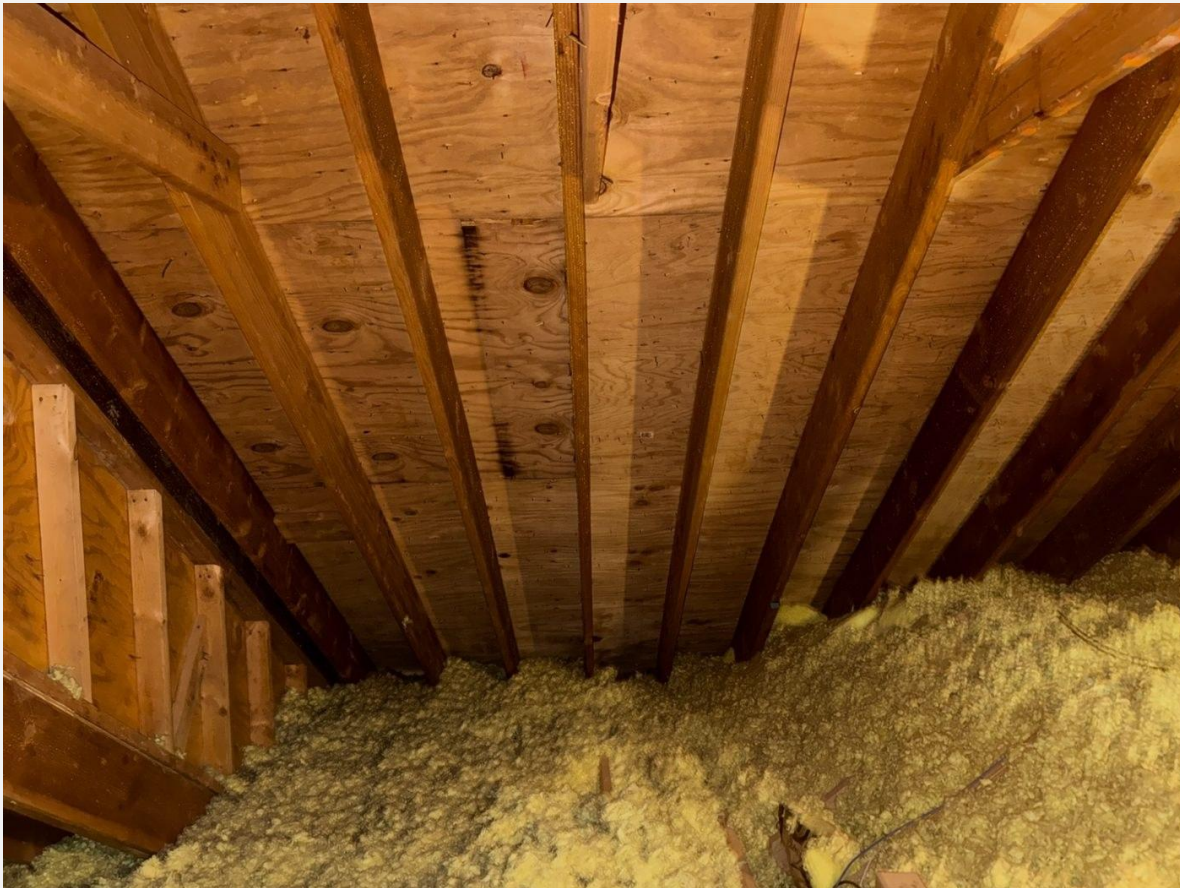
The decking is dry across the attic apart from a darkened band on the north slope directly below the chimney, consistent with the flashing above it. The staining is old and dry to the touch, with no soft sheathing and no delamination. Intake ventilation is short: the ridge carries a continuous vent but the soffits are largely blocked by insulation, so the ridge is drawing from the house rather than from outside.

**Figure 3.** Insulation packed against the roof deck at the eave, blocking the intake path. Dark streaking is visible on the sheathing above.

The blocked soffit intake is not local to one bay. A ridge vent with no intake beneath it pulls conditioned air out of the house instead of moving outside air through the attic, which shortens shingle life from underneath and, in winter, feeds ice at the eaves. It is a detail of how the insulation was installed rather than something that has gone wrong since, and it will keep producing the same result until the intake is opened.

**REMEDY** Correct the intake — install baffles and clear the soffit bays. No decking replacement.

3. **Open the soffit intake.** Baffles and clear bays, so the ridge vent works the way it was meant to.
4. **Fit a rain cap on the flue.** Small, and best done while the chimney work is under way.
5. **Leave the roof covering alone for now.** Re-assess in two to three years. Replacing it today would not have stopped this leak.
