11/19

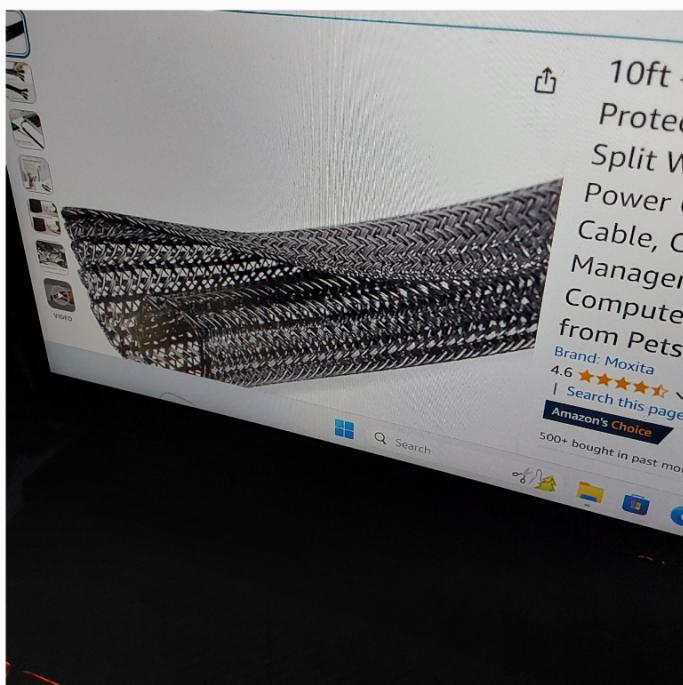
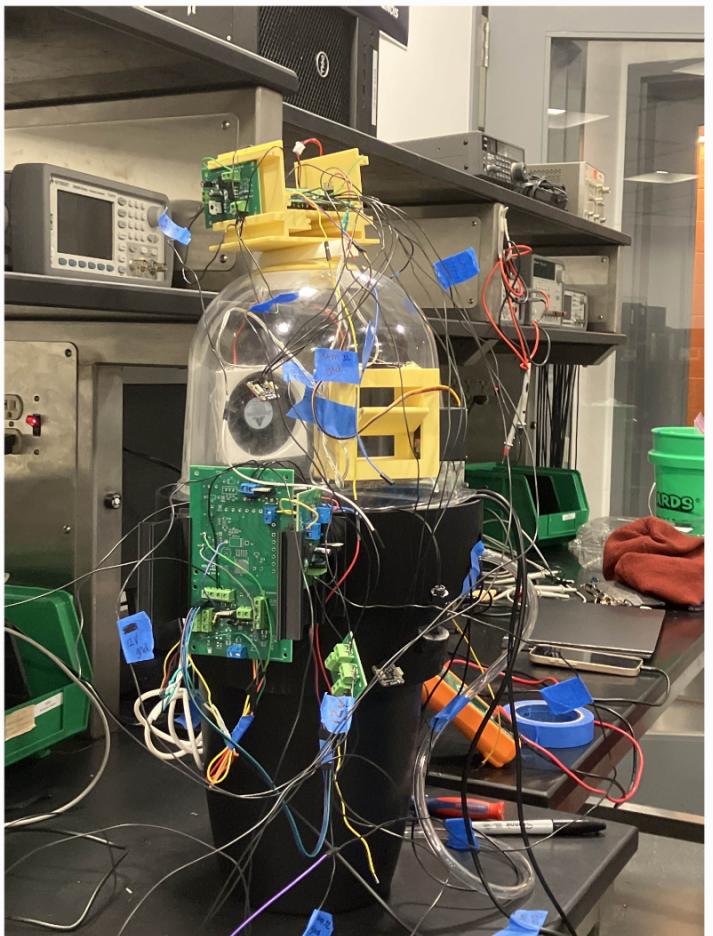
Mock demo today. Mostly everything was operational however the main problems were refining the physical build since there's wires every where and the humidity and i2c bus broke down part way through. Most systems are operational.

Wire sheathing is bought
