## D. BAY

### NORTH COAST EGYPT

ECG – Concept Design Review Report

01 BC- BEACH CABIN (40 sq.m)

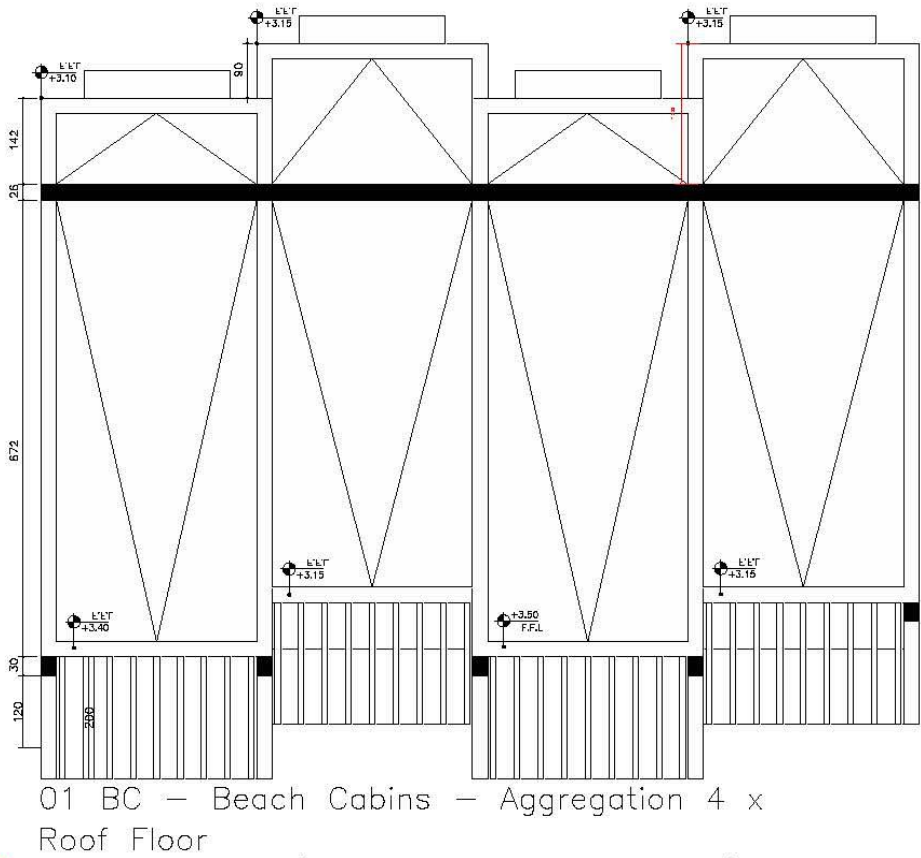
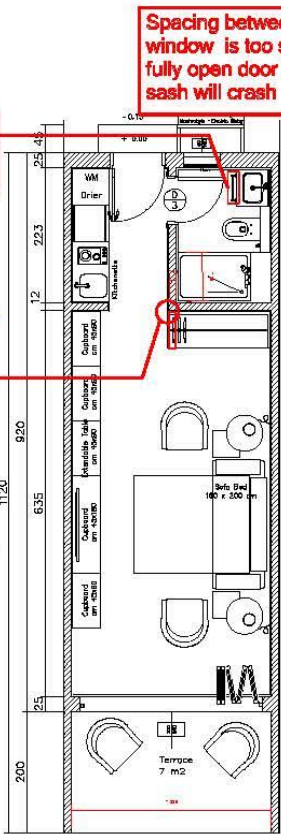
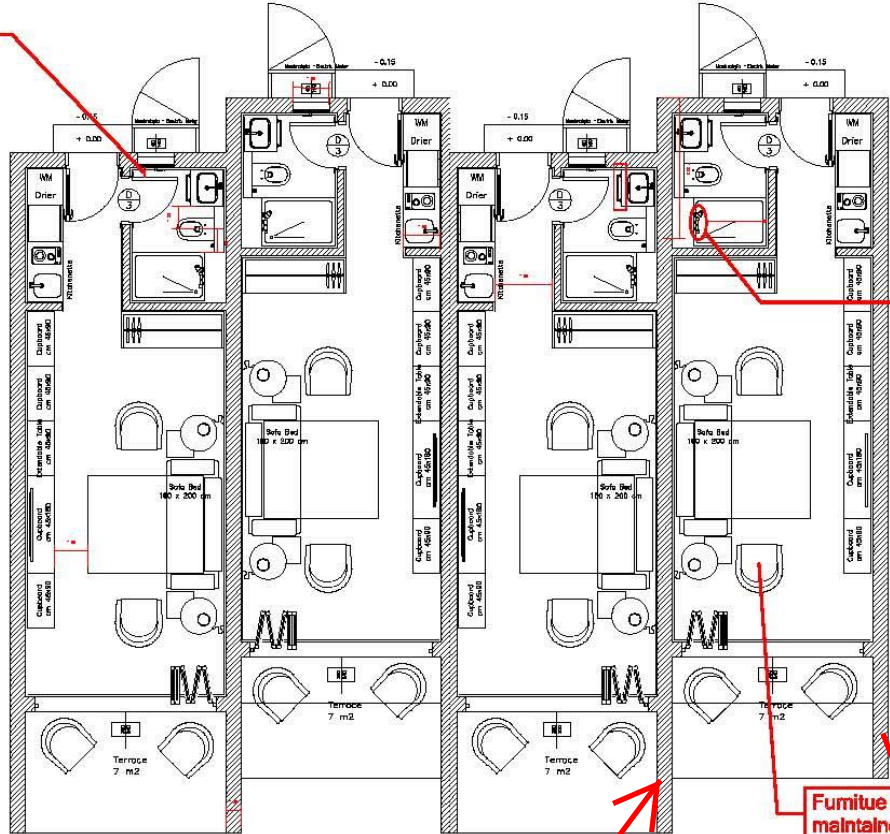
D.Bay  
01 BC - Beach Cabin  
40 m2

- If shower head is relocated at the opposite side, there'll be potential for built in seat or shelves to replace
- At the same time, this will facilitate manual test of water temp. prior to getting into shower tray

- Furniture layout needs to be revisited to enhance functionality, e.g. in case sofa bed is maintained at sleeping mode,
- > How to provide nice seating arrangement near window
- > How to use extendable table comfortably & without interrupting circulation

Ok, please proceed

Please to be coordinated with ID consultant
