Lou Blasco, VK3ALB  
[vk3alb@gmail.com](mailto:vk3alb@gmail.com)  
Version 1.1  
14 January 2018

## Restoration of the Eddystone 1002/2

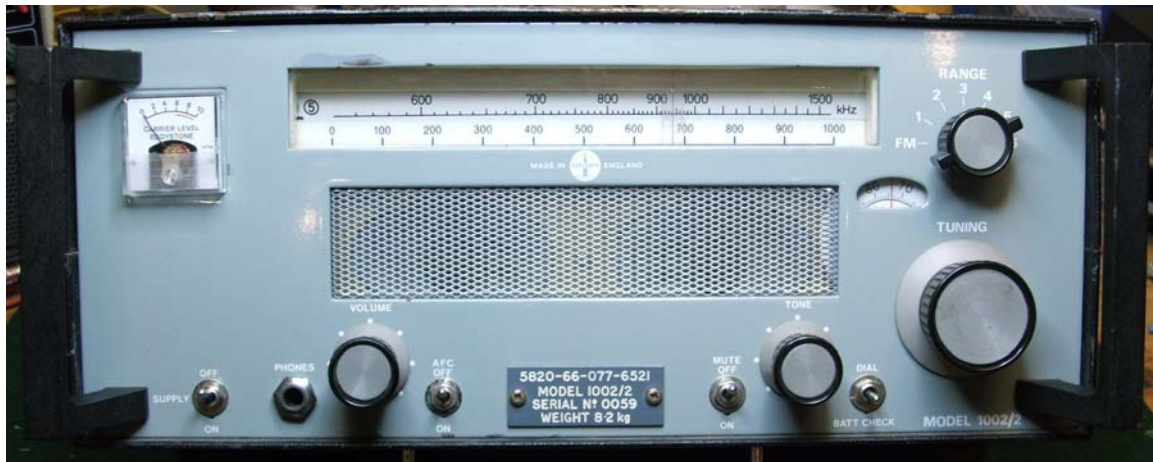
This particular set was a bit of a mess. The case was chipped, scratched and spattered with paint; the grey enamel on the front panel had been chipped and worn away in places. The S meter was missing the front cover, the speaker grille was missing, the tuning vernier was scraping against the dial glass and was scratched for almost 360 degrees probably as a result of the damaged speaker grille. Also missing was the DC connector and some knurled nuts from the binding posts on the back panel.

The front panel was removed and the new speaker grille and meter installed. I also reset the mechanical alignment of the dial which included moving the vernier dial back 1mm so it didn't scrape against the dial glass.

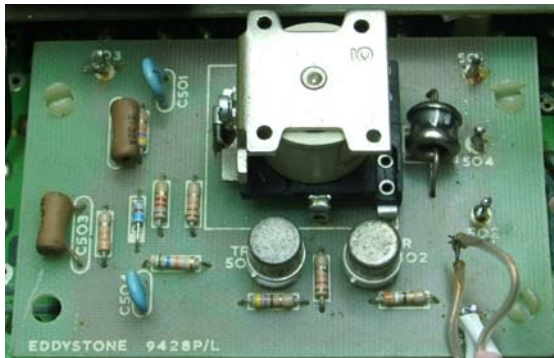
The 1002/2 incorporates a protection unit for the HF receiver. If a large transient or signal is sensed by the circuit RL1 will change over disconnecting the aerial and shorting the front end of the receiver to ground.

By today's standards the relay is an unusual design and replacements are not easily obtainable from hobbyist stores. In my set the circuit had been bypassed and further examination showed that the relay contacts were unreliable even after cleaning. No wonder it was disconnected. I didn't bother repairing it.

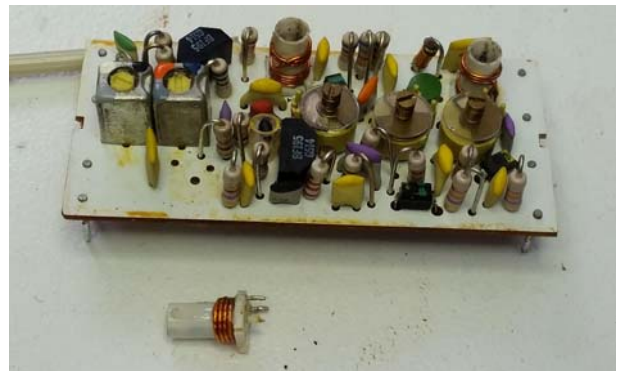
Sure enough, the slug for the OSC coil in the replacement unit was broken. Additionally, the tuner in my radio was a later revision and had several extra components added to the carrier board.

I noticed that the MIX and RF coils were the same physical construction, same number of turn, and simply had an extra winding. I figured it was unlikely that Eddystone would have used a different ferrite mix for the slugs. Since I was unsure of the state of the replacement unit I thought it best to replace the coils in my unit with those from the replacement unit.

A delicate task as the PCB quality was not that good and the tracks could not handle much heat. I removed the coils and pulled the top winding off one of the coil to use for the OSC. The other coil went in without modification.

With care and just enough heat to make a good solder joint I was able to rebuild the tuner. Thankfully my hunch about the ferrite cores was correct and the tuner performed as expected. Calibration was straight forward and even before I finished the job I knew I was on a winner. There was enough leakage to hear FM stations as I tuned back and forth along the dial.

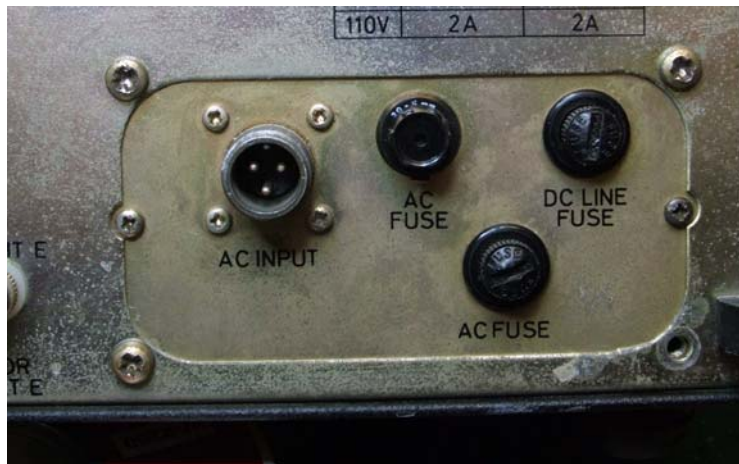
The remaining technical task is to see if I can find a connector to suit the mains input. I think this might be a Belling and Lee type connector but my searching has turned up nothing so far. I thought about installing a standard I.E.C. socket but there is not much room inside to accommodate something that size.
