Lou Blasco, VK3ALB  
[vk3alb@gmail.com](mailto:vk3alb@gmail.com)  
Version 1.1  
11 February 2018

## Introduction

I was given a Hakko 483 desoldering station that was destined for the rubbish heap. This document describes the revival of a unit which has seen better days.

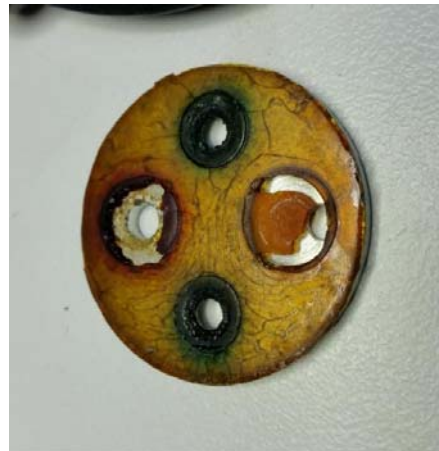
Trying to desolder an IC showed it wasn't working so well. A closer look at the tip showed that the melted solder was oscillating back and forth. Some solder was indeed entering the capture tube but just as much was being spat out onto the bench. This meant the pump was not working correctly.

The pump in the 483 is a big 600mm Hg unit. Most of it is motor but the diaphragm is almost 80mm in diameter. There should be a lot of suction from something if this size. The diaphragm was in good condition with no sign of tearing or perishing. The valve plate was another matter. This is a silicone rubber washer with two small flaps which act as the inlet/outlet valves. The plate had hardened, yellowed and perished. This was the issue.

I wondered if I could make a valve plate. A quick visit to eBay and I found a 500mm<sup>2</sup> sheet of silicon rubber that was 1mm thick. The price was little over \$10 free post and I thought it was worth another gamble.

The original valve plate was so badly perished that I couldn't use it for a template. I could however look at what was left of it and along with studying the fixing plate and the inside of the pump head work out that I needed to cut two flaps in the new material. I used a hobby knife with a brand new blade and went to it. In less than an hour the job was complete. The job was not very precise but the inlet and outlet ports were covered when required and it looked promising.
