Voting System Anomaly Root Cause Analysis Template v2.0

**VV40ECT-76: VxMARKSCAN ESD FAILURE AT PAT & ATI AND CARD READER - REV. 2
VxSUITE, VERSION 4.0 AND EAC CERTIFICATION #VXS4**

**VOTINGWORKS
548 MARKET ST, STE 53001
SAN FRANCISCO, CA 94104-5401**

SEPTEMBER 30, 2025

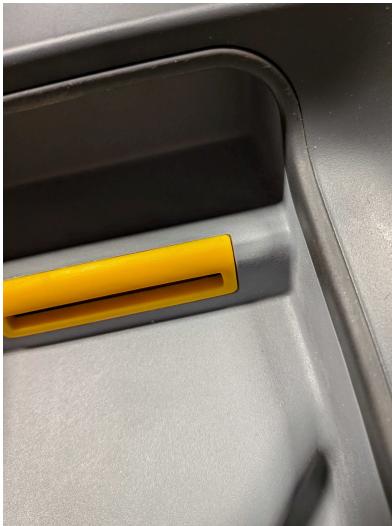
3. To reproduce the persistent card reader issue: Apply ESD to the card reader plastic housing, especially around the seam between the card reader housing and the surrounding plastic, shown in this photo:

14	7/23/25, 7:06am	In another VxMarkScan unit MK-11-003, the card reader fails on ESD applied to card reader housing.	Jessica Myers, Jesse DeWald, VotingWorks	Failure occurred at 8keV. The card reader did not function properly after restart. It was noted that ESD appeared to spark through the seam between the card reader plastic housing and the main unit plastic housing.

2. Too close a path between the card reader electronics and the external ESD source at the surface. At higher keV ESD levels, the generated air discharge spark could travel through openings around the plastic card reader holder to the card reader board. This could directly damage electronics.

- **ESD conducted to the card reader board** – This led to damage to the card reader leading to persistent errors. This stemmed from too short a distance that an ESD arc had to travel between the card reader housing and the card reader board electronics.
- **Optimal mitigation by only moving card reader** – Altering the card reader position by moving it further back into the system by 0.5-0.75" led to no ESD sparks, even at 15keV air discharge. This resolved card reader ESD issues in lab testing. See photo below of prototype positioning tested, where the bracket fastener holes were adjusted to shift the card reader deeper into the main module.

The bracket holding the card reader was modified to move the card reader deeper into VxMarkScan by approximately a half inch, determined by testing to be sufficient for ESD resistance. See the diagram below for a comparison of the original card reader bracket positioning versus the new positioning, that allows a greater offset between the card reader and the plastic housing:

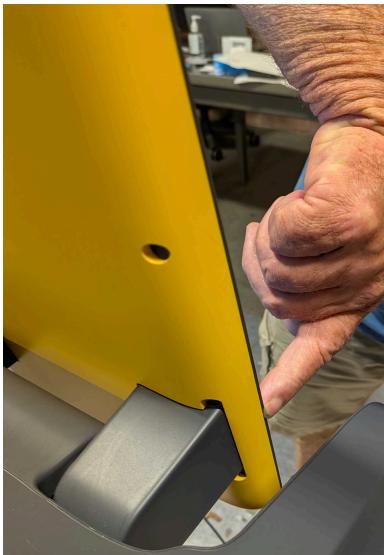
4. To reproduce the persistent display ESD issue affecting the PAT and ATI: Apply ESD to the lower left part of the touchscreen display, at the seam in the plastic housing, shown in this photo reported by SLI:

15	7/23/25, 7:06am	ESD applied on the lower left side of the VxMarkScan touchscreen display at the seam in the plastic housing cause the PAT and ATI to stop functioning.	Jessica Myers, VotingWorks	Did not recover upon reboot. The screen appeared to be unaffected and was still responding to touch. Log files were saved for analysis. Plans were made to partner with an EMC engineering firm to analyze the new ESD issues seen with VxMarkScan in July testing.
16	9/30/25, 2pm	EMI Test Lab in Longmont, CO, begins ESD investigations of VxMarkScan, on a unit different from the one that underwent ESD testing at Element. EMI Test Lab reports initial findings.	Dennis King, Uriah Higgins, EMI Test Lab; Pius Wong, VotingWorks	Some potential mitigations were found to help but not completely resolve the issue, including applying additional grounding between the card reader support bracket and the main chassis, and applying more electrical insulation around the card reader itself.

3. Compromised insulative material at the bezel around the display. Similarly to the point above, at higher keV ESD levels, the spark could travel through gaps at the seams around the touchscreen display plastic housing, and through thin or broken parts of the insulation around the screen. The ESD could transfer to other parts of the system from there, depending on the location of the discharge. At Element, the previously observed failure was likely through ESD conducting through the lower display support brackets to the PAT and ATI.

- **Existing gasket material around display compromised** – The tested unit at EMI Test Lab showed ESD sparking around the display edge in the upper left corner, and upon opening and analyzing the internals, the gasket material between the display glass and its bezel in this area was found to be thinned. This allowed ESD to penetrate into the display at this area and not in other areas around the display.
- **Reapplying electrical insulation around the screen prevented ESD sparking** – High-voltage RTV silicone with 30keV breakdown dielectric strength applied to the

The original compromised gasket material that lies between the display glass and the plastic display bezel would be inspected and replaced with insulative RTV silicone with 30keV dielectric breakdown strength. The silicone would also seal the gap between the two halves of the plastic housing for the display.
