## Voting System Anomaly Root Cause Analysis Template v2.0

**ANKER SOLIX UPS FAILURES IN ELECTROMAGNETIC COMPATIBILITY TESTING, REPRODUCED FOR  
VV40ECT-78: POWER DIPS TESTS - REV. 3  
VxSUITE, VERSION 4.0 AND EAC CERTIFICATION #VXS4**

**VOTINGWORKS  
548 MARKET ST, STE 53001  
SAN FRANCISCO, CA 94104-5401**

**JULY 17, 2025**

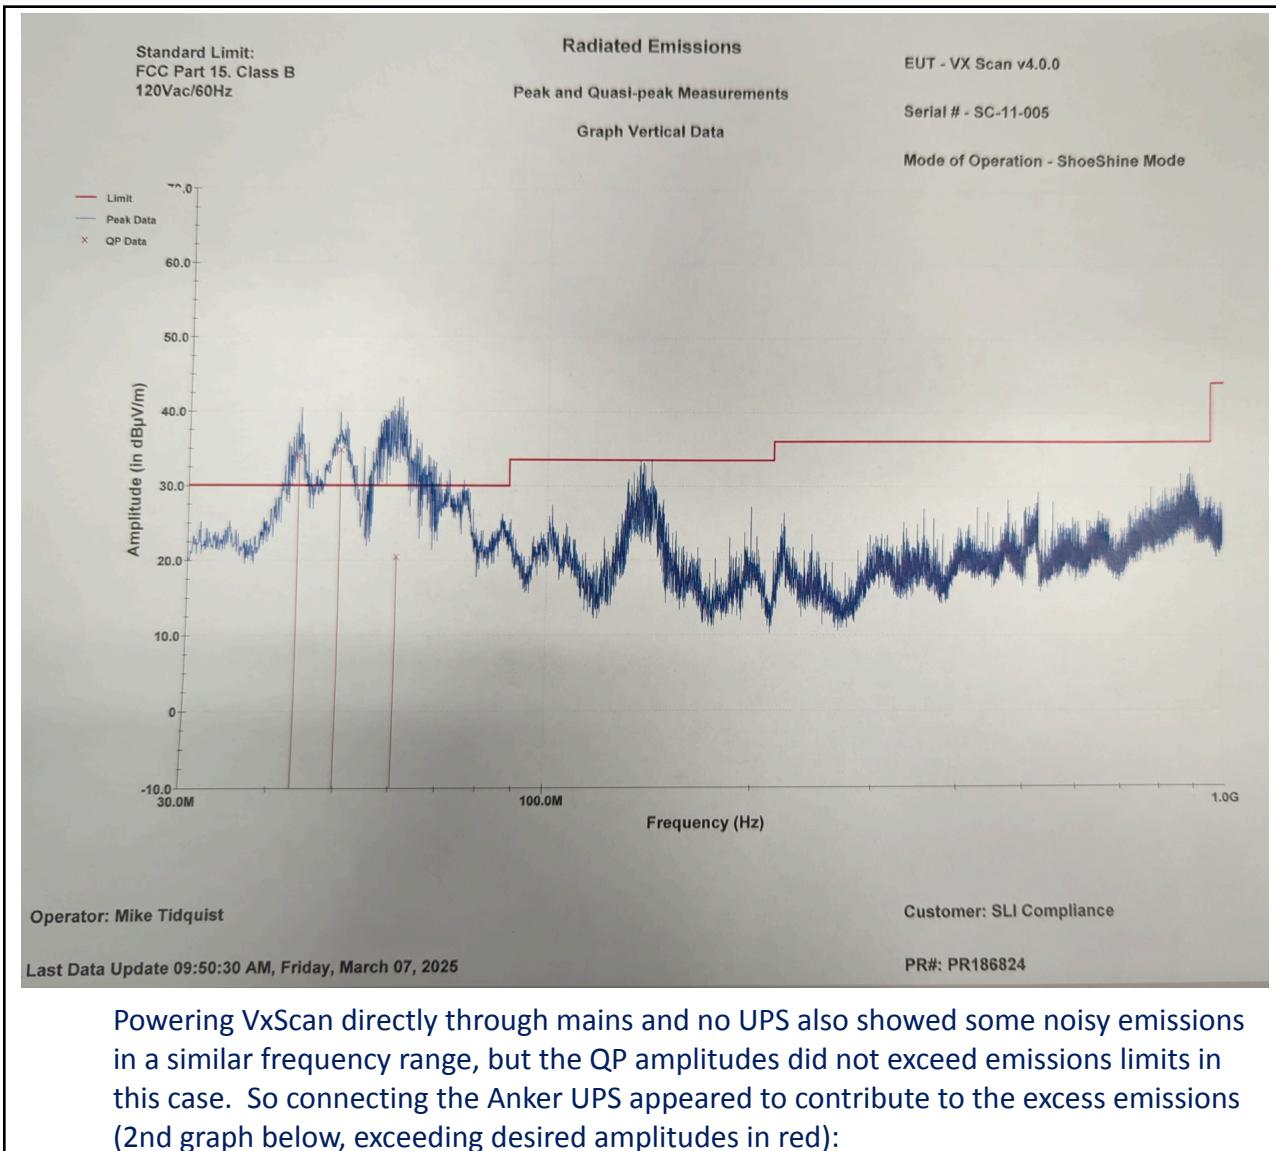
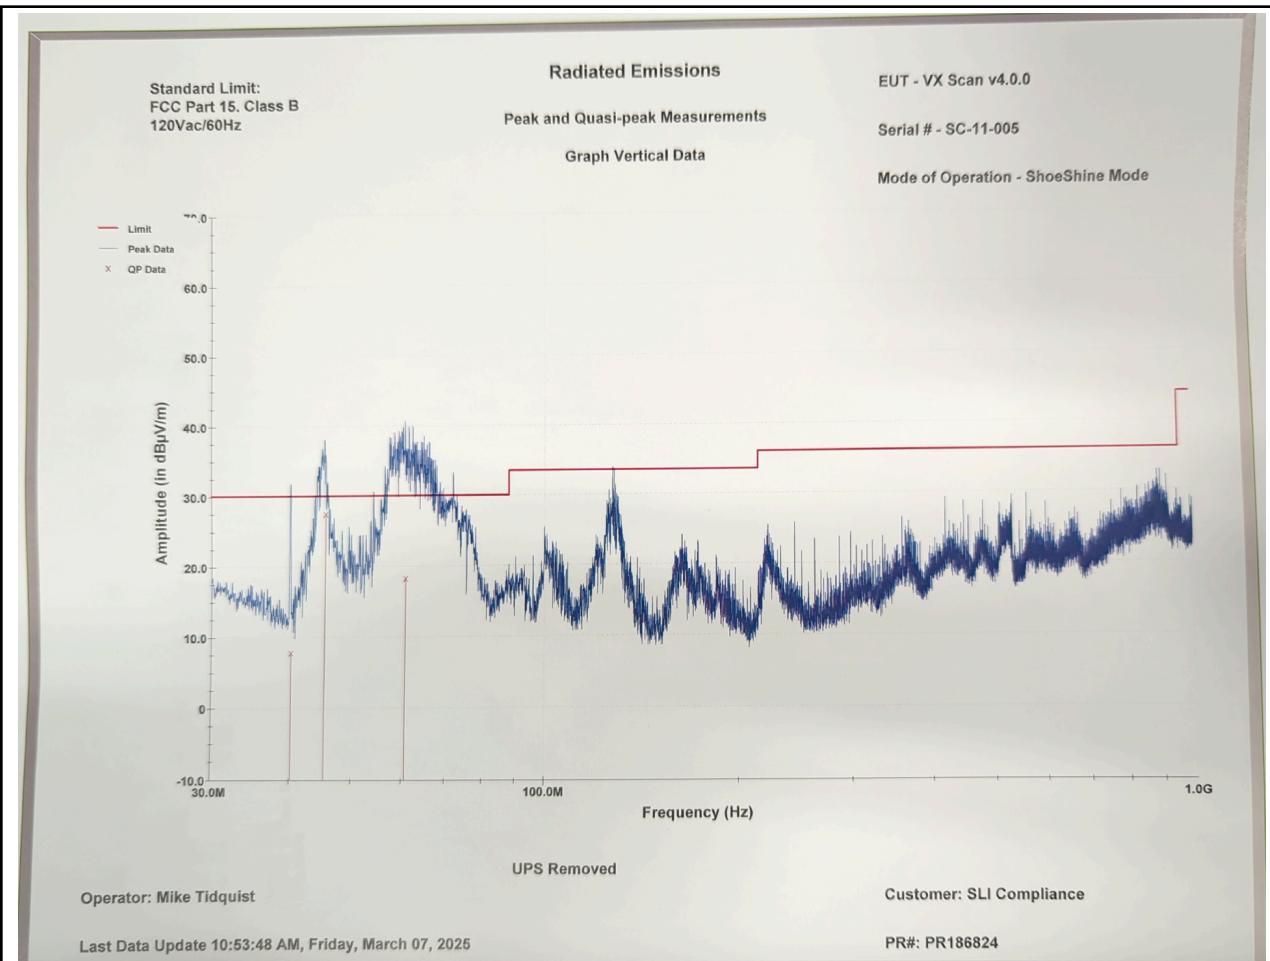
- Instead of passing emissions tests, the VxScan system when connected with the Anker UPS failed Radiated Emissions testing from 30 MHz to 1 GHz. Since this was unexpected, a series of additional tests followed to confirm emissions behavior of the system, showing the UPS appeared to show problematic emissions. This can be seen in emissions data from when VxScan was powered through the UPS connected to mains (first graph below, QP amplitudes exceeding desired amplitudes in red):

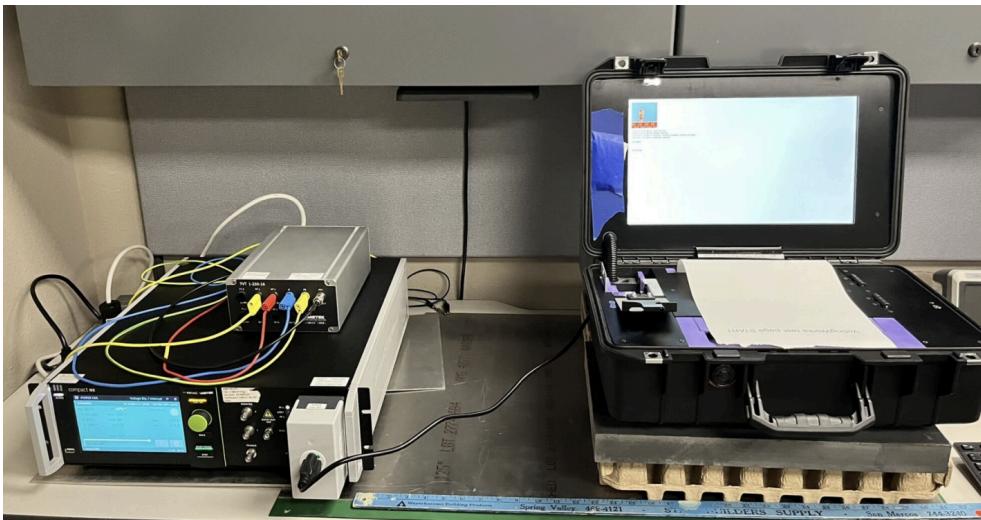
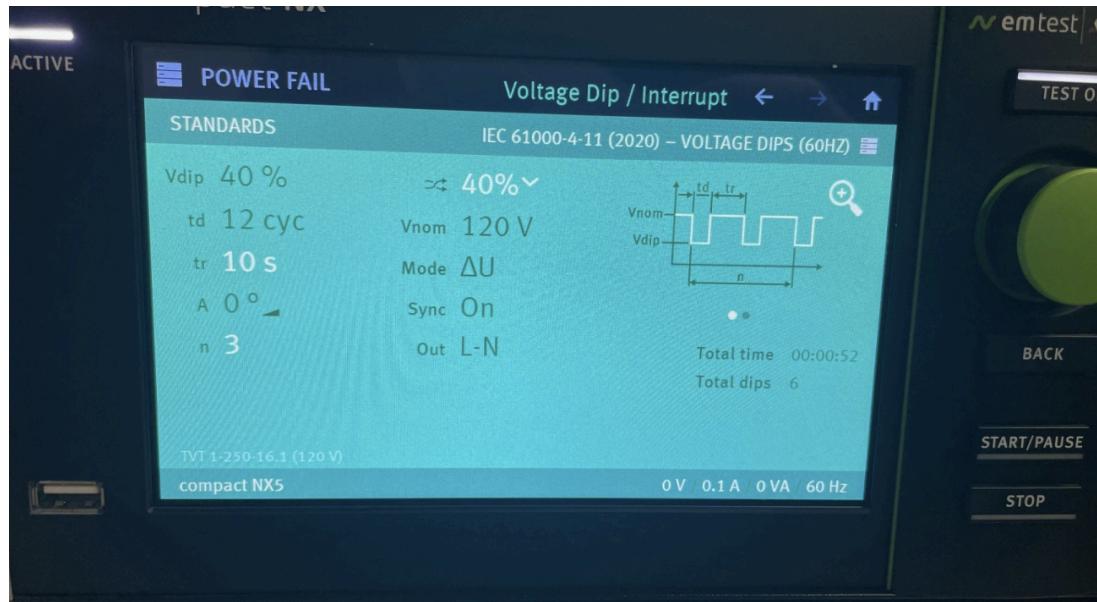
- Voltage Dip testing under IEC 61000-4-11 standards testing was carried out with NOVO Engineering using Compact NX5 test equipment loaded with standard modules and settings (setup picture in photos below) and resulted in similar failures as with SLI when using the Anker UPS with VxScan.

- With the exact same setup, the APC UPS did not show problems. As stated by NOVO about the APC connected to VxScan: "Once in a steady-state of operation the IEC 61000-4-11 Voltage Dip test was initiated and did not result in a reboot of the VxScan unit. About 15 seconds later, we initiated the Voltage Interrupt testing which also did not result in a reboot of the VxScan unit. Since no disruptions to the EUT normal operation occurred, pre-compliance testing resulted as a PASS."

1. Testing will continue with Element/SLI on the VxScan system with the APC UPS. Based on data supplied by NOVO Engineering as of March 31, 2025, this UPS is a viable alternative: the APC Back-UPS Pro 10-Outlet UPS (model number BN1500M2). It not only passes the tests at NOVO currently but also is part of the VxMark system.

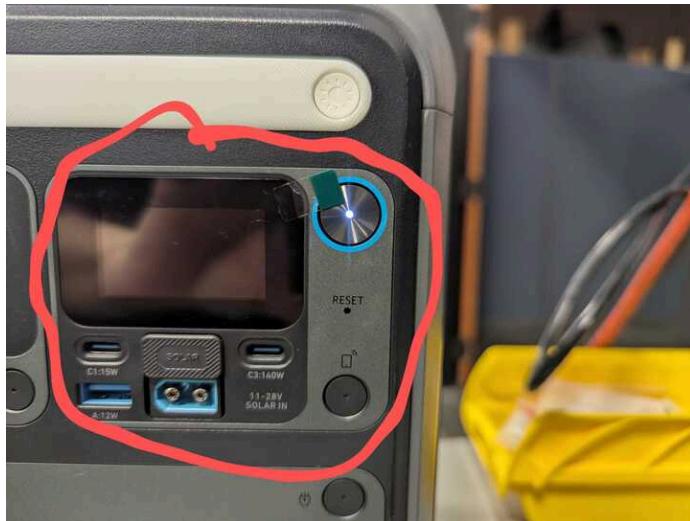
- Internal testing identified occasional difficulties with users confirming the IoT button was truly off, especially if the UPS was previously connected to its corresponding Anker UPS smartphone app.
- Element/SLI saw UPS emissions around the following region using the near-field probe:

This area of the UPS controls overall power, IoT function, and user displays, and not all these functions can be disabled during use.

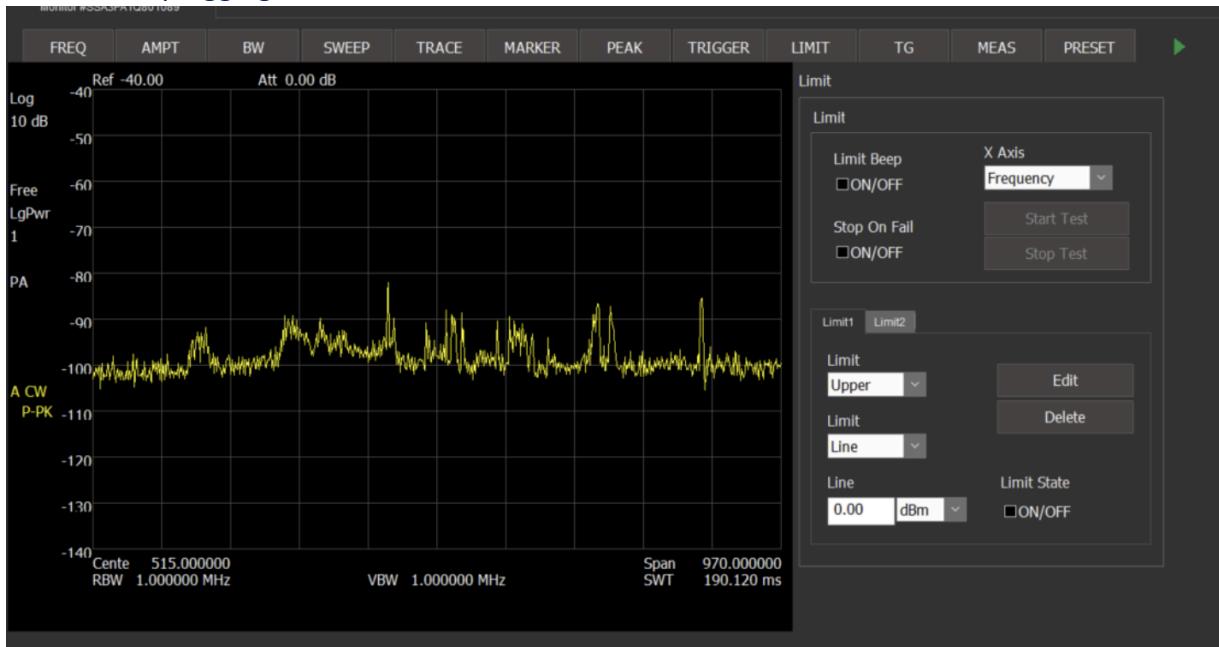
Data before plugging in UPS to mains:

- NOVO did find general rise in emissions of 10db when comparing a UPS plugged into mains, vs a UPS not plugged into mains, but nothing clearly problematic, and nothing particularly at the lower frequency range at issue with the testing at Element/SLI. NOVO writes, “Scans all around both the UPS and VxScan unit did not show any notable spurs or significant jump in the observed frequency spectrum.” Again this points to some inconsistency between Anker UPS units. Snapshots of emissions readings taken before and after plugging in the Anker UPS are below, showing benign emissions.
