Test Report - VxScan v4.0 Build 0 Drop Test - Bench Handling

Pius Wong Sep 3, 2024 updated Sep 12, 2024

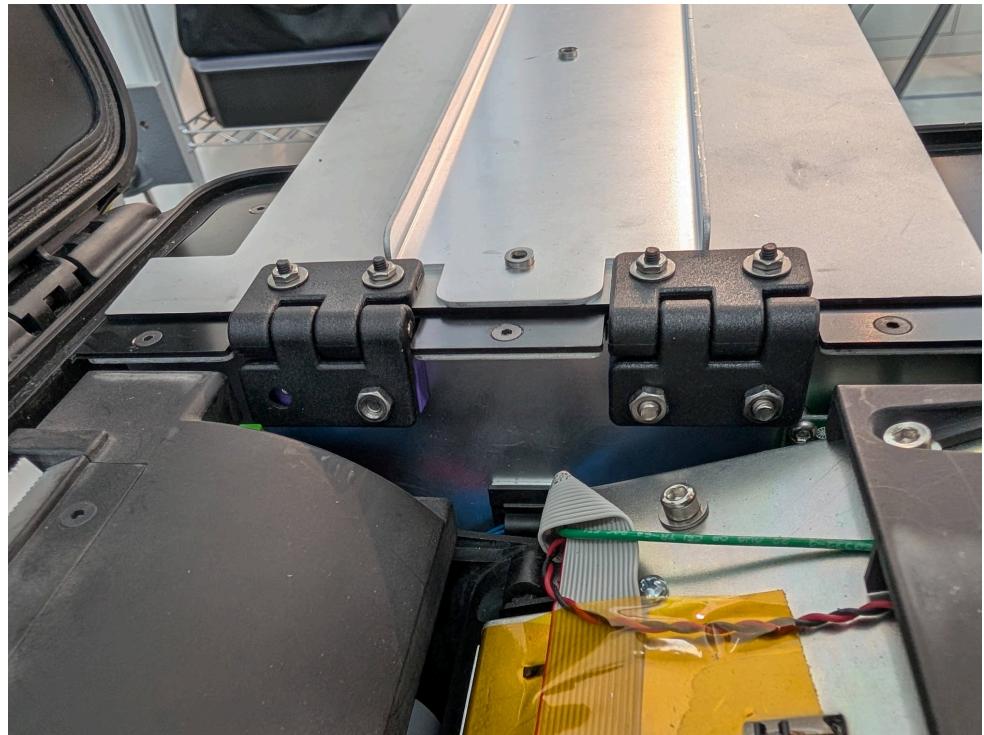
- vi. After dropping on the right face, along the 4 edges (4 drops):
 1. Small loose part(s) were audible still inside the lower tub. The scanner access door rear hinge lower segment lost a bolt and nut, and the remaining bolt/nut was loose. This made the scanner access door loose, compromising structural and functional integrity. See this [linked video](#) and the photo below, showing the loosened hinge on the left:

- a. Without opening up the device, the only structures compromised by benchtop drop testing were the hinges around the scanner access door (as seen in this [linked video](#) already described above).

However, these benchtop drops did loosen fasteners in the scanner access door that had no locking features. This could in turn compromise the security of the MCM Build 0 and should be prevented.

It is recommended to have a QA system in place to help ensure the appropriate loosening-resistant fasteners are used at all points in manufactured units. Future and final MCM designs should mitigate risks from drops by using locknuts, threadlocker adhesive, or any similar solution that can prevent loosening of fasteners at MCM hinges. Most of the MCM fasteners already have these solutions in place, and Pump Studios expressed desires to ensure all fasteners have it in place in the final designs.

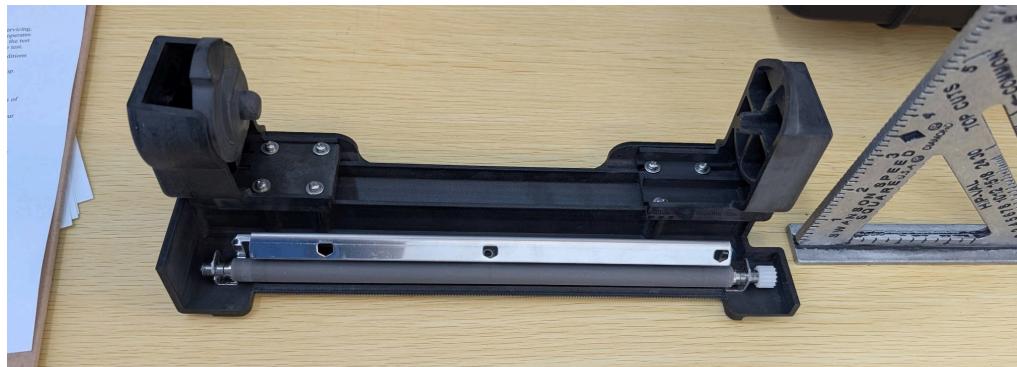
- b. The paper roll was removed from the thermal paper roll holder, and the empty paper roll holder was drop-tested, for a total of 24 drops. Because it was weighted more to one side, it frequently ended up on this side after drops, as shown here:

- c. No damage was found after all drops. Paper rolls could be removed and reinserted without problems. The holder could be reinserted into the MCM without problems.

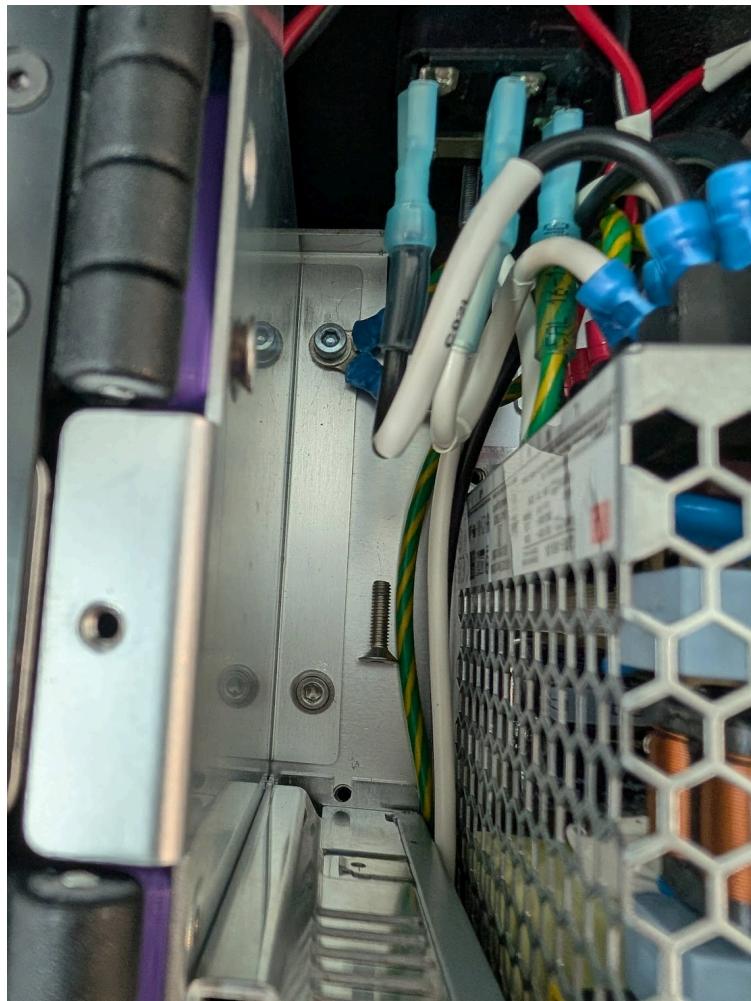
- b. Opening up the bottom tub panels revealed only those loose fasteners. One bolt fell out completely into the bottom of the tub that could be retrieved:

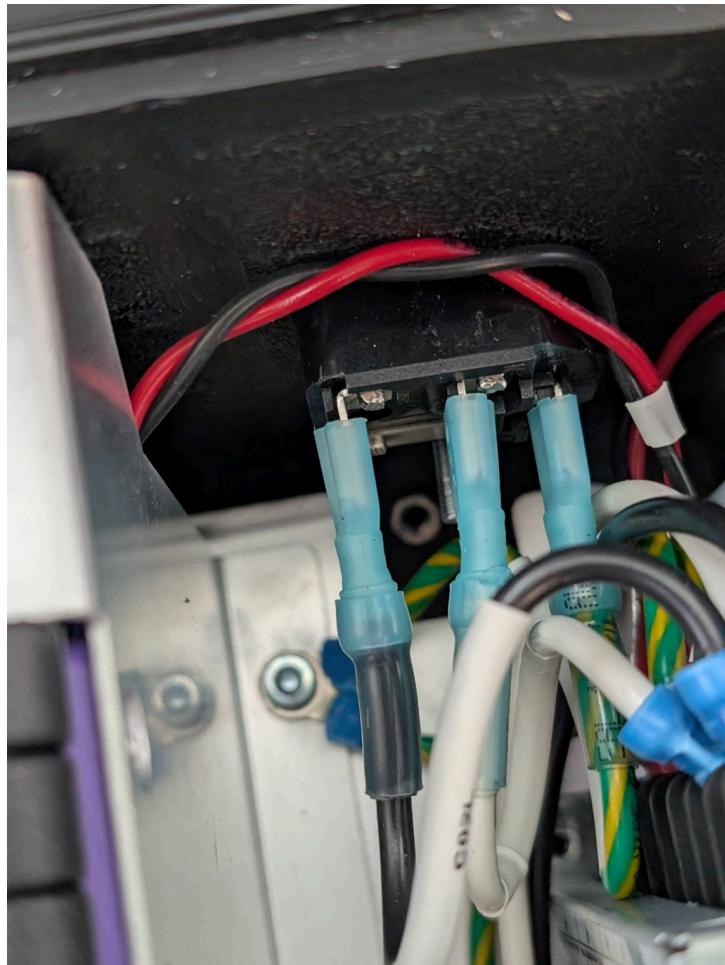
The associated loose nut was difficult to find, as it was under the metal subpanel, between the subpanel and the outer plastic case. The MCM had to be tilted back and forth to roll it into a position near the rear right corner by the mains power port, before it was positioned in a way to be retrieved without detaching more parts. It is shown near the center of the photo below, and it could be retrieved with a tool without disturbing other parts:

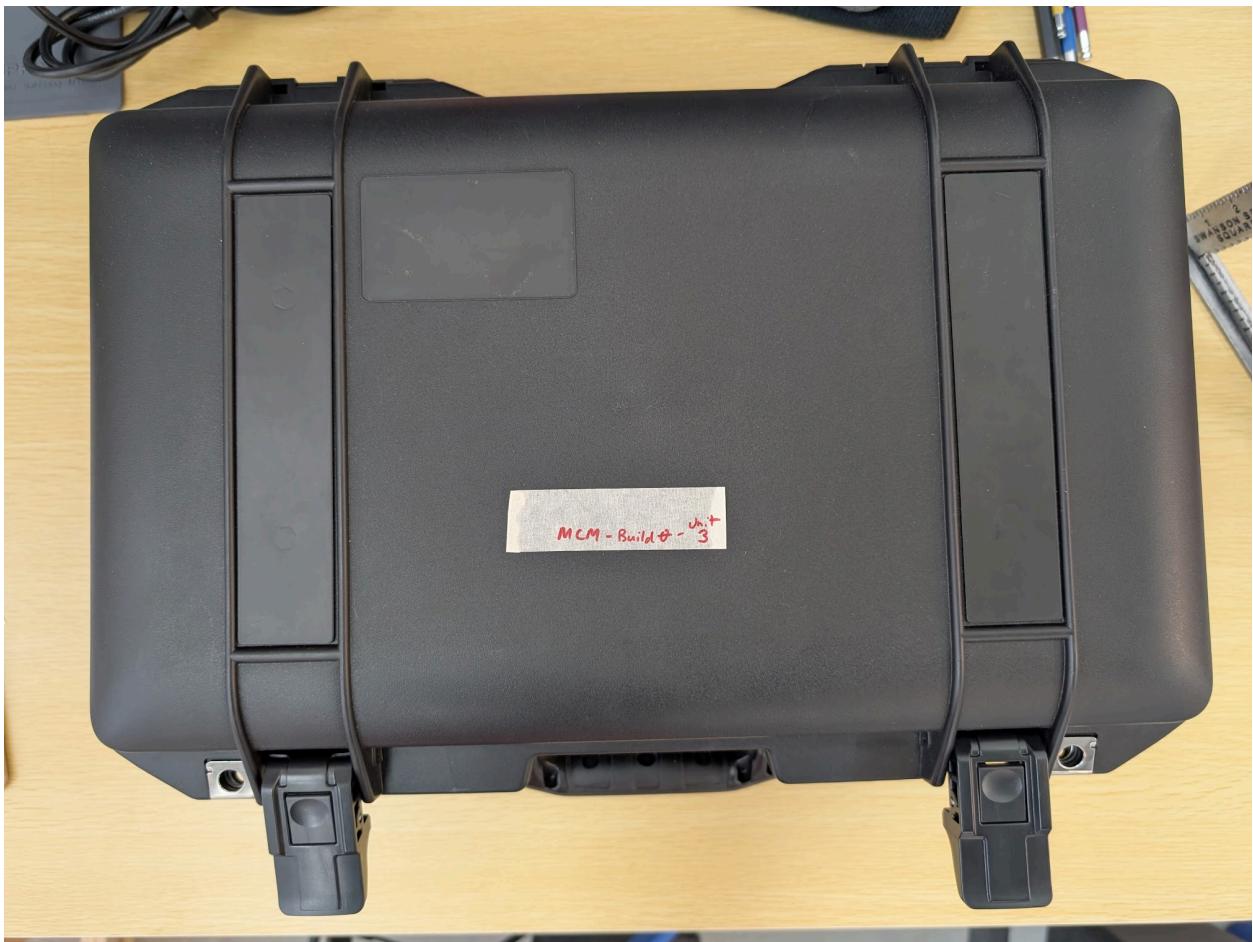
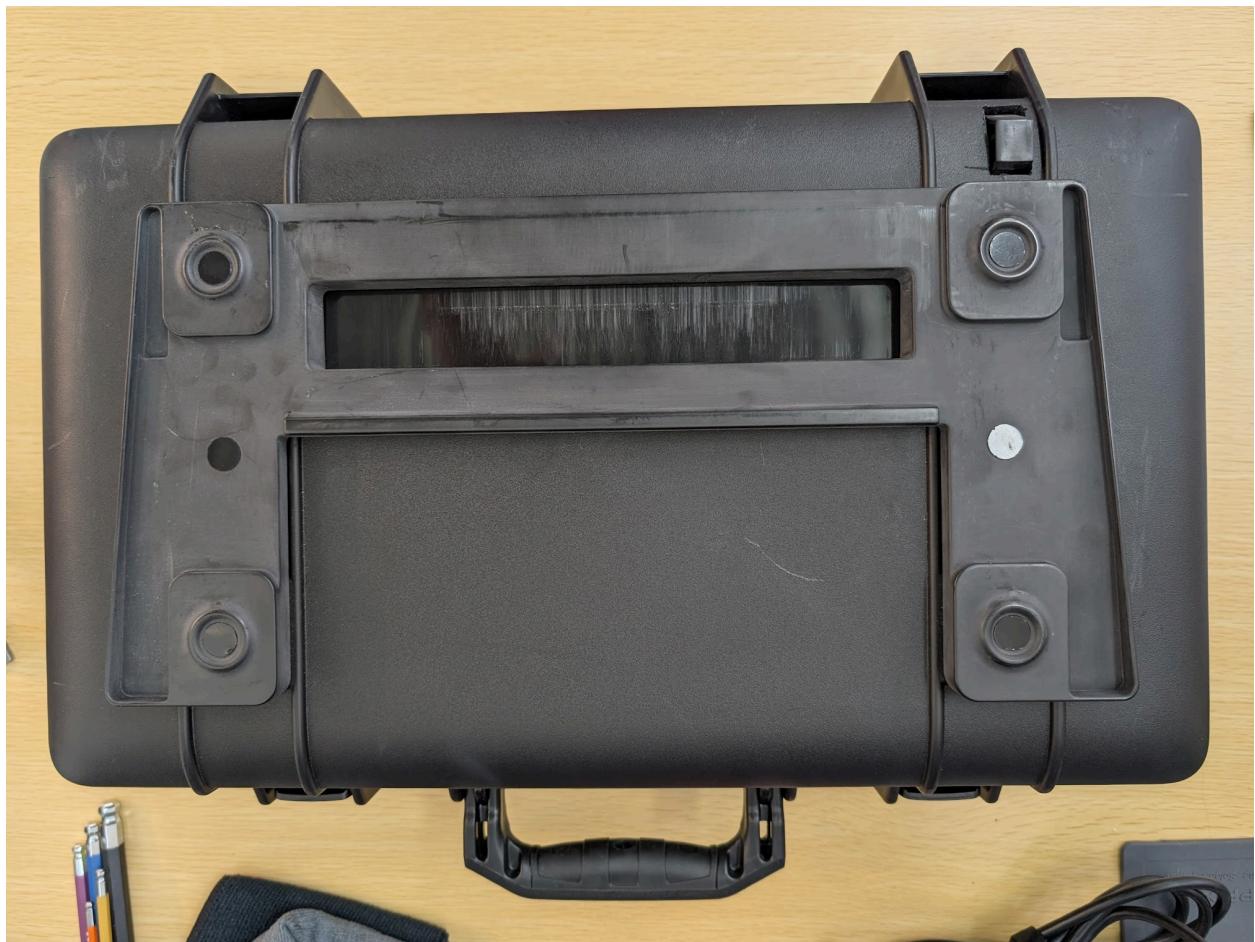
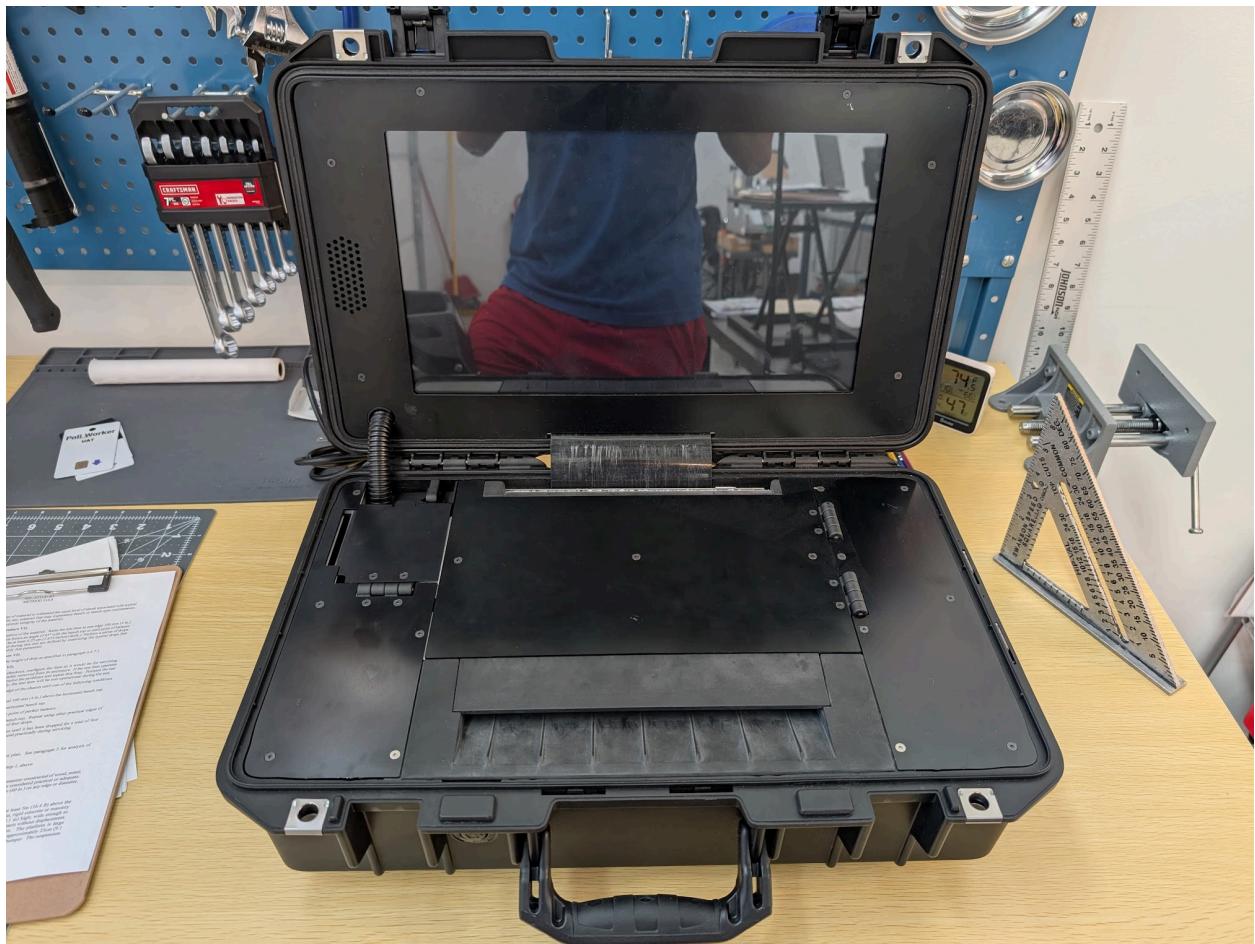
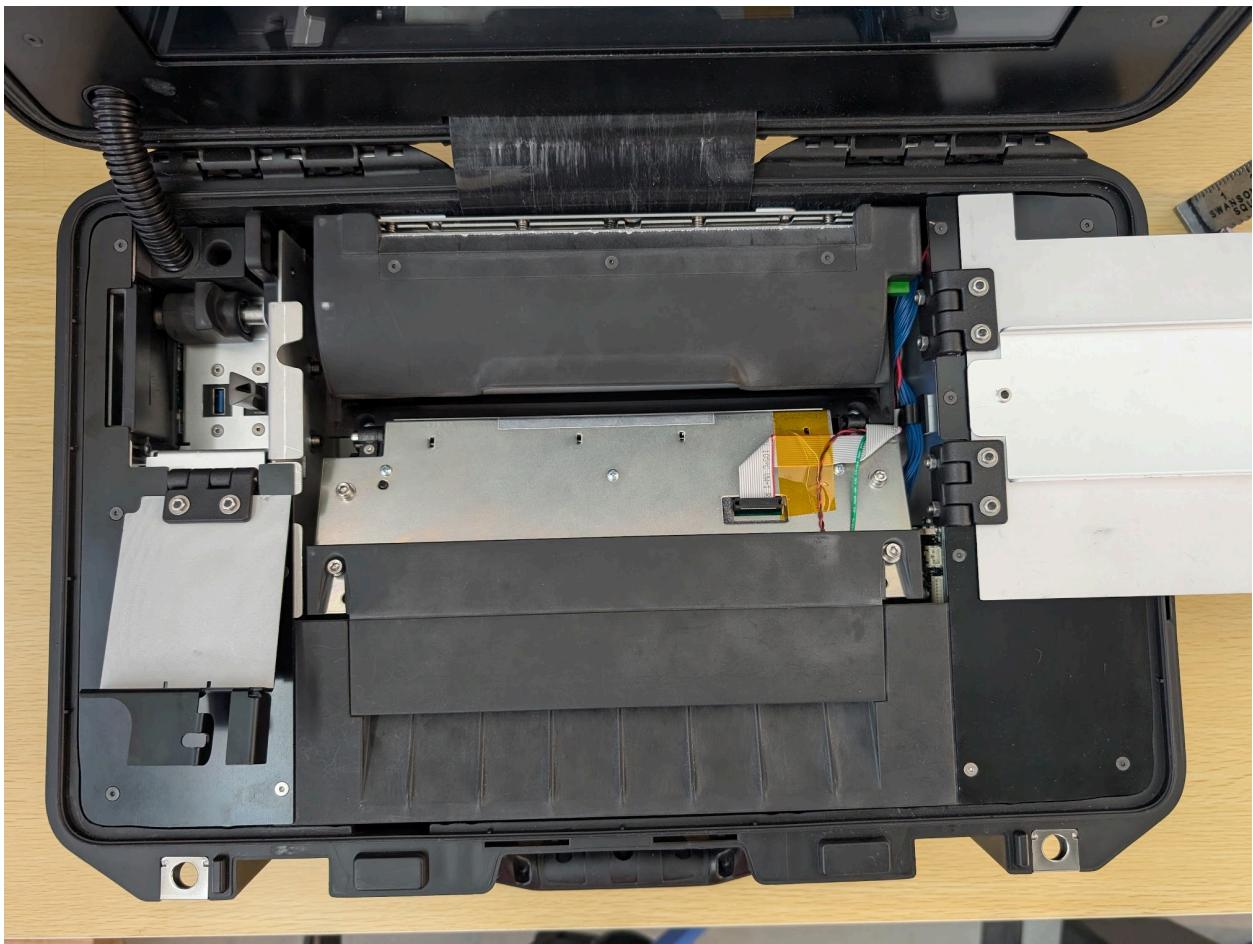
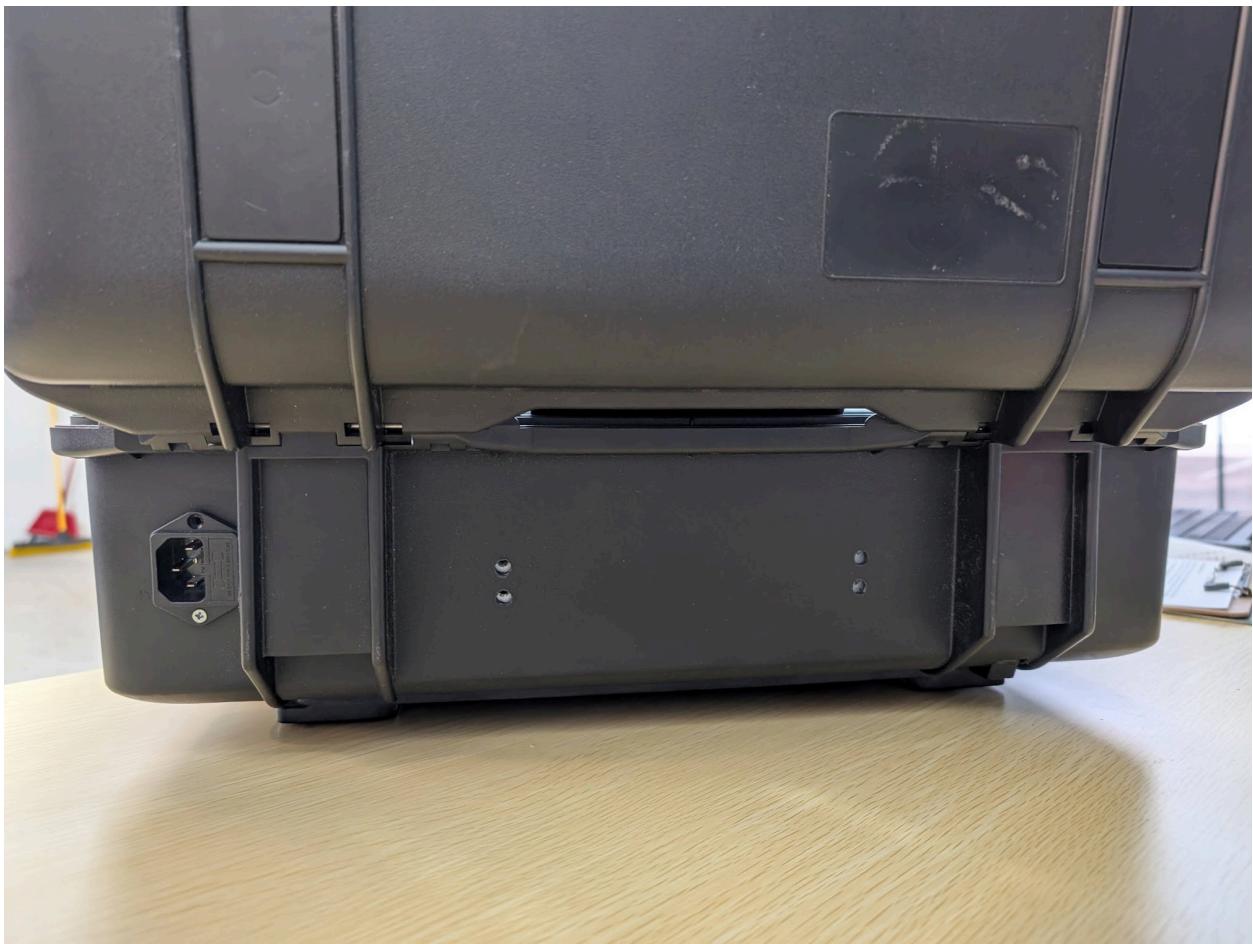
Appendix A: Device photos before drops

Note: This test unit did not have the rear cord holder or one of the bolts holding the power supply to begin with, due to previous use, as noted in this report.
