# Test Report - VxScan Drop Test, Bench Handling

Pius Wong Sep 3, 2024 updated Sep 12, 2024

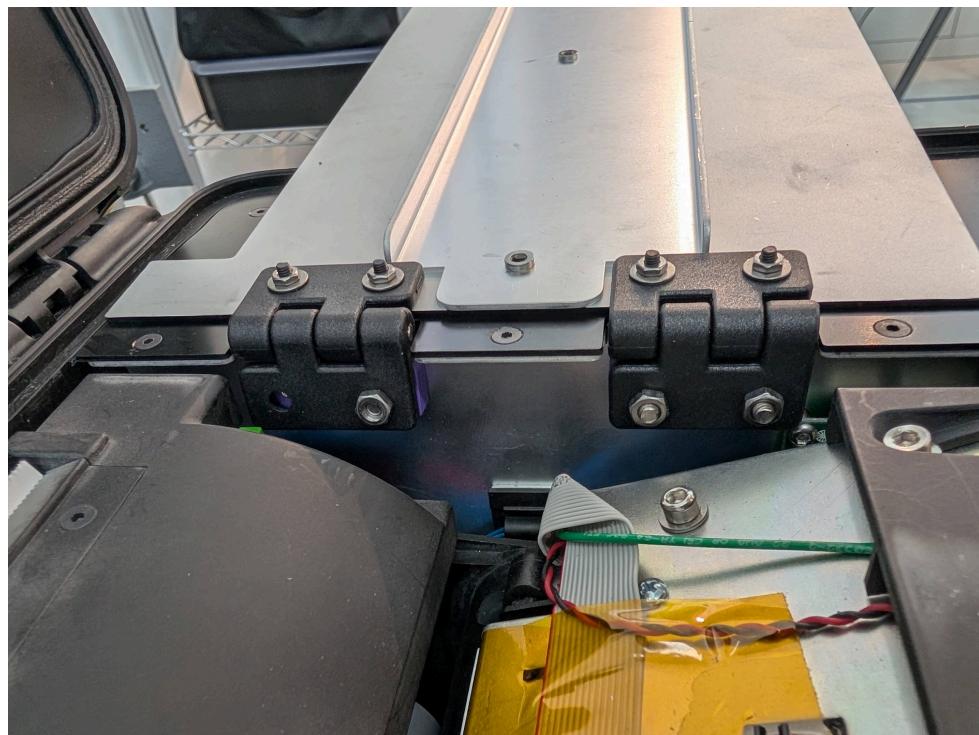
1. The loose part could not be heard, potentially stuck, or fallen back into place. It was noted to check for it again later.
- v. After dropping on the left face, along the 4 edges (4 drops):
  1. Small loose part(s) were audible again inside the lower tub. It could not be found in a quick inspection.
- vi. After dropping on the right face, along the 4 edges (4 drops):
  1. Small loose part(s) were audible still inside the lower tub. The scanner access door rear hinge lower segment lost a bolt and nut, and the remaining bolt/nut was loose. This made the scanner access door loose, compromising structural and functional integrity. See this the photo below, showing the loosened hinge on the left:

- a. Without opening up the device, the only structures compromised by benchtop drop testing were the hinges around the scanner access door

However, these benchtop drops did loosen fasteners in the scanner access door that had no locking features. This could in turn compromise the security of the MCM Build 0 and should be prevented.

It is recommended to have a QA system in place to help ensure the appropriate loosening-resistant fasteners are used at all points in manufactured units. Future and final MCM designs should mitigate risks from drops by using locknuts, threadlocker adhesive, or any similar solution that can prevent loosening of fasteners at MCM hinges. Most of the MCM fasteners already have these solutions in place, and Pump Studios expressed desires to ensure all fasteners have it in place in the final designs.

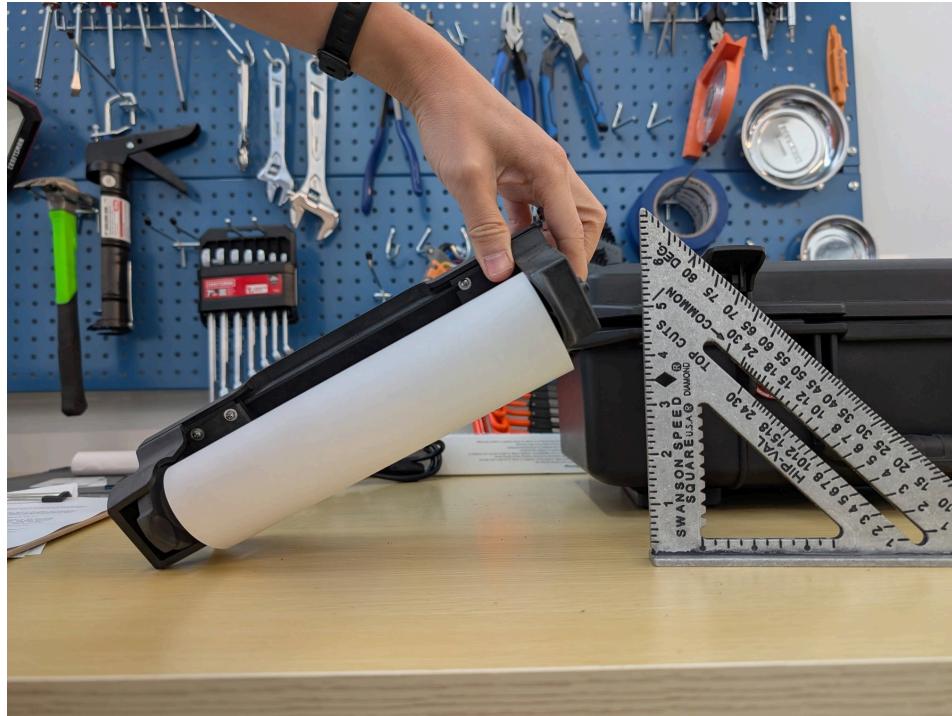
- a. The thermal paper roll holder was removed from the system and drop-tested with the paper roll in it, for a total of 24 drops. See image below for an example setup before dropping:

- c. No damage was found after all drops. Paper rolls could be removed and reinserted without problems. The holder could be reinserted into the MCM without problems.

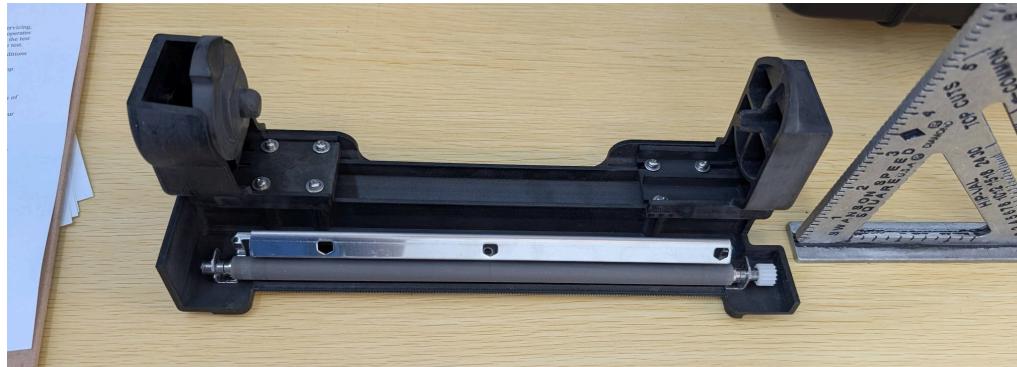
- b. The paper roll was removed from the thermal paper roll holder, and the empty paper roll holder was drop-tested, for a total of 24 drops. Because it was weighted more to one side, it frequently ended up on this side after drops, as shown here:

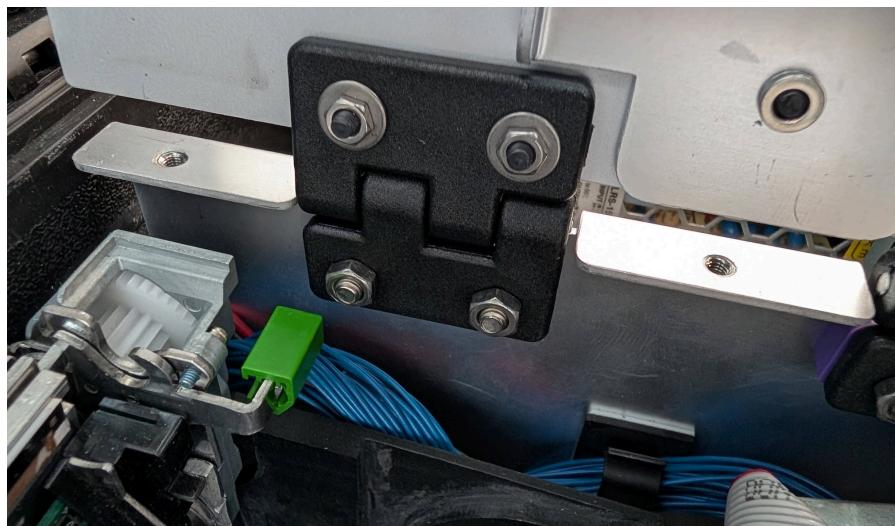
No other loose parts were found or heard, so these known loose parts were reattached, and the hinge nuts were tightened:

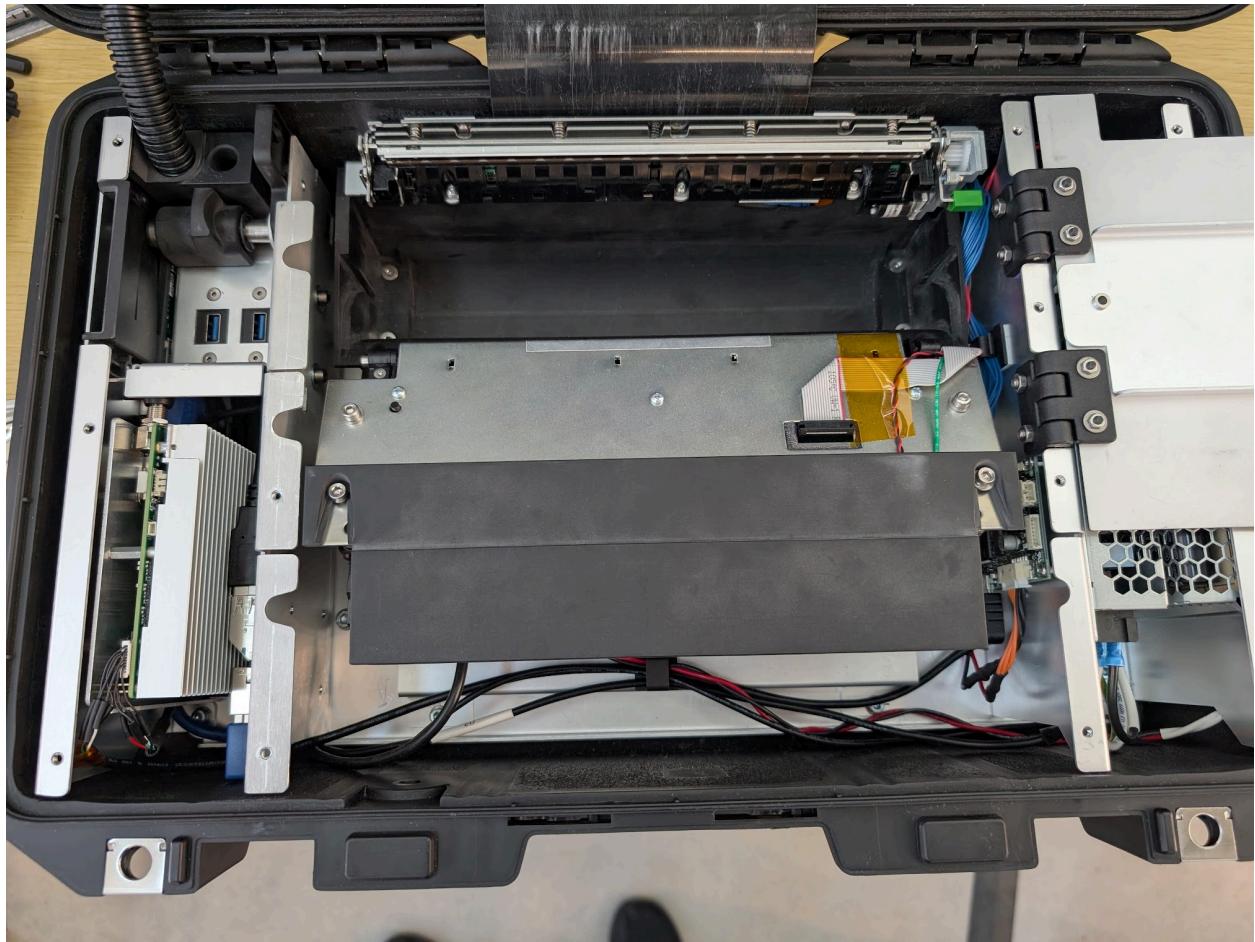
No other visible damage could be found on the inside of the lower tub, pictured here:
