## Voting System Anomaly Root Cause Analysis Template v2.0

**ANKER SOLIX UPS FAILURES IN ELECTROMAGNETIC COMPATIBILITY TESTING, REPRODUCED FOR  
VV40ECT-78: POWER DIPS TESTS - REV. 2  
VxSUITE, VERSION 4.0 AND EAC CERTIFICATION #VXS4**

**VOTINGWORKS  
548 MARKET ST, STE 53001  
SAN FRANCISCO, CA 94104-5401**

**MAY 13, 2025**

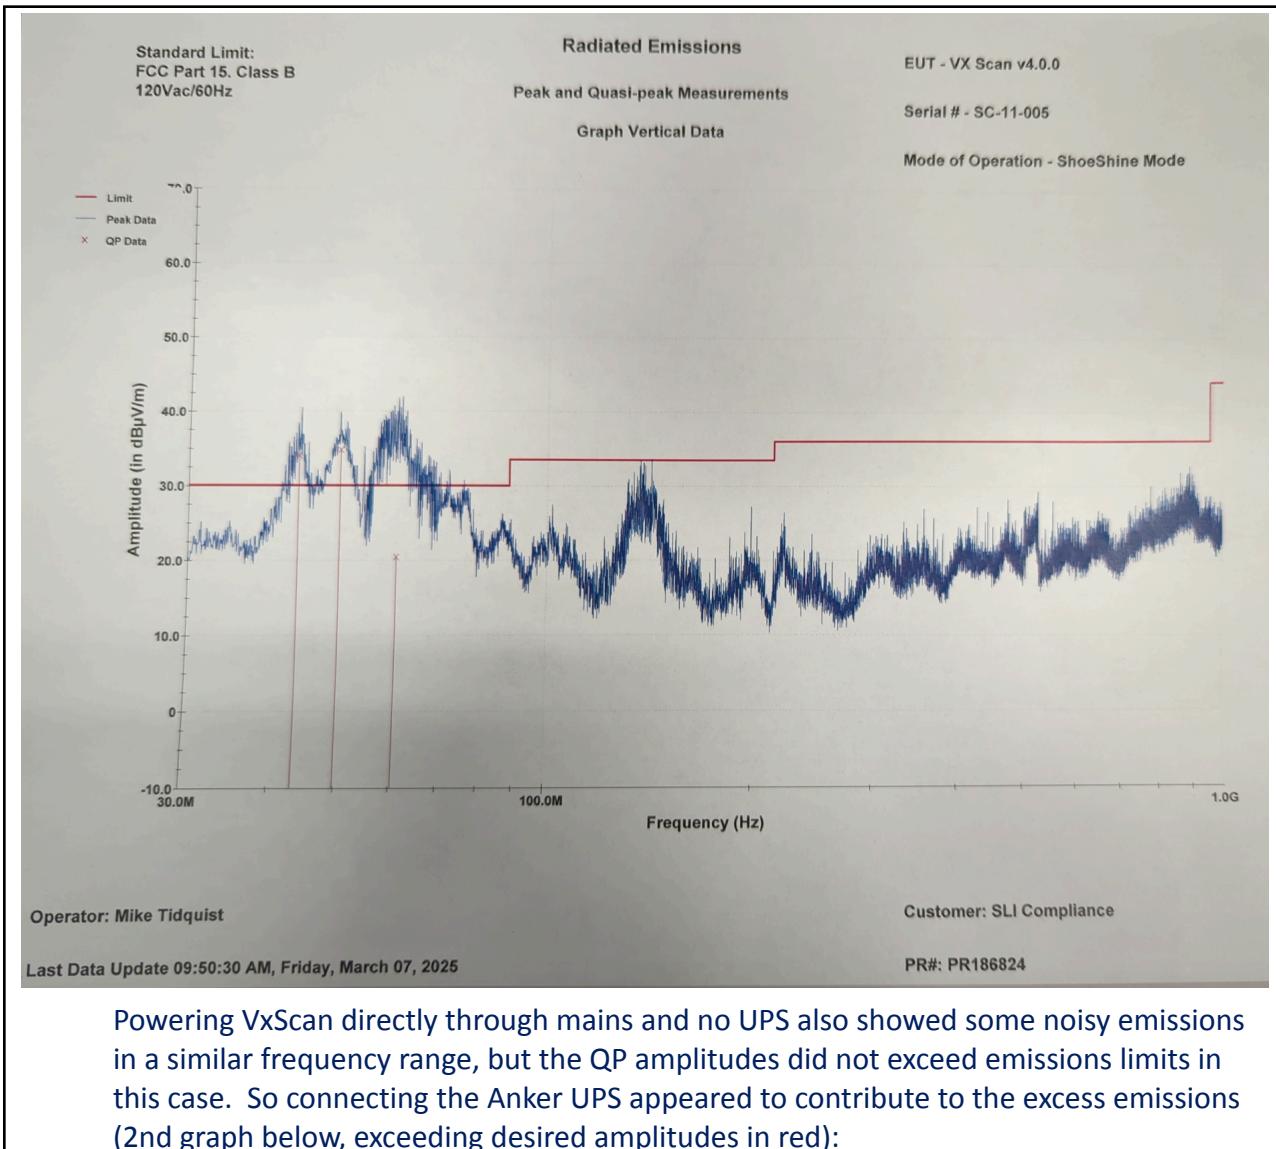
- Instead of passing emissions tests, the VxScan system when connected with the Anker UPS failed Radiated Emissions testing from 30 MHz to 1 GHz. Since this was unexpected, a series of additional tests followed to confirm emissions behavior of the system, showing the UPS appeared to show problematic emissions. This can be seen in emissions data from when VxScan was powered through the UPS connected to mains (first graph below, QP amplitudes exceeding desired amplitudes in red):

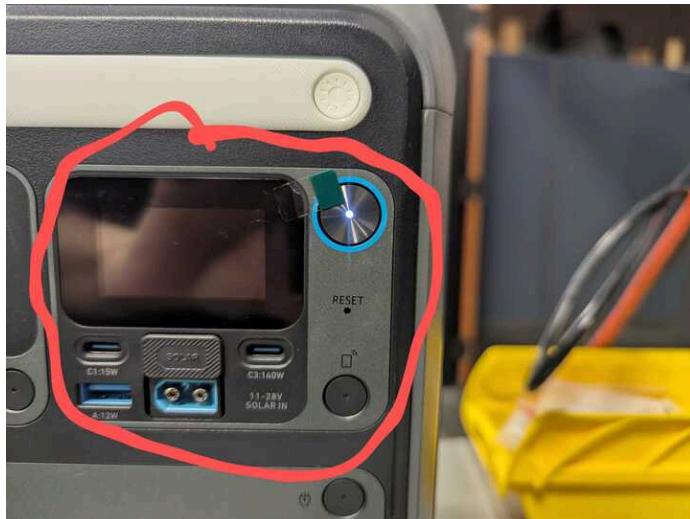
- Internal testing identified occasional difficulties with users confirming the IoT button was truly off, especially if the UPS was previously connected to its corresponding Anker UPS smartphone app.
- Element/SLI saw UPS emissions around the following region using the near-field probe:

This area of the UPS controls overall power, IoT function, and user displays, and not all these functions can be disabled during use.

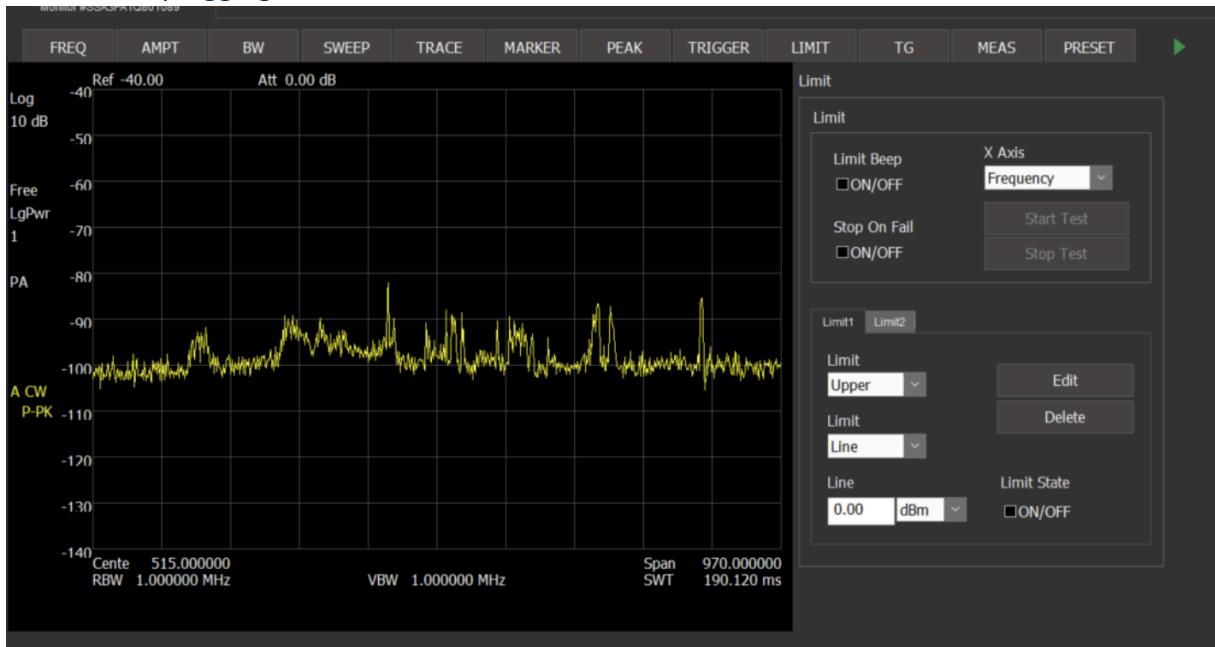
Data before plugging in UPS to mains:

- NOVO did find general rise in emissions of 10db when comparing a UPS plugged into mains, vs a UPS not plugged into mains, but nothing clearly problematic, and nothing particularly at the lower frequency range at issue with the testing at Element/SLI. NOVO writes, “Scans all around both the UPS and VxScan unit did not show any notable spurs or significant jump in the observed frequency spectrum.” Again this points to some inconsistency between Anker UPS units. Snapshots of emissions readings taken before and after plugging in the Anker UPS are below, showing benign emissions.
