## Voting System Anomaly Root Cause Analysis Template v2.0

**ANKER SOLIX UPS FAILURES IN ELECTROMAGNETIC COMPATIBILITY TESTING, REPRODUCED FOR  
VV40ECT-78: POWER DIPS TESTS - REV. 3  
VxSUITE, VERSION 4.0 AND EAC CERTIFICATION #VXS4**

**VOTINGWORKS  
548 MARKET ST, STE 53001  
SAN FRANCISCO, CA 94104-5401**

**OCTOBER 13, 2025**

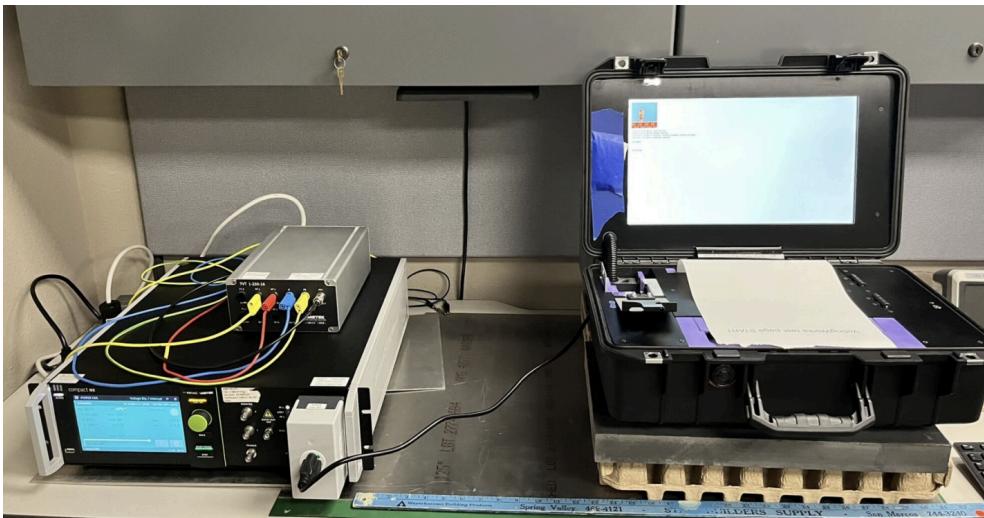
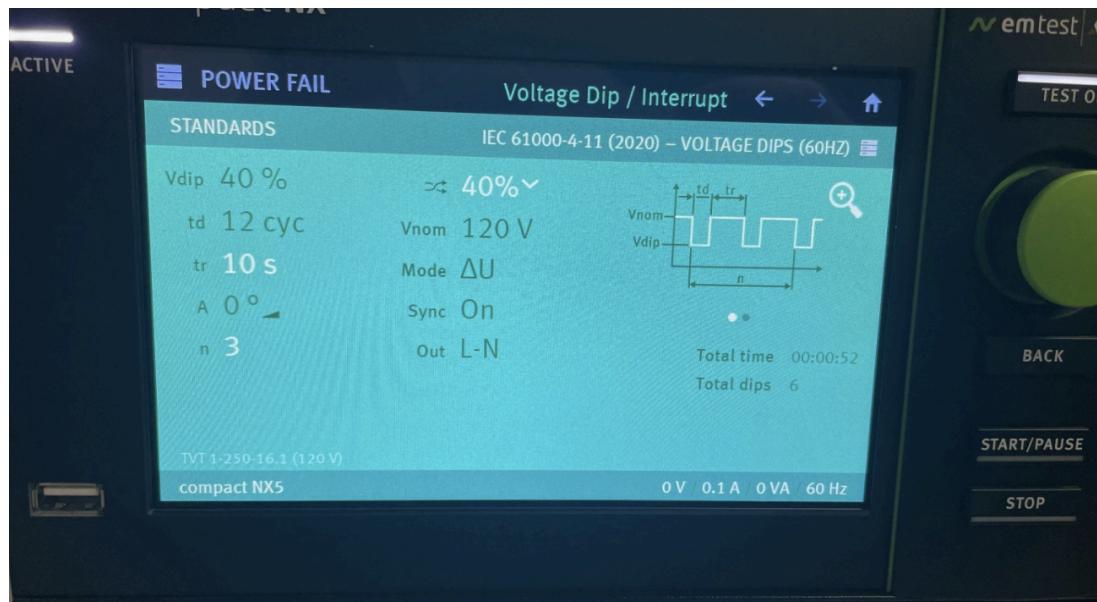
3. For Voltage Dip testing: Failure was reproduced for 40% Voltage Dips using the Anker UPS, but notably not for Voltage Interruption. NOVO explains, “Once in a steady-state of operation the IEC 61000-4-11 Voltage Dip test was initiated and resulted in a reboot of the VxScan unit. Such disruption to the EUT normal operation results in compliance FAILURE.” This failure was not reproduced for the Goldenmate nor APC UPS, only for the Anker UPS.

- Voltage Dip testing under IEC 61000-4-11 standards testing was carried out with NOVO Engineering using Compact NX5 test equipment loaded with standard modules and settings (setup picture in photos below) and resulted in similar failures as with SLI when using the Anker UPS with VxScan.

1. Testing will continue with Element/SLI on the VxScan system with the Goldenmate UPS. Based on data supplied by NOVO Engineering as of March 31, 2025, this UPS is a viable alternative and passes voltage dip and other EMC tests.
2. Testing continued with NOVO Engineering on the VxScan system with the Goldenmate UPS. This clarified emissions issues with the system. As shown earlier, an alternate UPS to the Anker UPS appeared to help emissions; and the Goldenmate UPS also showed better emissions than the Anker in pre-certification testing.
