Voting System Anomaly Root Cause Analysis Template v2.0

**ANKER SOLIX UPS FAILURES IN ELECTROMAGNETIC COMPATIBILITY TESTING, REPRODUCED FOR
VV40ECT-78: POWER DIPS TESTS
VxSUITE, VERSION 4.0 AND EAC CERTIFICATION #VXS4**

**VOTINGWORKS
548 MARKET ST, STE 53001
SAN FRANCISCO, CA 94104-5401**

MARCH 31, 2025

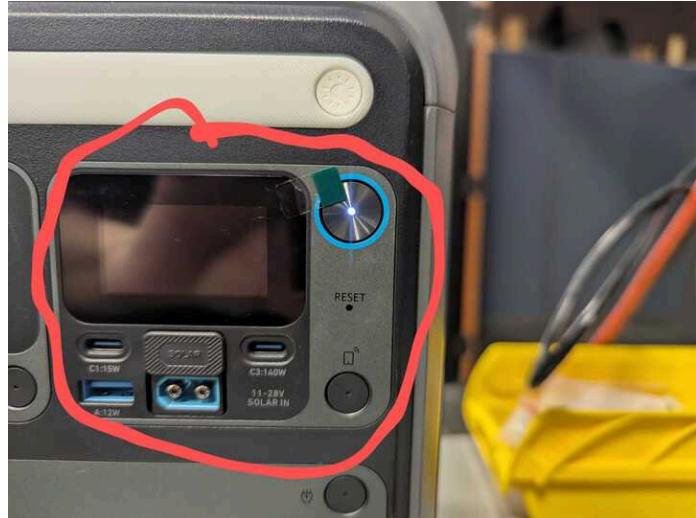
- Novo reported that when the Anker UPS IoT button is on, near-field probes saw random spurs of emissions around 2.45 GHz, in line with higher frequency bluetooth emissions.
- Internal testing identified occasional difficulties with users confirming the IoT button was truly off, especially if the UPS was previously connected to its corresponding Anker UPS smartphone app.
- Element/SLI saw UPS emissions around the following region using the near-field probe:

This area of the UPS controls overall power, IoT function, and user displays, and not all these functions can be disabled during use.
