Voting System Anomaly Root Cause Analysis Template v2.0

**VV40ECT-74: VxSCAN RADIATED ELECTROMAGNETIC EMISSIONS (CLASS B) FAILURE AT 54 MHz AND
66 MHz - REV. 1**
VxSUITE, VERSION 4.0 AND EAC CERTIFICATION #VXS4

**VOTINGWORKS
548 MARKET ST, STE 53001
SAN FRANCISCO, CA 94104-5401**

JULY 14, 2025

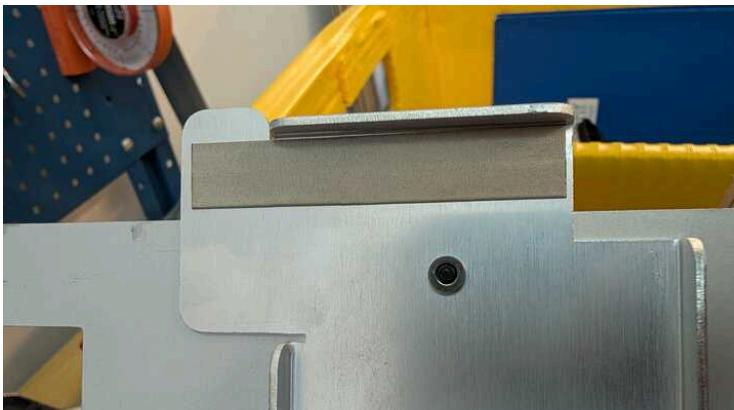
1. Insufficient contact between the closed scanner access panel and the metal support bracket underneath it on the left. This results in only partial or no electrical contact on the left, leading to insufficient grounding of the conductive metal access panel when closed, as well as a small gap from which emissions can leak and be amplified. The panel no longer acts as an effective shield to the emissions sources under the panel; and in fact it would amplify emissions from 48 to 80 MHz, 6 MHz apart, largely seen at 54 MHz and 66 MHz. These are harmonic frequencies of 6 MHz, which is a frequency emitted by clocks associated with the contact image sensor on the scanner PCB underneath the panel.

1. Apply EMI gasket tape under the left side of the scanner access panel, where it makes contact with the support bracket underneath. It can be a 2.5-2.7" strip of a compressible conductive gasket meant for repeated industrial use, such as the tested component [Wurth 3021005](#), which is widely available. The height can be 0.010" to 0.030" to fill a possible gap between the scanner access panel and the bracket when the panel is closed. See the image below for an example application:

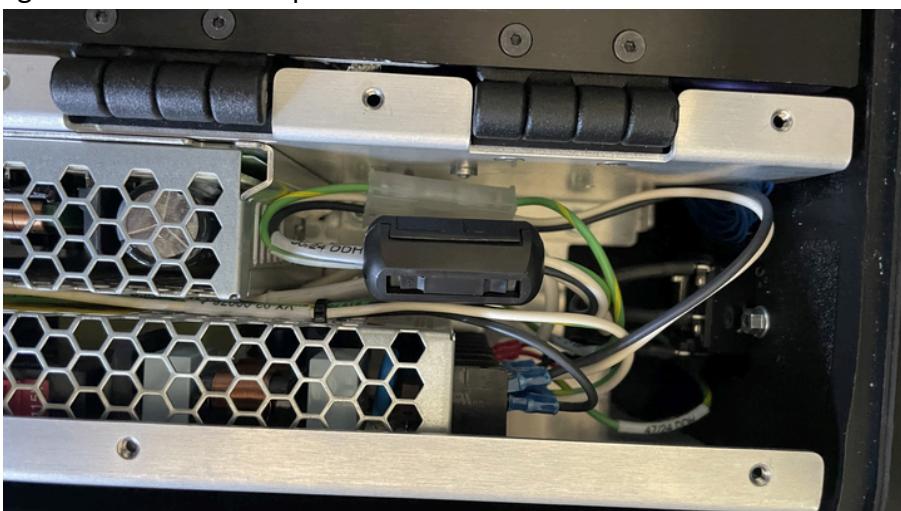
1. Unpredictable broadband noise contributed from the Anker UPS.
2. Broadband noise centered around 60 MHz contributed from the AC power entry port.

2. Apply a ferrite targeting 60 MHz emissions to the internal AC power line, around the L1, L2, and ground lines. This can be the tested component [Fair-Rite 0461164951](#), which is widely available. See image below for how it can be applied internally on the right-side internal compartment of VxScan:
