# Voting System Anomaly Root Cause Analysis Template v2.0

**ANKER SOLIX UPS FAILURES IN ELECTROMAGNETIC COMPATIBILITY TESTING, REPRODUCED FOR  
VV40ECT-78: POWER DIPS TESTS  
VxSUITE, VERSION 4.0 AND EAC CERTIFICATION #VXS4**

**VOTINGWORKS  
548 MARKET ST, STE 53001  
SAN FRANCISCO, CA 94104-5401**

**MAY 5, 2026**

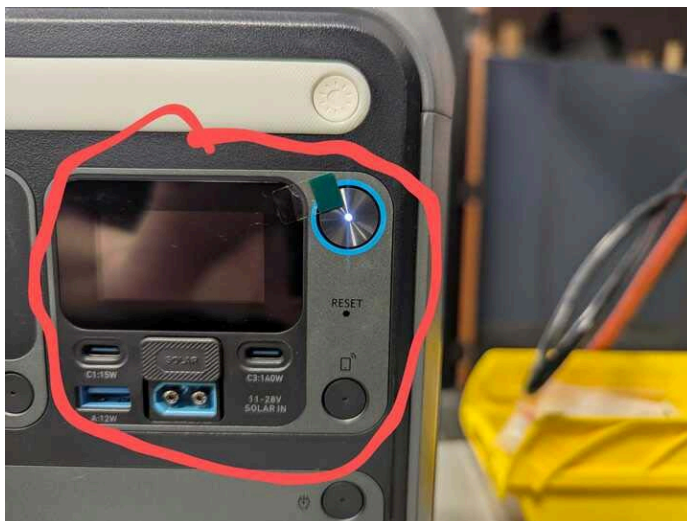
- Internal testing identified occasional difficulties with users confirming the IoT button was truly off, especially if the UPS was previously connected to its corresponding Anker UPS smartphone app.
- Element/SLI saw UPS emissions around the following region using the near-field probe:

This area of the UPS controls overall power, IoT function, and user displays, and not all these functions can be disabled during use.
