# Voting System Anomaly Root Cause Analysis Template v2.0

**VV40ECT-74: VxSCAN RADIATED ELECTROMAGNETIC EMISSIONS (CLASS B) FAILURE AT 54 MHz AND  
66 MHz  
VxSUITE, VERSION 4.0 AND EAC CERTIFICATION #VXS4**

**VOTINGWORKS  
548 MARKET ST, STE 53001  
SAN FRANCISCO, CA 94104-5401**

**MAY 5, 2026**

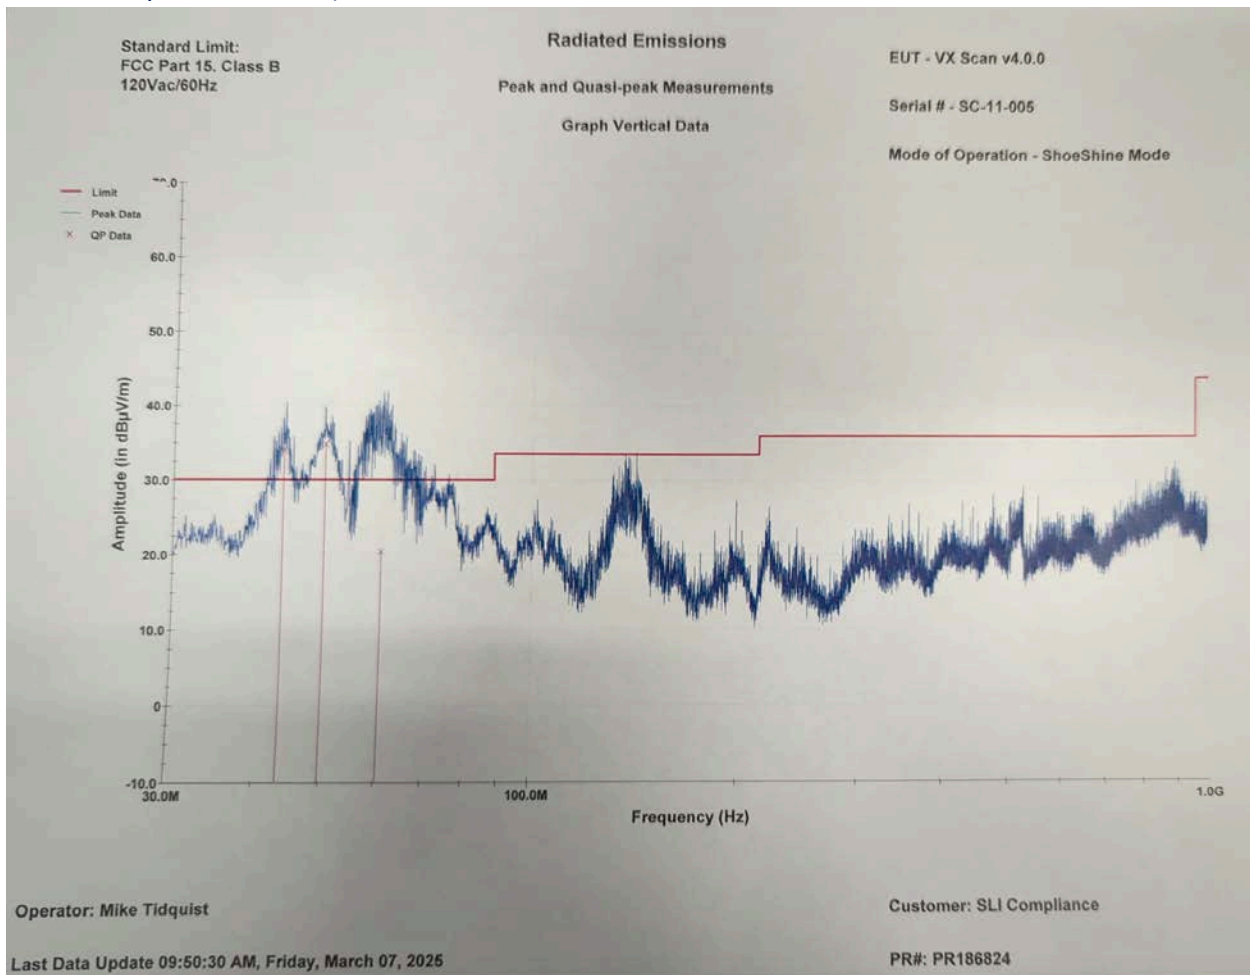
Instead of passing emissions tests, the VxScan system when connected with the Anker UPS failed Radiated Emissions testing from 30 Mhz to 1 GHz. Since this was unexpected, a series of additional tests followed to confirm emissions behavior of the system, showing that the UPS appeared to show problematic emissions. This can be seen in emissions data from when VxScan was powered through the UPS connected to mains (first graph below, QP amplitudes exceeding desired amplitudes in red):

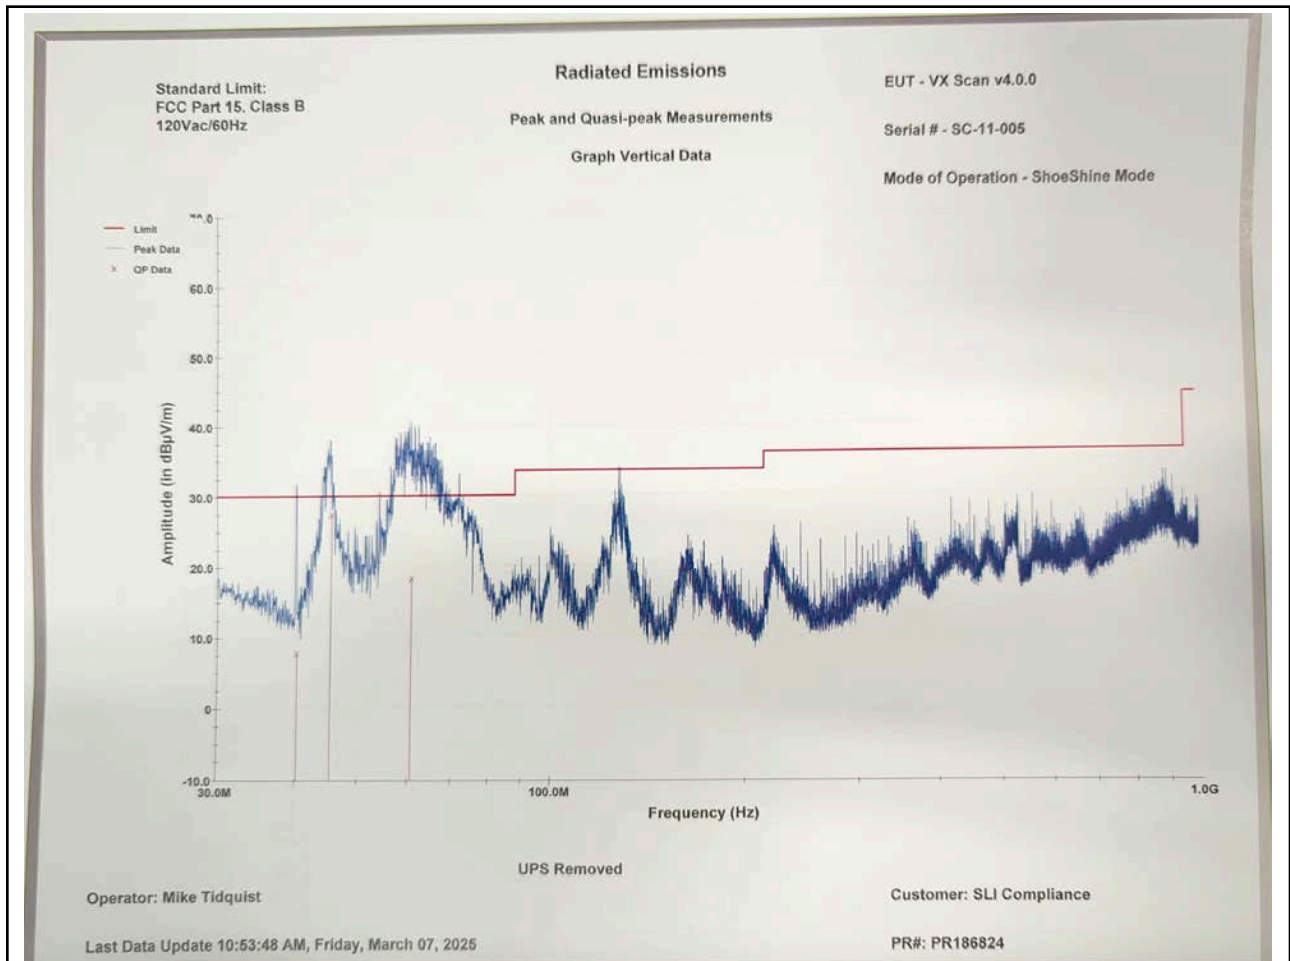
Powering VxScan directly through mains and no UPS also showed some noisy emissions in a similar frequency range, but the QP amplitudes did not exceed emissions limits in this case. So connecting the Anker UPS appeared to contribute to the excess emissions (2nd graph below, exceeding desired amplitudes in red):

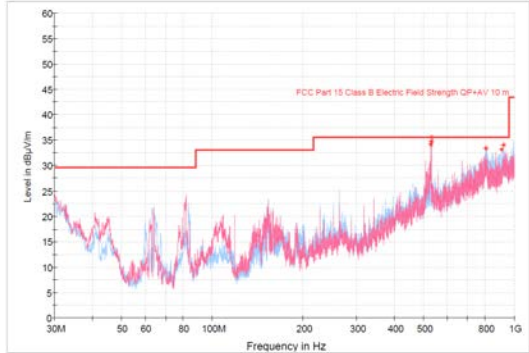
| 12 | 7/10/25 | <p>Standard FCC emissions testing was performed on the VxScan unit just tested at Nemko, except that the APC UPS would now be configured properly, plugged in and fully charged for testing.</p> | Al Walters, Mike Engelmann, NOVO Engineering, and Nemko San Diego | <p>NOVO and Nemko reported passing results for VxScan in this configuration, both without the UPS and with the UPS (APC model), but notably without any controllers or audio devices connected to the USB ports:</p> <p>The graph shows the FCC Part 15 Class B Electric Field Strength limit (red line) and the measured signal (blue line). The y-axis is Level in dBuV/m (0 to 60) and the x-axis is Frequency in Hz (30M to 1G). The signal is generally below the limit, with a notable spike around 30 MHz.</p> |

| | | | | <p>The 54 and 66 MHz spikes seen at SLI were not present, nor other 6 MHz harmonics. This further confirmed the root cause of failures at SLI being from improper contact on the left side of the scanner access panel, coupled with noise from the AC power input.</p> |

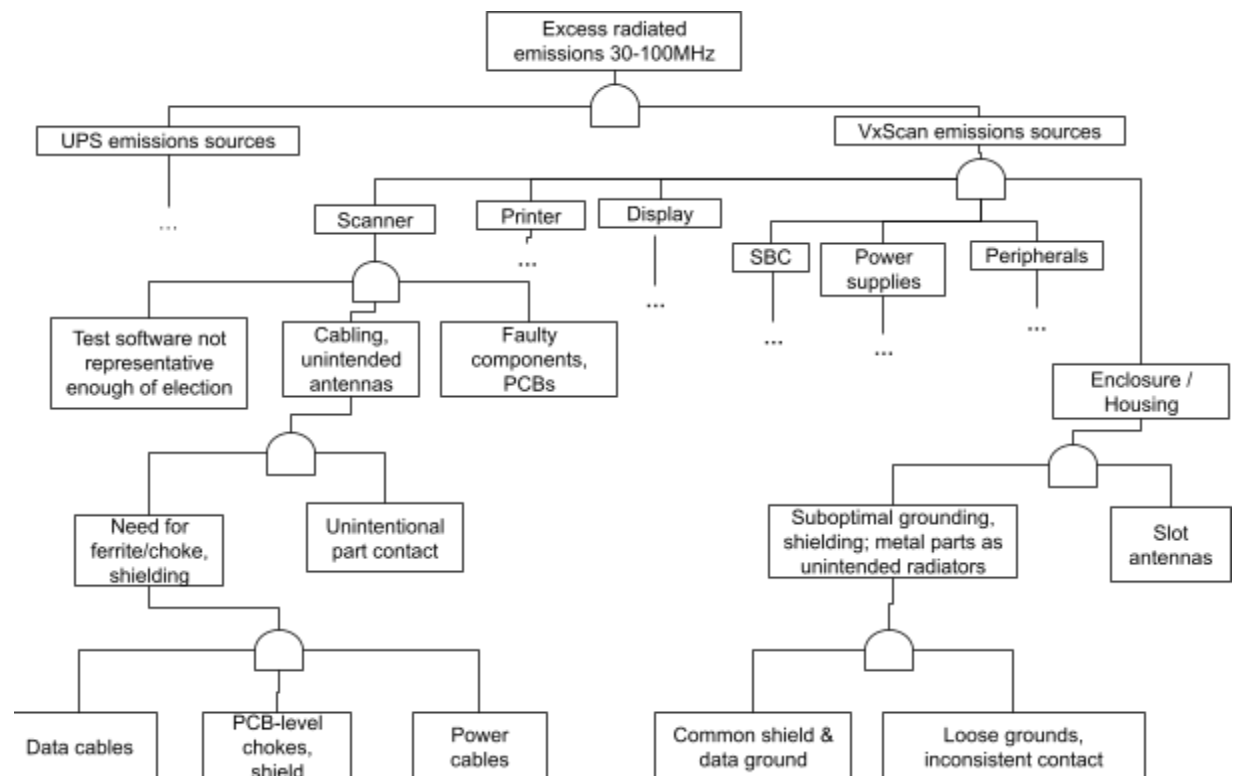
These questions were parts of the analysis that followed the fault tree analysis pattern below. Each branch was investigated either on-site at Element, with a testing partner, or internally with VotingWorks staff, to identify the root cause of the failure seen at SLI/Element.

Ultimately the scanner, power supply, and enclosure/housing branches led to finding root causes of failures seen by SLI. However, other VxScan components were investigated, too, in

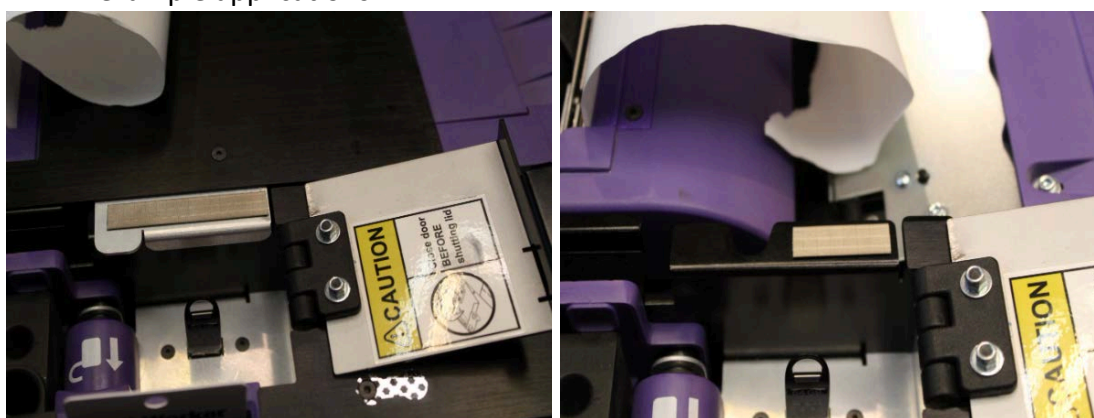
The primary root cause of the observed emissions failure was insufficient grounding connectivity and cable filtering around key internal electrical components. This primarily includes a small gap that sometimes appeared between the access panel doors and the support brackets underneath them, associated with emissions from 48 to 80 Mhz, 6 Mhz apart, largely seen at 54 Mhz and 66 MHz. This explains the original 54 and 66 MHz spikes seen at Element on 3/7/25. These are harmonic frequencies of 6 MHz, which is a frequency emitted by clocks associated with the contact image sensor on the scanner PCB underneath the panel. The gap at the panel reduced grounding connectivity in the top panel and may have acted as a slot antenna for these emissions.

1. Apply EMI gasket tape under the left side of the scanner access panel to increase connection with the support bracket underneath. This can be compressive conductive gasket material meant for repeated industrial use, such as the tested component Wurth 3021005, with an appropriate height between 0.010" to 0.030". This reduces the major low frequency emissions spikes seen originally. See the images below for example applications:
