# Voting System Anomaly Root Cause Analysis Template v2.0

**ANKER SOLIX UPS FAILURES IN ELECTROMAGNETIC COMPATIBILITY TESTING, REPRODUCED FOR  
VV40ECT-78: POWER DIPS TESTS - REV. 4  
VxSUITE, VERSION 4.0 AND EAC CERTIFICATION #VXS4**

**VOTINGWORKS  
548 MARKET ST, STE 53001  
SAN FRANCISCO, CA 94104-5401**

**MAY 5, 2026**

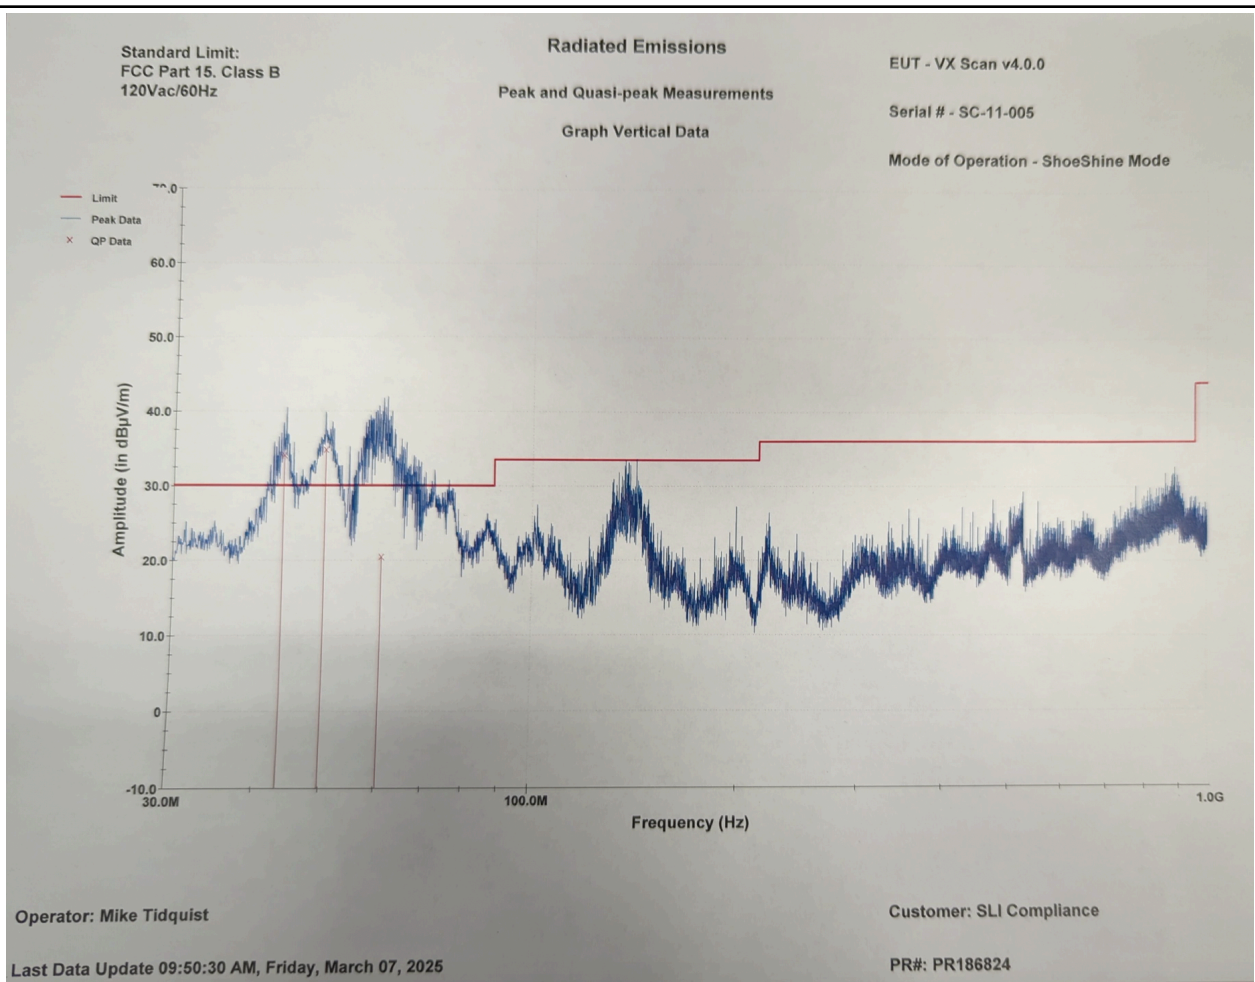
- Instead of passing emissions tests, the VxScan system when connected with the Anker UPS failed Radiated Emissions testing from 30 Mhz to 1 GHz. Since this was unexpected, a series of additional tests followed to confirm emissions behavior of the system, showing the UPS appeared to show problematic emissions. This can be seen in emissions data from when VxScan was powered through the UPS connected to mains (first graph below, QP amplitudes exceeding desired amplitudes in red):

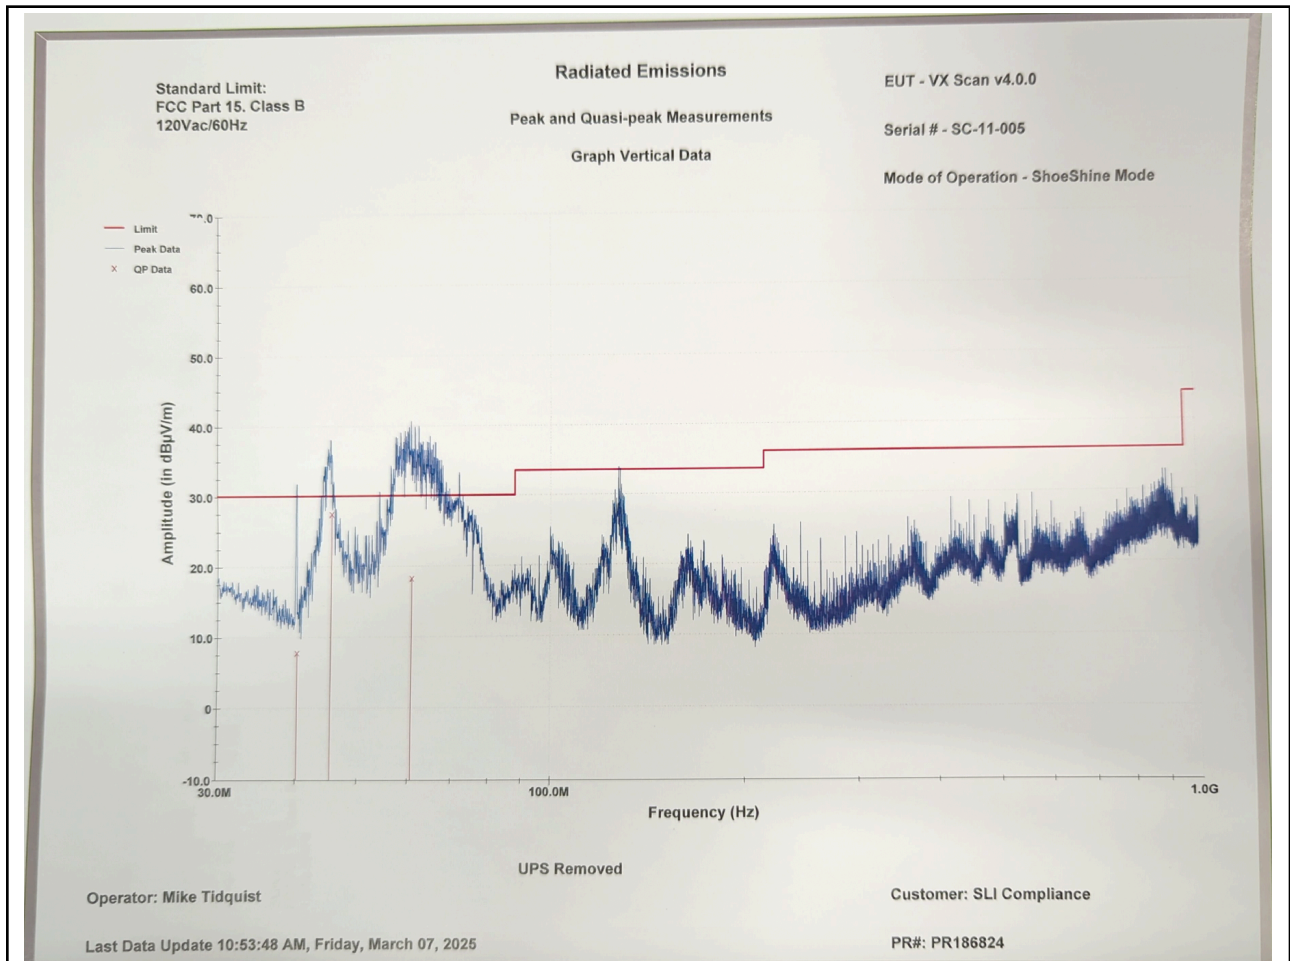
Powering VxScan directly through mains and no UPS also showed some noisy emissions in a similar frequency range, but the QP amplitudes did not exceed emissions limits in this case. So connecting the Anker UPS appeared to contribute to the excess emissions (2nd graph below, exceeding desired amplitudes in red):

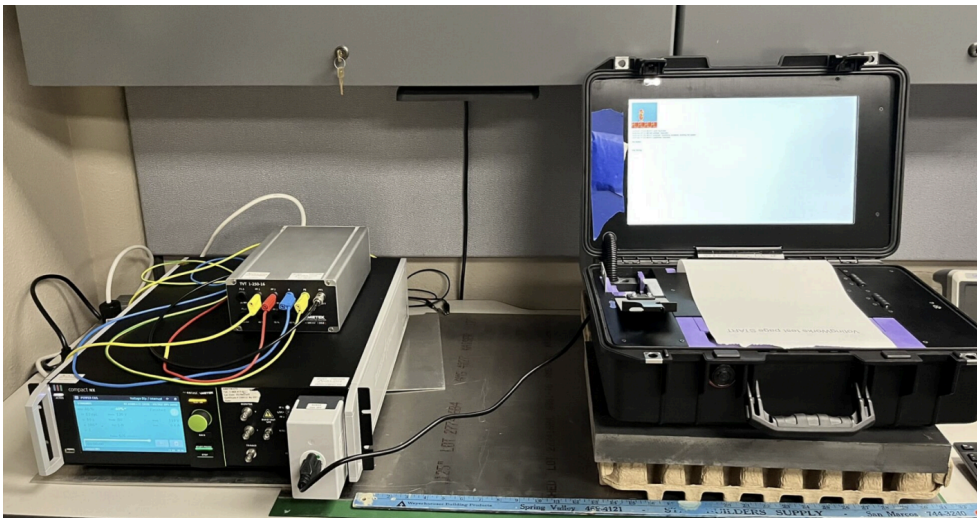
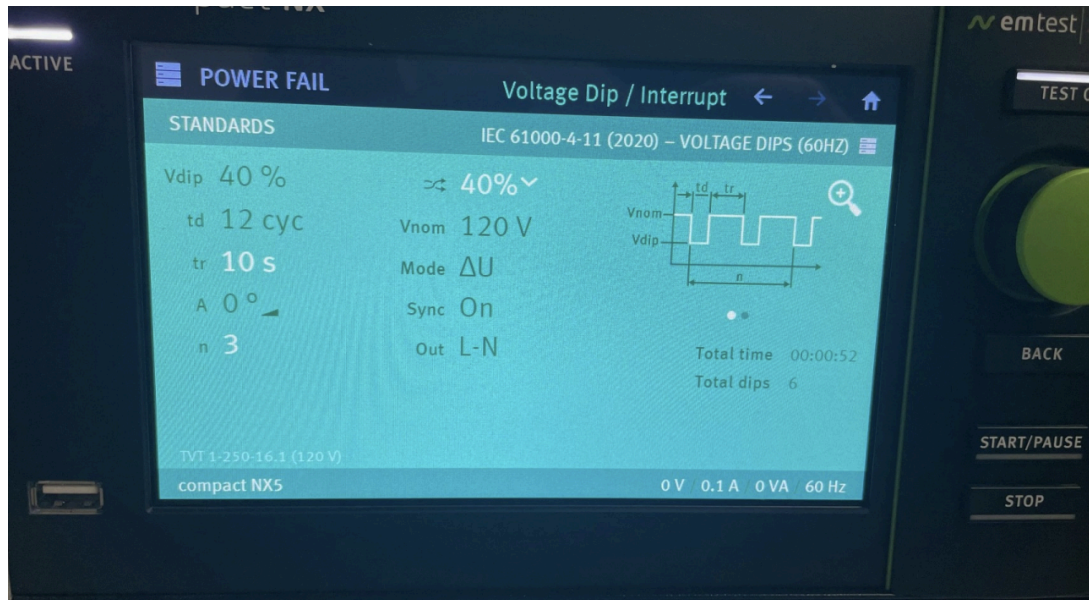
- Voltage Dip testing under IEC 61000-4-11 standards testing was carried out with NOVO Engineering using Compact NX5 test equipment loaded with standard modules and settings (setup picture in photos below) and resulted in similar failures as with SLI when using the Anker UPS with VxScan.

- With the exact same setup, the Goldenmate UPS did not show problems. As stated by NOVO about the Goldenmate connected to VxScan: “Once in a steady-state of operation the IEC 61000-4-11 Voltage Dip test was initiated and did not result in a reboot of the VxScan unit. About 15 seconds later, we initiated the Voltage Interrupt testing which also did not result in a reboot of the VxScan unit. Since no disruptions to the EUT normal operation occurred, pre-compliance testing resulted as a PASS.”

1. Testing continued with Element/SLI on the VxScan system with the Goldenmate UPS. Based on data supplied by NOVO Engineering and other test labs, this UPS is a viable alternative and passes voltage dip and other EMC tests.
2. Testing continued with NOVO Engineering and other test labs on the VxScan system with the Goldenmate UPS. This clarified emissions issues with the system. As shown earlier, an alternate UPS to the Anker UPS appeared to help emissions; and the Goldenmate UPS also showed better emissions than the Anker in pre-certification testing.

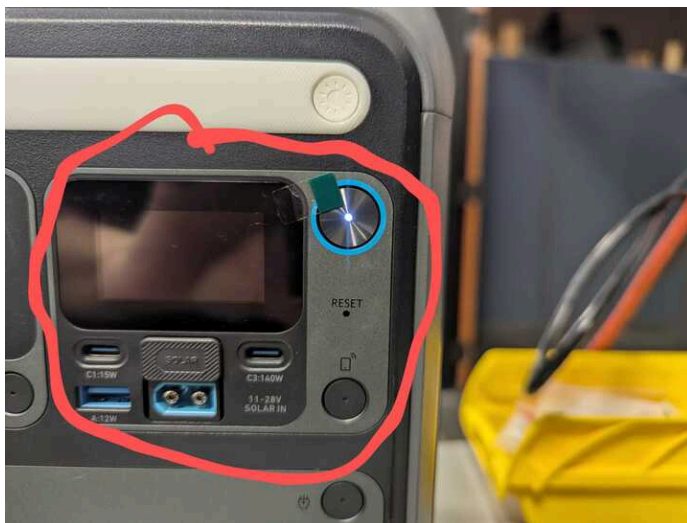
- Internal testing identified occasional difficulties with users confirming the IoT button was truly off, especially if the UPS was previously connected to its corresponding Anker UPS smartphone app.
- Element/SLI saw UPS emissions around the following region using the near-field probe:

This area of the UPS controls overall power, IoT function, and user displays, and not all these functions can be disabled during use.

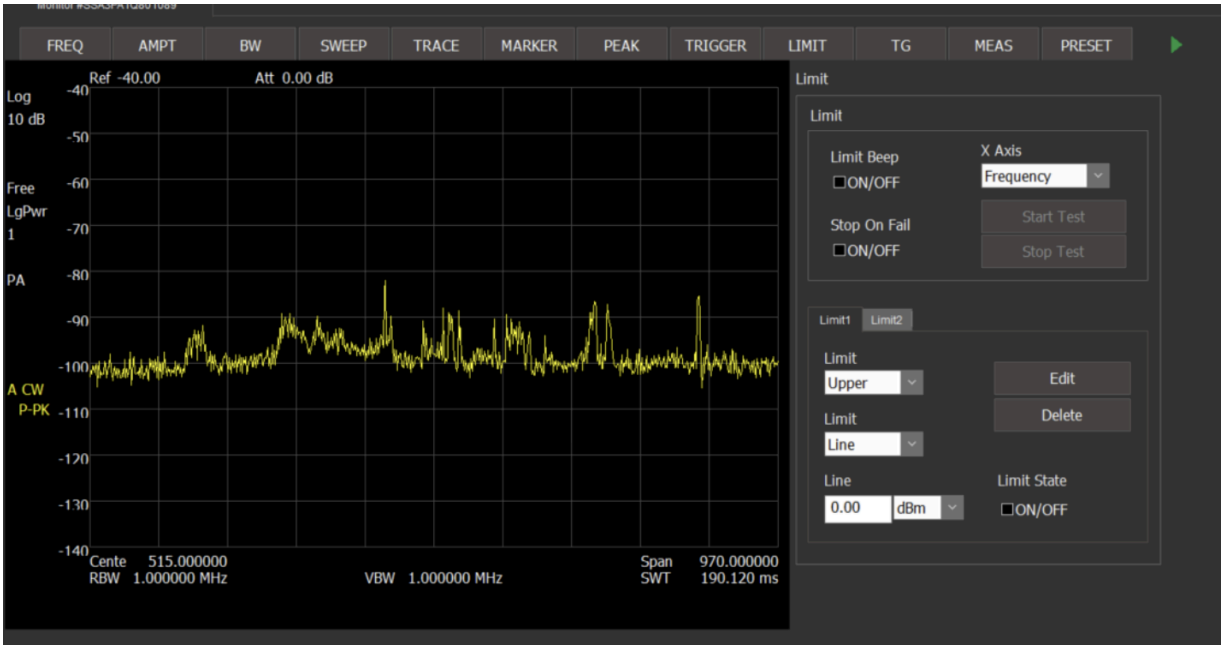
Data before plugging in UPS to mains:

- NOVO did find general rise in emissions of 10db when comparing a UPS plugged into mains, vs a UPS not plugged into mains, but nothing clearly problematic, and nothing particularly at the lower frequency range at issue with the testing at Element/SLI. NOVO writes, "Scans all around both the UPS and VxScan unit did not show any notable spurs or significant jump in the observed frequency spectrum." Again this points to some inconsistency between Anker UPS units. Snapshots of emissions readings taken before and after plugging in the Anker UPS are below, showing benign emissions.
