# Test Report - VxScan Drop Test, Bench Handling

Pius Wong , created Sep 3, 2024 updated Oct 17, 2025

- VxScan, v4.0, Build 0

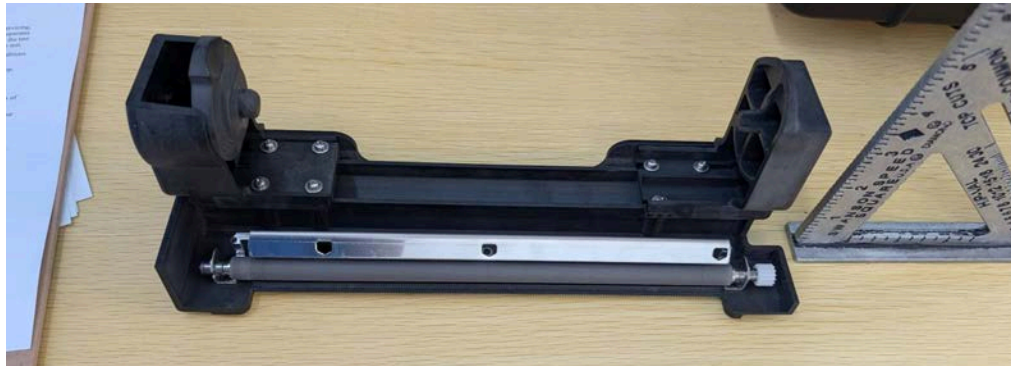
- b. The paper roll was removed from the thermal paper roll holder, and the empty paper roll holder was drop-tested, for a total of 24 drops. Because it was weighted more to one side, it frequently ended up on this side after drops, as shown here:

- c. No damage was found after all drops. Paper rolls could be removed and reinserted without problems. The holder could be reinserted into the MCM without problems.

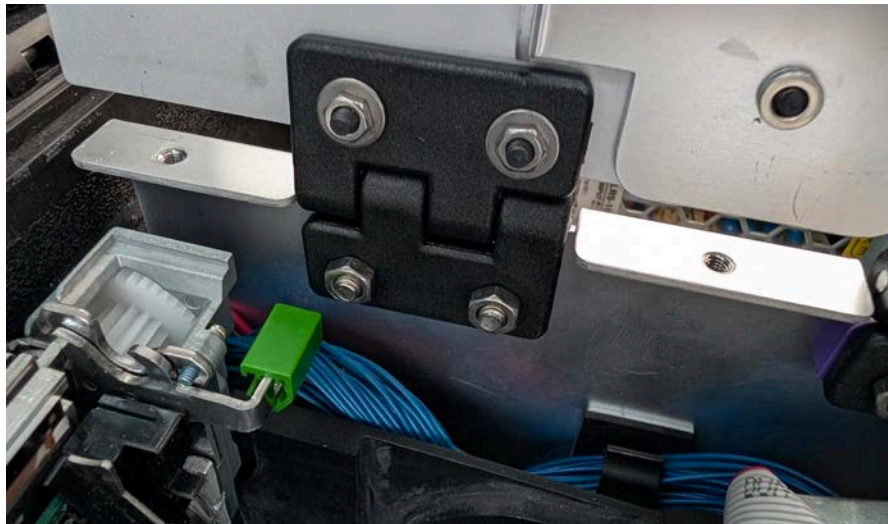
No other loose parts were found or heard, so these known loose parts were reattached, and the hinge nuts were tightened:

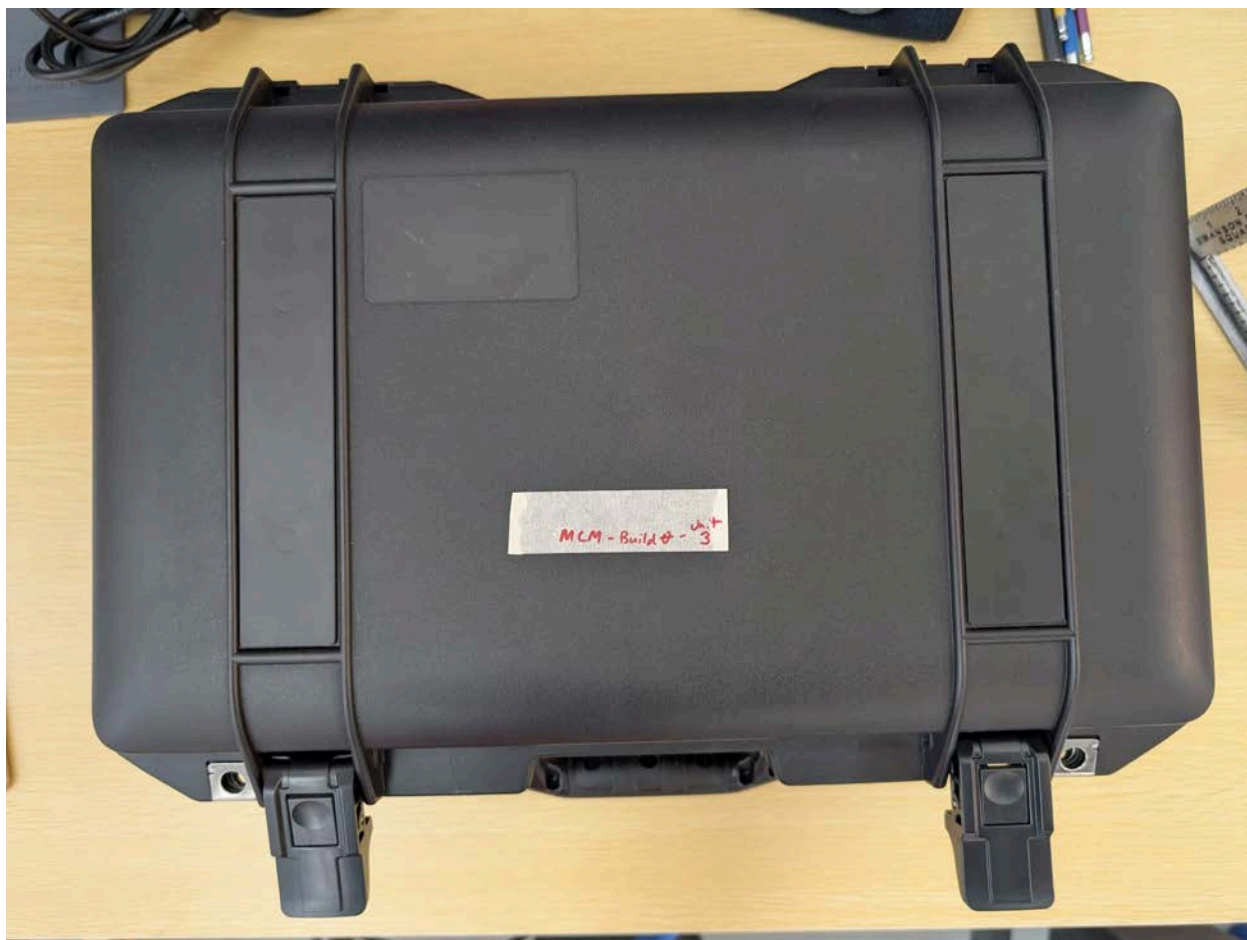
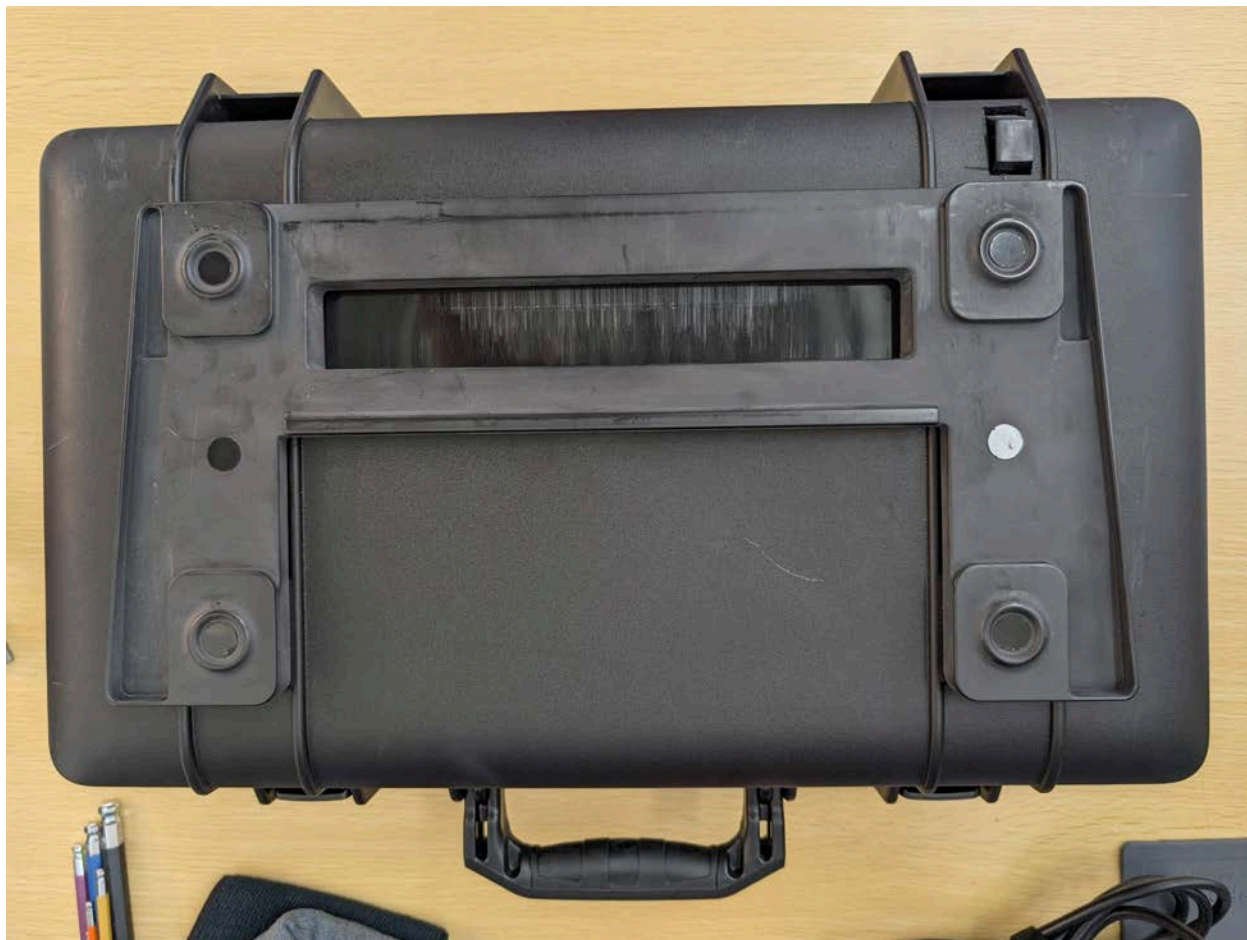
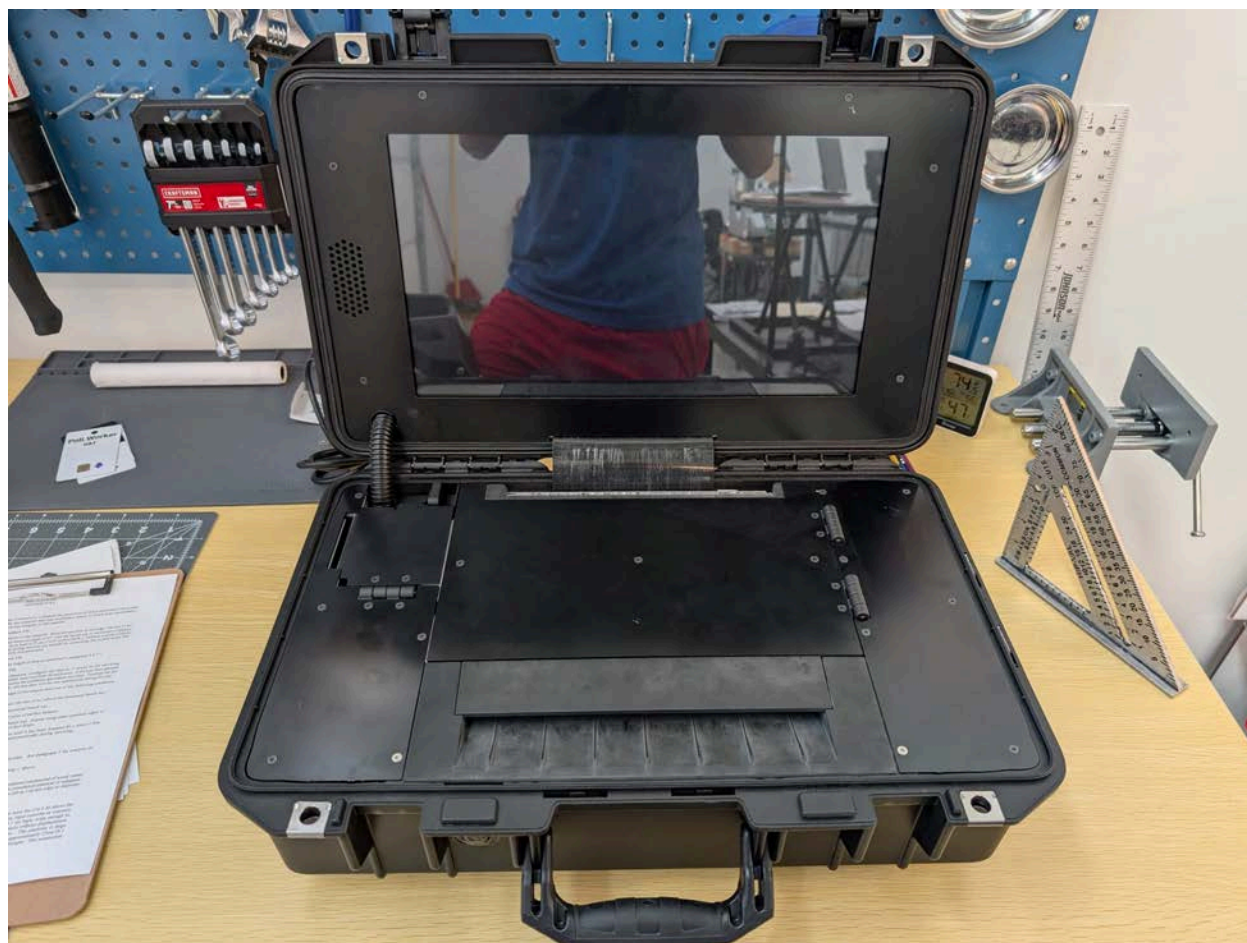
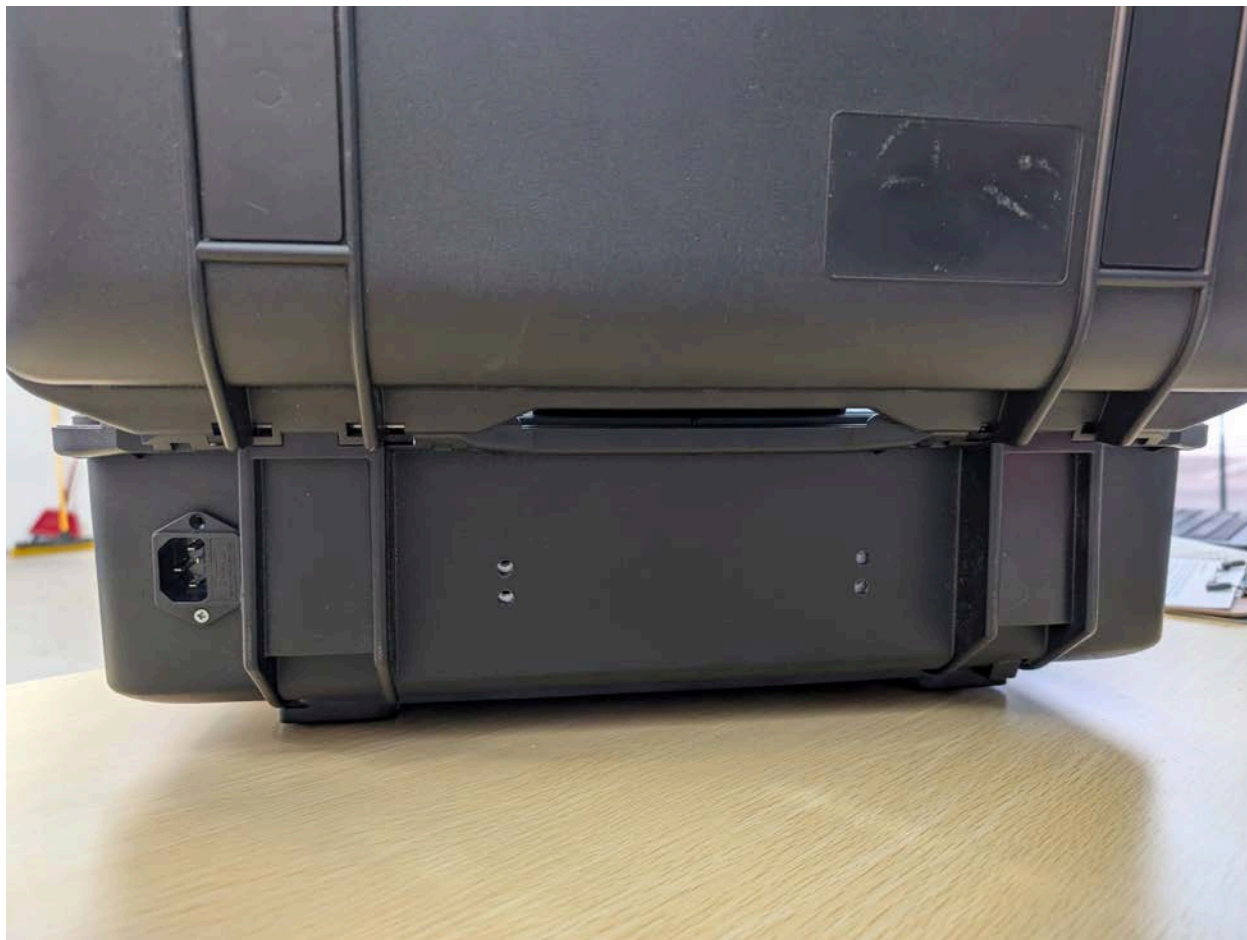
## Appendix A: Device photos before drops

- i. It was missing the upper bolt holding the mains power port.
- ii. It was missing the rear power cord holder structure.

Note: This test unit did not have the rear cord holder or one of the bolts holding the power supply to begin with, due to previous use, as noted in this report.
