# **Voting System Anomaly Root Cause Analysis Template v2.0**

**VV40ECT-76, -168, -233, -240: VxMarkScan ESD FAILURES AT PAT & ATI INPUTS, CARD  
READER, AND REAR POWER - REV. 4  
VxSuite, Version 4.0 AND EAC CERTIFICATION #VXS4**

**VOTINGWORKS  
548 MARKET ST, STE 53001  
SAN FRANCISCO, CA 94104-5401**

**MAY 12, 2026**

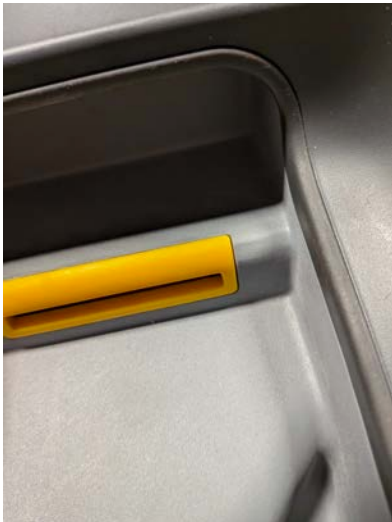
3. To reproduce the persistent card reader issue: Apply ESD to the card reader plastic housing, especially around the seam between the card reader housing and the surrounding plastic, shown in this photo:

2. The path between the card reader electronics and the external ESD source at the surface was too short. At higher kV ESD levels, the generated air discharge spark could travel through openings around the plastic card reader holder to the card reader board. This could directly damage electronics.

The bracket holding the card reader was modified to move the card reader deeper into VxMarkScan by approximately a half inch, determined by testing to be sufficient for ESD resistance. See the diagram below for a comparison of the original card reader bracket positioning versus the new positioning, that allows a greater offset between the card reader and the plastic housing:
