# Voting System Anomaly Root Cause Analysis Template v2.0

**VV40ECT-74: VxSCAN RADIATED ELECTROMAGNETIC EMISSIONS (CLASS B) FAILURE AT 54 MHz AND  
66 MHz - REV. 3  
VxSUITE, VERSION 4.0 AND EAC CERTIFICATION #VXS4**

**VOTINGWORKS  
548 MARKET ST, STE 53001  
SAN FRANCISCO, CA 94104-5401**

**MAY 5, 2026**

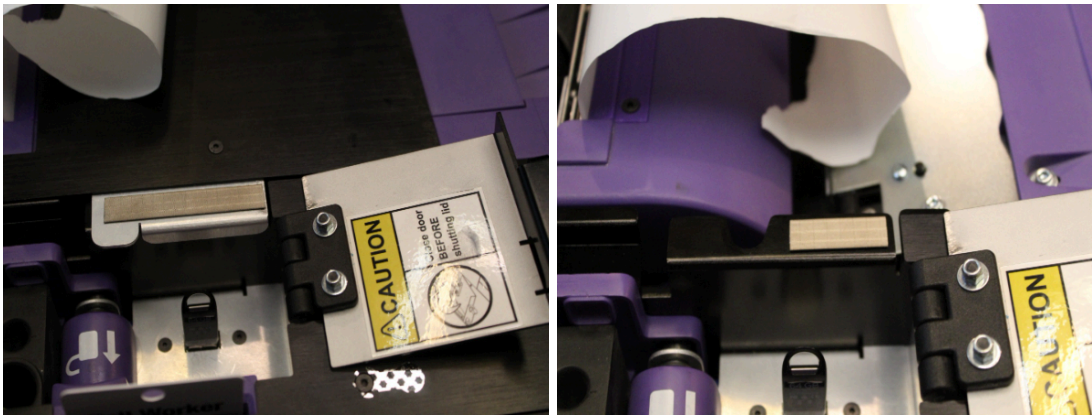
The primary root cause of the observed emissions failure was insufficient grounding connectivity and cable filtering around key internal electrical components. This primarily includes a small gap that sometimes appeared between the access panel doors and the support brackets underneath them, associated with emissions from 48 to 80 Mhz, 6 Mhz apart, largely seen at 54 Mhz and 66 MHz. This explains the original 54 and 66 MHz spikes seen at Element on 3/7/25. These are harmonic frequencies of 6 MHz, which is a frequency emitted by clocks associated with the contact image sensor on the scanner PCB underneath the panel. The gap at the panel reduced grounding connectivity in the top panel and may have acted as a slot antenna for these emissions.

1. Apply EMI gasket tape under the left side of the scanner access panel to increase connection with the support bracket underneath. This can be compressive conductive gasket material meant for repeated industrial use, such as the tested component Wurth 3021005, with an appropriate height between 0.010" to 0.030". This reduces the major low frequency emissions spikes seen originally. See the images below for example applications:
