# Voting System Anomaly Root Cause Analysis Template v2.0

**VV40ECT-76, -168, -233, -240: VxMARKSCAN ESD FAILURES AT PAT & ATI INPUTS, CARD  
READER, AND REAR POWER  
VxSUITE, VERSION 4.0 AND EAC CERTIFICATION #VXS4**

**VOTINGWORKS  
548 MARKET ST, STE 53001  
SAN FRANCISCO, CA 94104-5401**

**MAY 12, 2026**

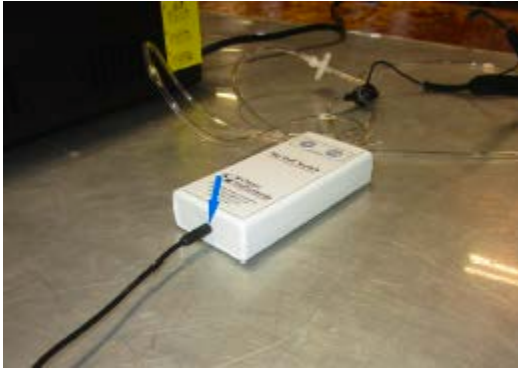
2. To reproduce the temporary PAT and ATI issue: Apply ESD (15kV air discharge, 10 pulses, 1 per 2 sec) according to IEC 61000-4-2 to the PAT accessory where it starts to connect to its phone jack cable, which in turn is plugged into the PAT port on VxMarkScan. This location is indicated by the blue arrow in the photo below, as reported by SLI Compliance:

1. Software did not attempt to reconnect or restart the PAT and ATI connections after ESD. The PAT/ATI subsystem lost normal function because the Hardware Test Utility's daemon was not configured to exit (and thus would not auto-restart) when the PAT or ATI devices momentarily disconnected after an ESD event. The absence of an automatic restart left the ATI and PAT accessory in an unrecoverable state until the entire VxMarkScan unit was power-cycled.

- **Reproducibility & fix verification** – In-house re-tests faithfully reproduced Element/SLI failures and subsequently demonstrated full immunity after the daemon-restart patch. The root cause in software fully explains why **all** failures cleared after a reboot (fresh daemon instantiation), why **no** physical component damage was detected, and why ferrite or grounding experiments alone gave no benefit. The updated daemon (exit-on-error → systemd restart) restores functionality within 10 s after each discharge and has now passed ESD campaigns during internal testing.

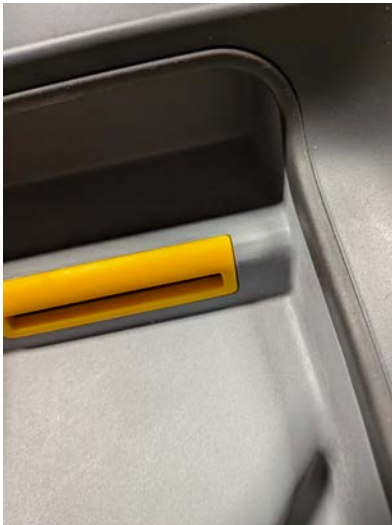
3. To reproduce the persistent card reader issue: Apply ESD to the card reader plastic housing, especially around the seam between the card reader housing and the surrounding plastic, shown in this photo:

2. The path between the card reader electronics and the external ESD source at the surface was too short. At higher kV ESD levels, the generated air discharge spark could travel through openings around the plastic card reader holder to the card reader board. This could directly damage electronics.

- **ESD conducted to the card reader board** – This led to damage to the card reader leading to persistent errors. This stemmed from a distance that was too short that an ESD arc had to travel between the card reader housing and the card reader board electronics.
- **Optimal mitigation by only moving card reader** – Altering the card reader position by moving it further back into the system by 0.5-0.75" led to no ESD sparks, even at +/-15kV air discharge. This resolved card reader ESD issues in lab testing. See photo below of prototype positioning tested, where the bracket fastener holes were adjusted to shift the card reader deeper into the main module.

The bracket holding the card reader was modified to move the card reader deeper into VxMarkScan by approximately a half inch, determined by testing to be sufficient for ESD resistance. See the diagram below for a comparison of the original card reader bracket positioning versus the new positioning, that allows a greater offset between the card reader and the plastic housing:

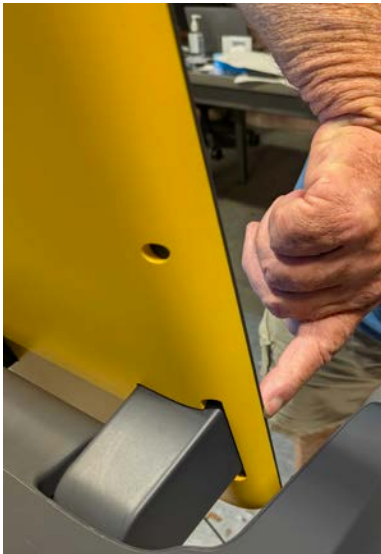
4. To reproduce the persistent display ESD issue affecting the PAT and ATI: Apply ESD to the lower left part of the touchscreen display, at the seam in the plastic housing, shown in this photo reported by SLI:

3. Insulative material at the bezel around the display was compromised. Similarly to the point above, at higher kV ESD levels, the spark could travel through gaps at the seams around the touchscreen display plastic housing, and through thin or broken parts of the insulation around the screen. The ESD could transfer to other parts of the system from there, depending on the location of the discharge. This issue is inconsistent between units and may not exist or be at the same location along the bezel unit-to-unit. At Element, the previously observed failure was likely through ESD conducting through the lower display support brackets to the PAT and ATI.

- **Existing gasket material around display compromised** – The tested unit at EMI Test Lab showed ESD sparking around the display edge in the upper left corner, and upon opening and analyzing the internals, the gasket material between the display glass and its bezel in this area was found to be thinned. This allowed ESD to penetrate into the display at this area and not in other areas around the display.
- **Reapplying electrical insulation around the screen prevented ESD sparking** – High-voltage RTV silicone with 30kV/mm breakdown dielectric strength applied to the outer touchscreen bezel to seal the seams prevented ESD sparking and associated damage.

The original compromised gasket material that lies between the display glass and the plastic display bezel was inspected and replaced with insulative RTV silicone with 30kV/mm dielectric breakdown strength. The silicone was also used to seal the gap between the two halves of the plastic housing for the display. This helps prevent ESD sparks from entering the display.

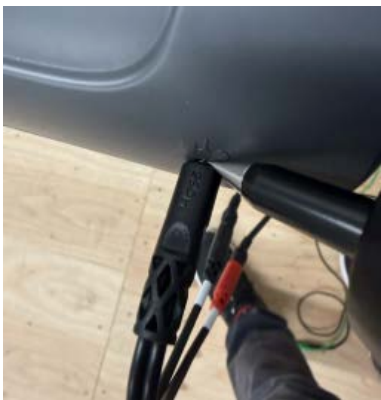
5. To reproduce the power module issue: Apply +15kV air discharge ESD at the rear power button. After that apply ESD to the nearby rear power input port. Observe the test app functionality for errors.
6. To reproduce the extraneous inputs issue: Conduct standard vertical coupling plane testing on the VxMarkScan system, with the plane to the left of the unit, and observe the test app functionality and screen presses following ESD.
7. To reproduce the PAT jack issue: Apply -8kV contact discharge into the thin strip of exposed metal where the PAT device inputs into the PAT jack, as shown:

- **Metal is exposed on the PAT jack when plugged into the PAT port.** This makes it susceptible to possible contact ESD. The standard contact ESD test equipment tip can fit in that space, and suitable mitigations include properly insulating and blocking that exposed metal.
- **The electrical hardware at the PAT/ATI temporarily fails upon high contact discharge applied directly at the interface of the PAT jack/port.** Contact discharge of -8kV right at the port is strong enough to overcome the protection diodes and firmware keeping the PAT/ATI and its interconnected systems running smoothly. The system can detect

A sufficient mitigation was to apply an insulating neoprene grommet around the PAT port with cyanoacrylate adhesive. The grommet measured 3/8 inches inner diameter and 5/8 inches outer diameter and 0.24 inches in thickness, as shown in the images below. This prevented access to the area for contact discharge, now requiring air discharge tests up to 15kV that did not cause issues.

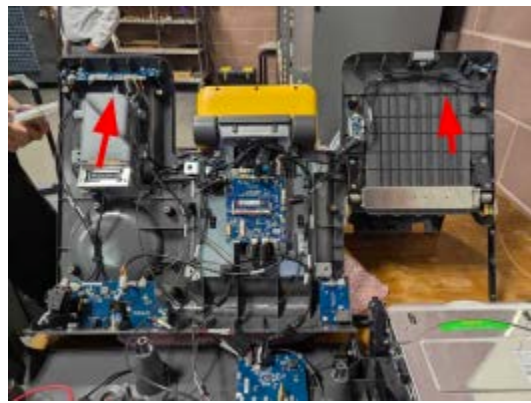
| ID | Date/Time | Description | Entity<br>Org/person | Result / Notes |
|---|---|---|---|---|
| 4 | 3/13/25,<br>8:09am | Reported that ESD testing was proceeding without issues, then failed when +15kV air ESD was applied to the sip/puff device itself. | Jessica Myers, Don Chu, VotingWorks | <p>Don Chu opened up the alternate VxMarkScan unit MK-11-005 to plan mitigations. Mitigations were applied to VxMarkScan unit MK-11-005 involving an internal cable running between the PAT and the ATI along the front edge of the system. Ferrites were added on either side of the cable, denoted with arrows in the photo below:</p> <p>The original unit MK-11-004 was planned to be used for power dip testing.</p> |
