| Issue number: 6 | | | |

## 1 Introduction

Starting May 2025, several glider missions in the Baltic sea have been affected by GNSS jamming. The issue display as incorrect surface locations several hundred kilometers off transect (figure 1), no GNSS fix and/or incorrect timestamps. Incorrect timestamps affect the mission by displaying surface navigational data during the dive as per figure 2. All affected missions are defined in table 1 with corresponding issue descriptions and dataset adjustment to affected cycles described in table 2.

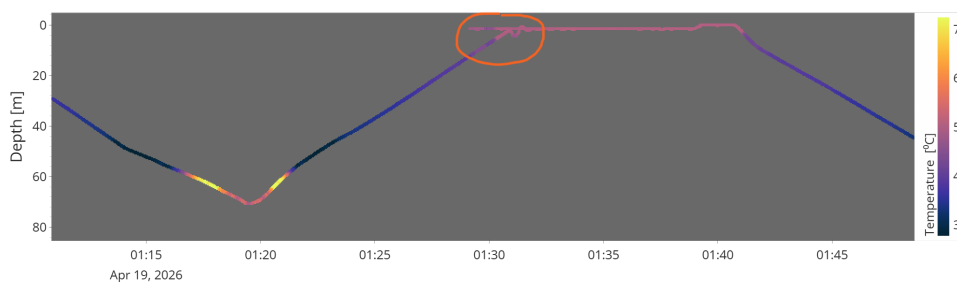
**Figure 2:** Issue description B (table 2) displayed in temperature data from SEA067 M86. Instance of incorrect timestamps is circled in orange where surface data on following dive is displayed before late dive data. Data displayed and downloaded from VOTO Glider Dashboard [2].
