# Service Report

Jensen, Van Cleve Equipment evaluation

2 – 4 August 2022

Inspection of PipePro Forms to determine condition and establish cost of refurbishment

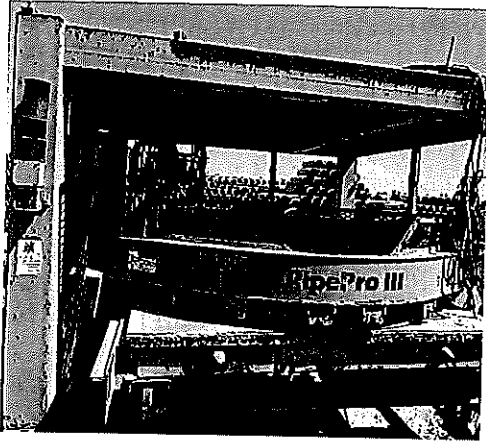
- 1.2.A. AR top plate needs replaced due to separation.
- 1.2.B. Minor fatigue cracks (already repaired) in jacket bottom rib.
- 1.2.C. Minor fatigue cracks in jacket top tie plates.
- 1.2.D. Header clamp wear areas need replaced.
- 1.2.E. P-lock valve and hoses need to be replaced.
- 1.2.F. Filler section is bent, see picture.
