PROSPECTING THE URBAN MINES OF AMSTERDAM

**Refining the PUMA method based
on findings from practice**

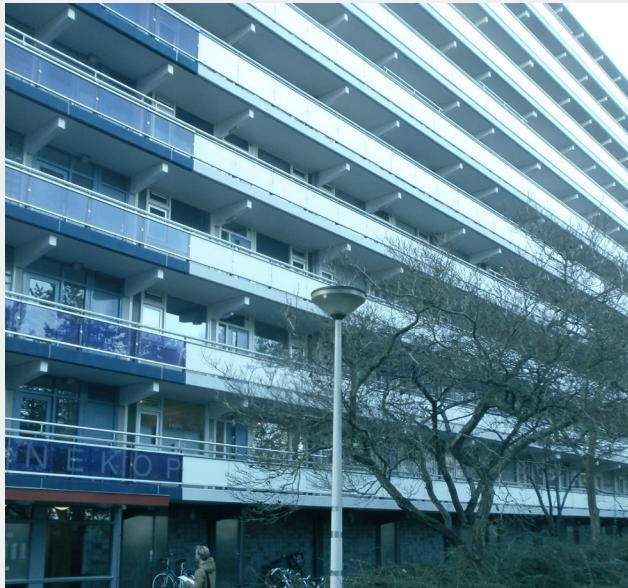
SPINNEKOP 18

Spinnekop 18 is a gallery-flat built in 1968. It measures 31.1 meters with ten floors. The residential flat counts eighty apartments, although one of these contained a physiotherapy practice. The facade contained metal in the galvanized steel and aluminum gallery railings, as well as galvanized steel rain tubing and aluminum plates on the doors and mailboxes. The bearing structure is likely to be steel-reinforced concrete and the apartments can be reached via two elevators or two stairways with steel handrail supports. The roof was not accessible, but metal chimneys and solar panel support was visible.

The 90m² apartment contained a kitchen, separate toilet, and a bathroom without toilet. The sink and tap in the kitchen were made of stainless steel, while the toilet and bathroom sink contained no metal. The central heating of the building was connected to seven steel radiators in the apartment. The copper water and gas piping was connected to the boiler, the casing of this boiler was however missing due to recent repairs. The door and window frames were made of wood and there were no visible signs of renovations in the apartment.

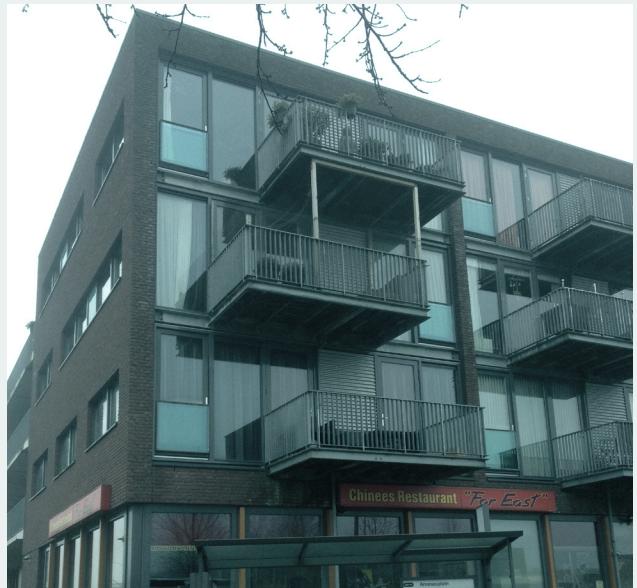
PRUIJNENSTRAAT 6A

This flat was built in 2006 and contains 29 apartments, which are spread over two buildings that have a shared front door and can be reached via stairs, an elevator, and walkways. There is a Chinese restaurant on the ground floor of the building and a large parking garage and ventilated storage sheds in the basement. Other building features included shading panels in front of some windows and corrugated sheets—both aluminium. Every apartment had a balcony with galvanized steel beams and the gutters, drains, and railings of the walkways and stairs were made of the same material. Lead sheets were found at the base of the building for waterproofing.

The 80m² apartment has a kitchen, bathroom with toilet, and a separate toilet. Notably, next to the central heating with five radiators, the apartment has floor heating as well in the hallway and bathroom, totalling to approximately 17m². The apartment additionally contained a ventilation system with aluminium and steel ducts. The fuse box furthermore contained a spare copper pipe and the internal door frames were made out of steel.

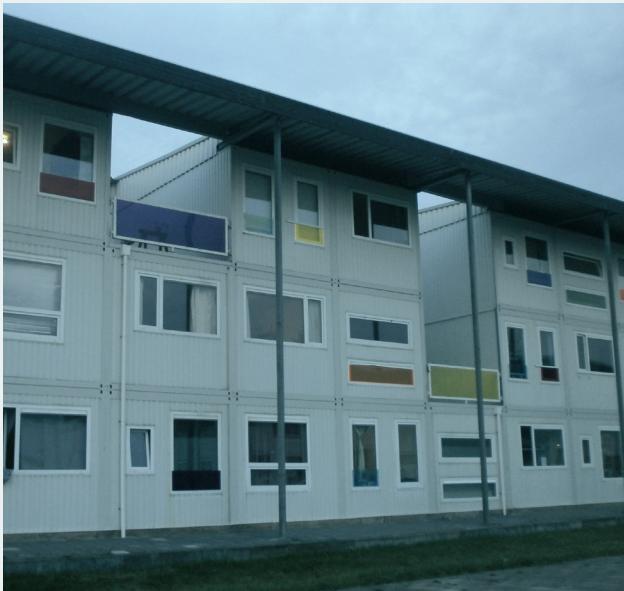
VOETBALSTRAAT 87

This flat in Westlandgracht consists of stacked shipping containers that have been transformed into small studios. The flat provides housing for young refugees and students, both of which inhabit half of the studios to promote integration. Prior to the project's realization in 2016, the containers were used for residential purposes in Houthavens, which provides a practical example of metal recycling in residential buildings of Amsterdam. The steel containers, which make up the whole load-bearing structure, can weigh between 2200 and 4150 kg each (Vantage Freight, 2013; Balk Trade B.V., 2016). The actual contribution of the containers to the steel content will be lower due to the windows, doors, and their plastic frames. The building furthermore has corrugated metal plates as roofing, galvanized steel rain tubes, and corridors between the buildings.

Galvanized steel stairs lead to a central hallway with steel doorframes through which the 78 studios can be reached. Four central heating facilities with steel piping supply the radiators in the building, of which each studio has one. The studios have a single room with a kitchen block with a steel countertop and sink, no gas connection, and a bathroom containing a boiler and toilet. There were no visible signs of renovations since the building's construction.

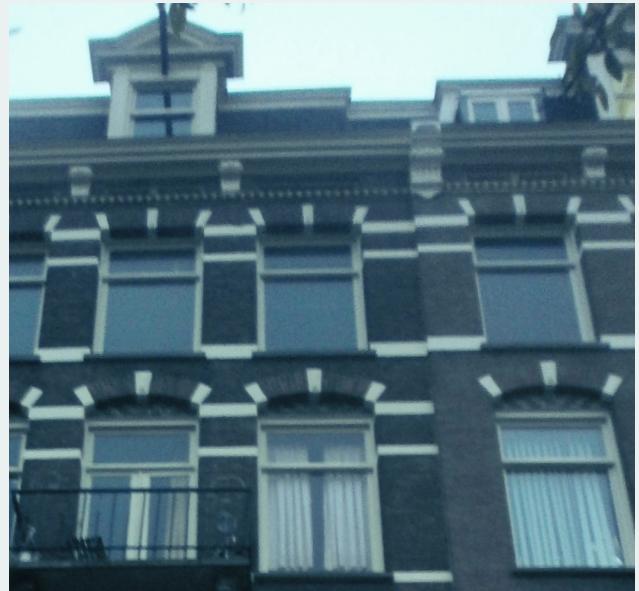
NICOLAAS WITSENKADE 12A

This canalhouse contains three apartments spread over six stories, including the basement. The building could not be dated in the BAG register, but the neighboring houses date back to the end of the nineteenth century according to the register. The load-bearing structure consists of stone and concrete bricks, and thus is unlikely to be reinforced with steel. The frames of the doors and windows are made of wood. Cast iron was found in the fences of the stairs, the four balconies, and basement windows. A steel staircase to reach the first floor's entrance was visible as well, which continues inside up to the sixth floor.

The apartment has one kitchen and two bathrooms with separate toilets, one of which has a tap and sink. An extra tap was found in the hallway and a steel tap, sink, and countertop was present in one of the rooms. The central heating is connected to eight radiators that varied significantly in size, and an extra disconnected radiator was found in the fusebox. All door and window frames were wood. The copper piping of the boiler was significantly corroded, which raised questions on its reusability. Although there were no visible signs of renovations, a large renovation is planned in January 2017 that will remove walls and integrate two of the apartments within the building into one larger apartment.

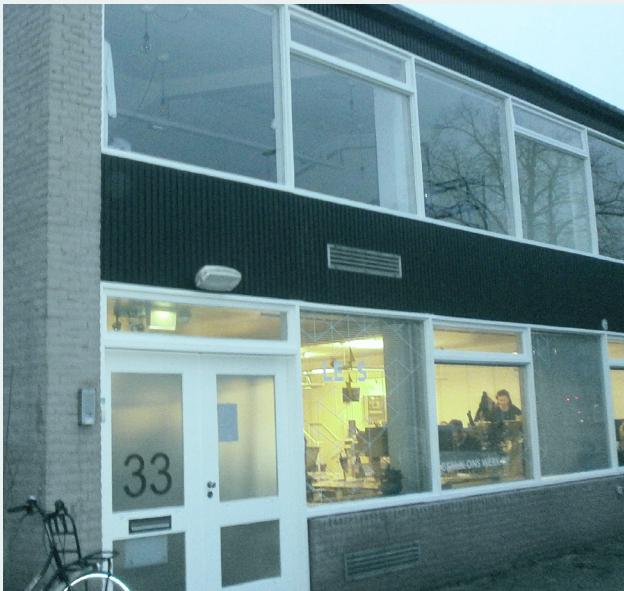
SURINAMEPLEIN 35

This five story building in Hoofddorppleinbuurt is a former nursing home and is now a cultural incubator, providing housing to 62 people, eight rehearsal rooms and 11 ateliers and offices. Although the building's official function is still healthcare, its current use is mixed residential and commercial. Notable is that it is attached to the office space in Surinameplein 33, which is in fact not an official address and is part of Surinameplein 35 according to the cadastre. The eight balconies have steel railings and the window and door frames leading to them are made of steel. The facade contains galvanized steel drainpipes up to the first floor, from which point onwards they continue as plastic. The entrance to the building has a staircase, and two old elevators and stairs with steel railings lead up to the apartments.

Although the building contains a single apartment of 3420m² according to the cadastre, and thus in the PUMA framework as well, the floor was defined here as a functional unit for apartment during the site-visit. The findings were multiplied by five to obtain the building and apartment results to compare with the PUMA assumptions. Each floor serves as a separate large apartment, providing housing to 14 people who share one kitchen, four showers and four toilets, and every bedroom has its own tab and sink. The apartments have central heating with 25 radiators per floor. The door frames contain some steel, of which there are 28 per floor with an additional three fireproof doors. There were clear signs of renovations; five walls were removed and the kitchen infrastructure was moved to another room.

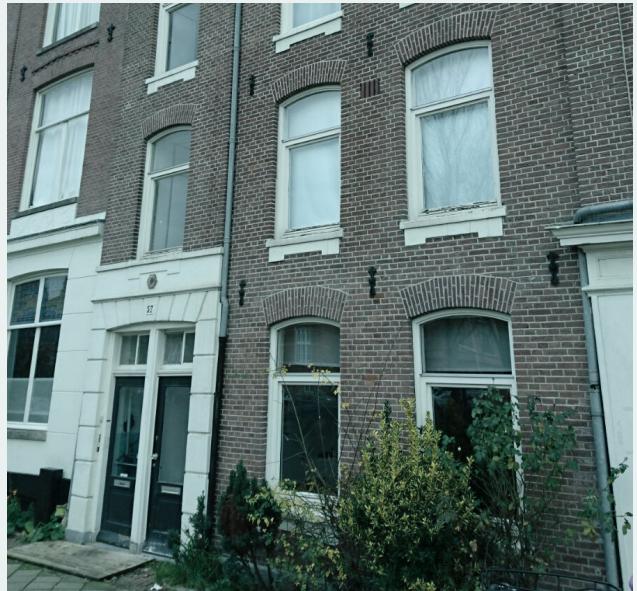
RUYSDAELKADE 57 HS

This house from 1875 in Oude Pijp is made of stone bricks for its load-bearing structure. Although the partitioning of the facade and doors suggest the presence of four apartments, the building is actually bigger and contains fifteen apartments and one gallery on the ground floor. The facade furthermore contains cast iron ornaments and galvanized steel rain pipes.

The apartment was on the ground floor and had a separate door, so no stairs leading to the other apartments were visible. There was one kitchen with a gas connection, a stainless steel sink, and a countertop, as well as one bathroom with a toilet but no sink. A separate toilet was not present. The door and window frames were made of wood. There was central heating in the apartment with four radiators. It was indicated that this heating system was recently changed, implying a renovation that might have affected the metal content.
