Messages for Manufacturing Personnel

We Have Liftoff!!!

October 2007

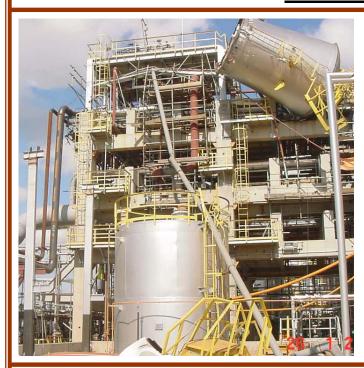
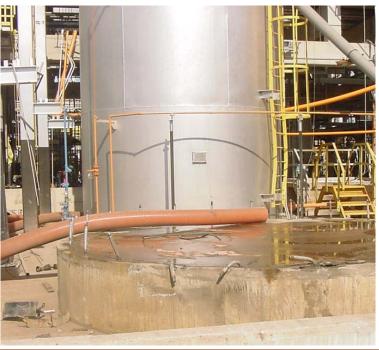
A plant was doing a pneumatic pressure test on a pipe connected to a tank. There was no blind flange between the piping being tested and the tank. The tank was isolated from the pressurized piping with a closed block valve. The block valve leaked, allowing the pressure from the pneumatic test to leak into the tank. The tank (which either did not have a pressure relief device installed, or the pressure relief device was too small) was overpressured, and it failed at the bottom. The tank lifted into the air and came to rest on the top of the plant.

- > During pressure tests, or any other maintenance or non-routine activities involving pressure, make sure that all equipment is capable of withstanding the test pressure, is positively isolated from the source of pressure, or has adequately sized pressure relief devices for the testing conditions.

- ➤ Equipment can be protected from being overpressured more reliably by using blinds, or by physically disconnecting piping, rather than using valves to isolate the equipment from pressure.

- ➤ Do a process safety review before starting any non-routine operations to identify potential hazards and required safeguards during the operation.
- ➤ Keep workers away from the area where pressure testing operations are being conducted.

- ➤ If possible, pressure test lines using liquid pressure (hydrostatic pressure) rather than pneumatic (gas) pressure the energy which can be released from a liquid overpressure is MUCH LESS than from a gas overpressure.
