# Process Safety Beacon

#### Is this valve open?..... or closed?

**June 2006**

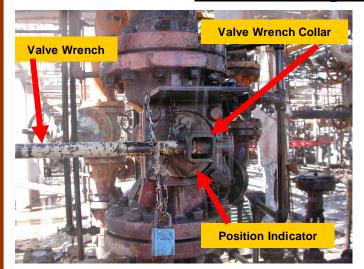
Many people would expect this valve to be closed - the position of the valve handle (in this case, a "valve wrench") is perpendicular to the pipe. But close inspection of the valve position indicator shows it is parallel to the pipe, clearly indicating the valve is open! WHY? The valve wrench collar is square and can be positioned in two ways — one with the valve wrench parallel to the valve position indicator and the other with the valve wrench perpendicular to the position indicator.

This confusing setup was one cause of an incident which injured 6 people, resulted in 13 million

US dollars in damage, shut down a refinery for several months and required off site evacuations. Operations personnel used this valve to isolate a pump for maintenance and mistakenly believed the valve was closed. It was not! The result: release of a large quantity of flammable liquid at 150 psig (10 bar g) and 350 degrees F (175 degrees C), followed by an explosion and fire.

←Actual Position and flow

The valve wrench collar →

- Look for equipment that does not work the way you would expect. Have it modified! Pay special attention to confusing control displays, valve position indicators, equipment running status indicators and instrument displays.
- ➤ Local culture and/or practices can change the way things are "expected" to appear. For example, some translations of this Beacon will read from right to left. If you use equipment manufactured in another country, it may not operate the way you expect it to it is also deserving of special attention.
- ➤ Take a few minutes to read the United States Chemical Safety and Hazard Investigation Board case study on this incident. It will provide additional information as well as other causes for this incident.
