Messages for Manufacturing Personnel

July 2007

Fire Caused by Hose Repaired with Duct Tape!

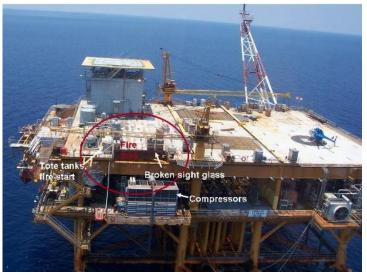
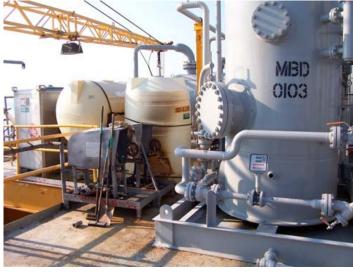
On an offshore oil platform, operators were transferring methanol from a portable chemical transporter tank connected by a hose to a storage tank. When the tank was lifted by a crane to gravity feed the storage tank, methanol began spraying out from a hole in the hose. The methanol ignited on the top deck. Methanol that was sprayed over the side also ignited by the hot exhaust of a compressor located immediately below the transfer point on the second deck. The fire was compounded by the breaking of the transfer tank's sight glass when a crewman attempted to kick the valve closed. The fire spread as relief valves on two other chemical transport tanks opened.

After twenty-two 30-pound hand-held chemical fire extinguishers, two 125-pound wheeled fire extinguisher units, and the firewater system were used, the fires on both decks were contained. One man received second-degree burns. After the fires were extinguished, it was discovered that the hose used to feed methanol from the transporter to the storage tank was split and had been repaired with duct tape prior to the operation!

- NEVER make temporary or unauthorized repairs on equipment in hazardous material service without a management of change review by qualified personnel.
- ALWAYS inspect equipment before using it. If there is any sign of damage, corrosion, improper repair, or any other defect, replace the equipment before you start the job.
- Avoid transferring flammable products near ignition sources such as compressors.
