Process Safety Beacon http://www.aiche.org/ccps/safetybeacon.htm

October 2003

Don't pop your top...

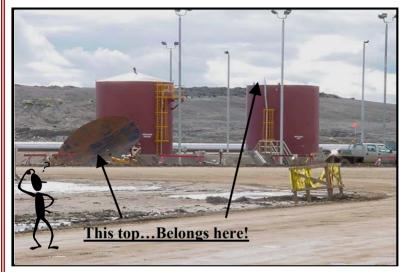
A very simple job—fill the tank with water. This is a common occurrence at a manufacturing plant and has minimal hazards. In this case, site personnel were being extra cautious. They started the water flow and confirmed that air was coming out of the vent on top of the tank. Everything seemed to be fine...**BUT**, the source of the water was the plant fire water system---and the flow was **VERY** high! The vent did not have enough capacity to relieve all of the displaced air, pressure built up in the tank, and **BOOM**—the top blew off when the roof seam failed

Problems occur when the inflow or outflow of liquid is greater than the capacity of the vent system. For inflow, it leads to an increase of pressure inside the tank because the vapor can't get out fast enough.

It doesn't take much pressure (in some cases just a few inches of water) to cause a lot of damage. Tanks usually have large surface areas, so when pounds per square inch is multiplied by a large number of square inches, the force can be huge! In this case, the roof seam was the weak point and failed first.

Watch out for "Temporary" operations—this tank vent was probably sized for normal processing conditions, not for fire water addition. If uncertain---CHECK!

Testing—SafeOut—Cleaning: there are many times that a vessel must be filled with water. Each time it is, make sure that the fill rate is slow enough for the vent system to handle the displaced And just to be sure, vapor. monitor the pressure in the vent space to make sure it is less than the vessel's pressure rating.

When unsure, add water at "normal" processing rates.

Liquid transfer can lead to major vessel damage. "Transfer rate" must not exceed "vent capacity."
