Messages for Manufacturing Personnel

<u>Thirty Years Ago – An LPG Tragedy</u>

November 2014

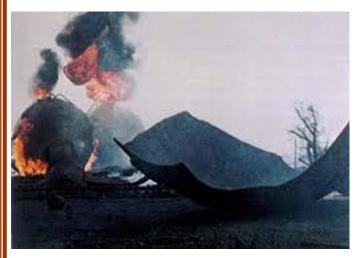
At about 5:30 AM on November 19, 1984 there was a major fire and a series of explosions at a liquefied petroleum gas (LPG) storage and distribution terminal at San Juan Ixhuatepec, Mexico City, Mexico. There were approximately 600 fatalities, approximately 7,000 injuries, 200,000 people were evacuated, and the terminal was destroyed. The blasts were recorded on a seismometer 20 km (12.4 miles) away, and the largest blast registered 0.5 on the Richter scale. Most of the injuries and fatalities were in the surrounding community – people were living as close as 130 m (425 ft.) from the terminal.

The cause of the accident could not be definitively established because of the destruction of the facilities and absence of witness reports. It is believed that LPG leaked from a tank or pipeline into a walled enclosure. LPG vapors formed a flammable vapor cloud about 2 m (6.6 ft.) high. The cloud was ignited, possibly by a ground flare.

There is evidence that some storage tanks in the facility may have been overfilled, leading to diversion of LPG flow to ground flares. The initiating release may have come from overfilling a tank or overpressure of one of the storage tanks.

Many causes contributed to the disaster, including the design of the terminal (for example, inadequate spacing of tanks, ineffective gas detection, lack of passive fire protection systems), destruction of the fire fighting system by the explosions, improper maintenance of safety equipment, and a large number of people living close to the terminal.

- Understand the magnitude of a potential incident in your plant, and what safety systems are in place to prevent and mitigate the event.
- Report all failures of safety systems and equipment and ask your management to have them repaired.
- Check that all pressure relief devices are inspected and maintained as required by your plant's policy.
- Confer with your safety and production engineers to determine how to manage risk, including the possibility of shutting down, if critical safety equipment is not working properly.
- Remember that poor housekeeping in a plant is often a symptom of a poor safety culture. Take care of your plant and all of its equipment, especially safety equipment.
