Process Safety Beacon

April 2006

Mechanical Integrity

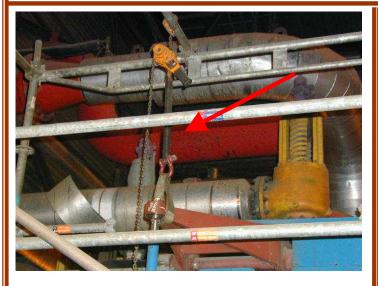
This picture shows an improvised pipe support made from scaffolding, springs and clamps.
