# NGV: Borrador Instrucciones limpieza counterpart Top Seal

# Ropex Tools

# Ropex Hanger Hole.

# Malas Soldaduras Top Seal

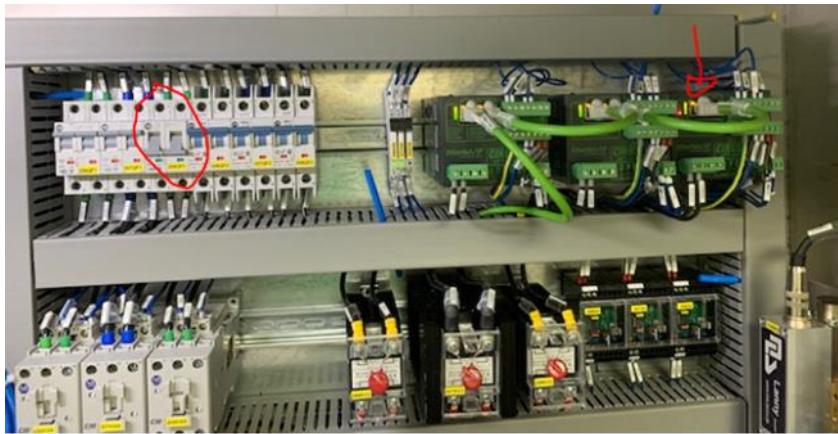
Based on this I checked the electrical cabinet and a thermal was off and a module in alarm:

Please share with the maintenance team.
