**805 High Mesa,
Wimberley, TX**

PROPERTY INSPECTION REPORT FORM

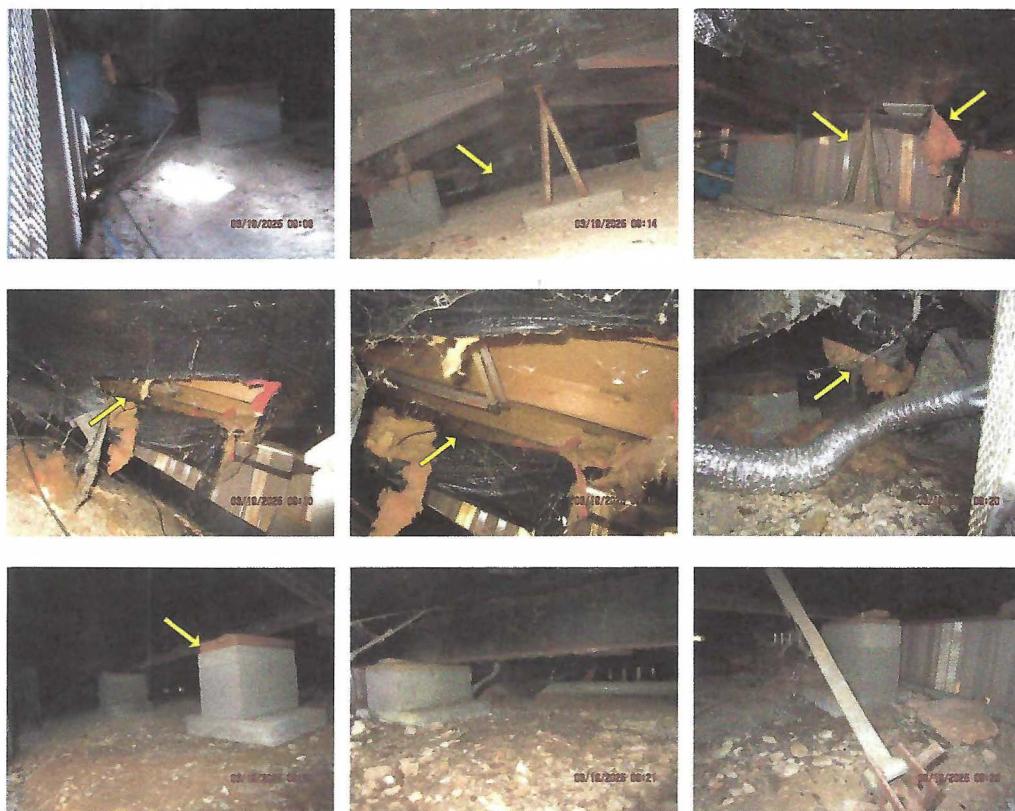
- Note: the piers were concrete block on pad and screw jacks. The beams were iron. The foundation was anchored with metal straps.
- The particular screw jacks used for adjustable piers are the wrong type for this application. I would recommend further evaluation and repair by a qualified foundation company.

- Several of the concrete block piers are leaning and no longer supporting the structure. I would recommend further evaluation and repair by a qualified foundation company.

- Subfloor insulation was damaged and hanging down in several locations. The vapor barrier holding the insulation in place was also damaged. I would recommend further evaluation and repair by a qualified contractor.

- In my opinion the foundation has settled some as evidenced by some of the piers no longer supporting the beams, out of square interior door margins, sloping interior floors, and is no longer performing adequately. I would recommend further evaluation and repair by a qualified foundation company.

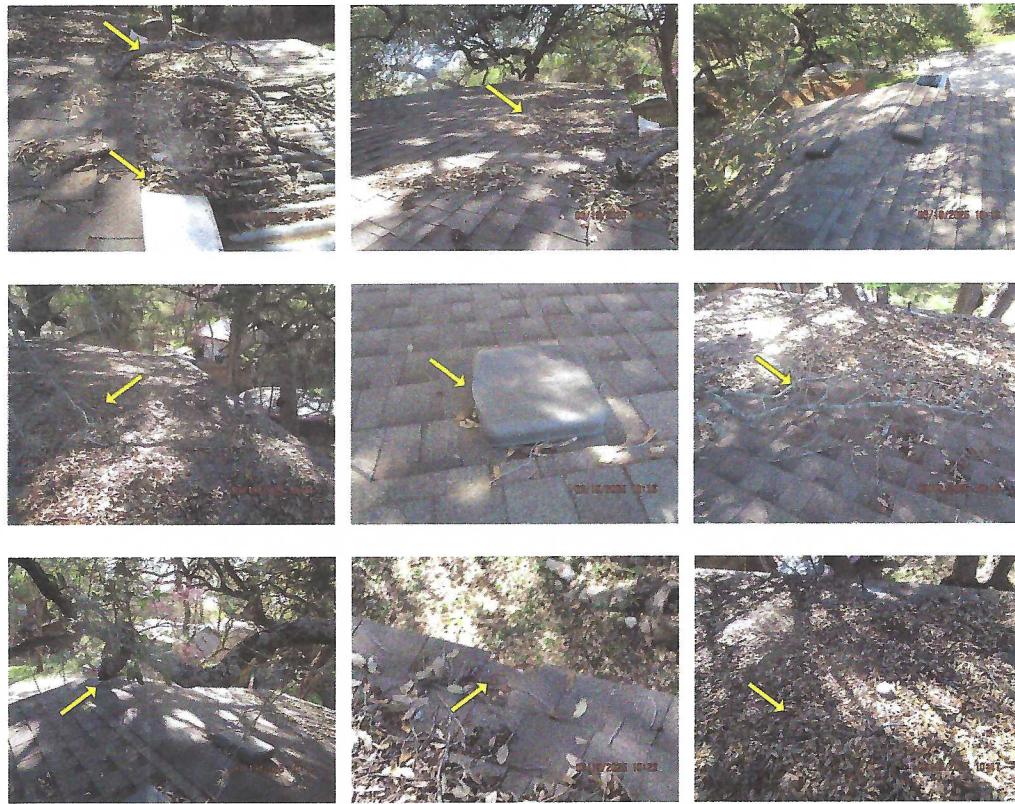
- Note: much of the roof surface was concealed from view by tree limbs and leaf debris covering the surface. All debris needs to be removed from the roof surface for proper drainage.
- All tree branches need to be trimmed away from the roof surface by at least five feet. I would recommend further evaluation and repair by a licensed arborist.
- One of the exhaust vents near the ridge of the roof was damaged restricting the air flow. I would recommend further evaluation and repair by a qualified roofing company.
- Damaged shingle edges and damaged flashing were observed at the back edge of the house. Other damaged shingles may be present, but were concealed from view. I would recommend further evaluation and repair by a qualified roofing company.

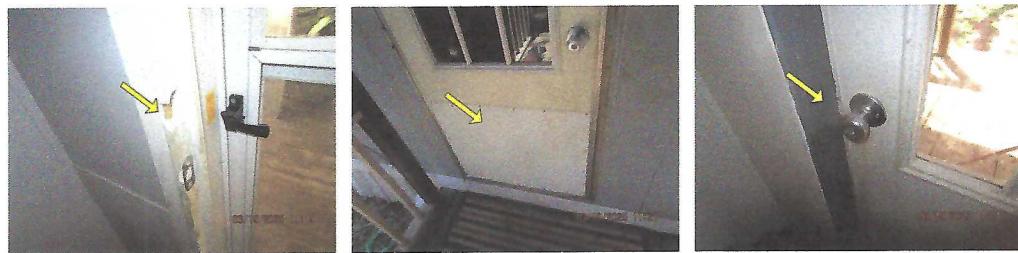
- The front exterior door had no striker plate installed for the deadbolt lock and the door frame was cut out so the deadbolt lock was ineffective. I would recommend further evaluation & repair by a qualified contractor.
- The back exterior door has been patched at the exterior and would not lock or latch. I would recommend further evaluation & repair by a qualified contractor.
- The master bathroom door rubbed the door frame.
- The master bedroom door hit the door frame and would not close.
- The front left bedroom door would not close and the closet door was missing.

Will be addressed for the exception of the missing closet door.

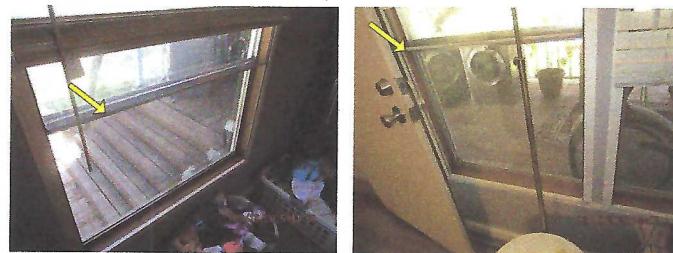
- Most of the interior bottom window panes were missing. The outer window panes were present. I would recommend further evaluation & repair by a qualified contractor.

This will not be addressed.

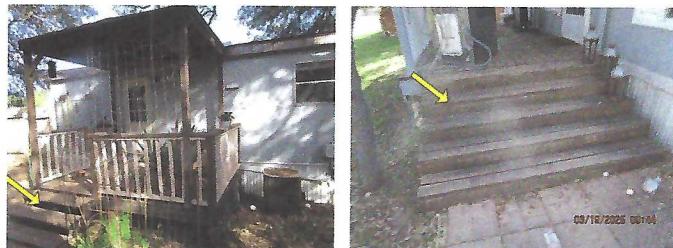
- Open face risers observed at the back exterior stairs; this is a child safety hazard. The space between the steps should not allow the passage of a 4 inch sphere.
- No proper graspable handrail installed at the front stairs with four or more risers; this is a hazard. I would recommend further evaluation & repair by a qualified contractor.

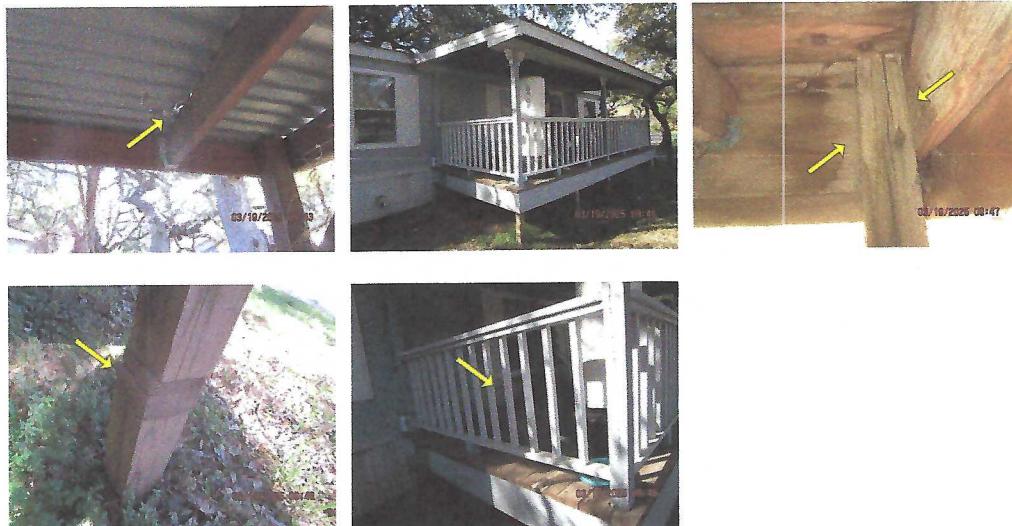
- The back deck roof covering had a hole in it and the flashing to the house roof was damaged and improperly installed. I would recommend further evaluation & repair by a qualified contractor.
- The deck beams are improperly attached to the deck support posts; they need to be

- resting on top of the posts or in a notch on the posts with a through bolt.
- Improper baluster spacing at the guard rail on both decks. The balusters should be spaced so that a 4 inch sphere cannot fit through the balusters. This is a child safety hazard. I would recommend further evaluation & repair by a qualified contractor.

This will not be addressed.

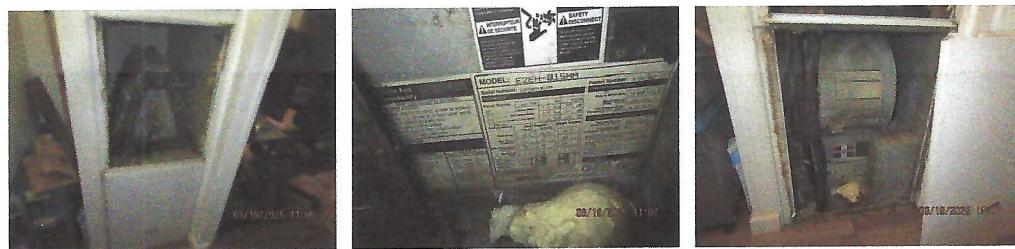
- Note: the heating system has aged & maybe near the end of its useful lifespan. Central heaters typically last about 15-30 years. This heater was 27 years old.
- The heating system did not appear to be heating adequately. With the thermostat set for heating, the highest temperature that was coming from the floor registers was about 79F. Typically, I would expect to see the heater producing over 100F. It may be that a heating element was inoperative. I would recommend further evaluation & possible repair by a licensed HVAC technician.

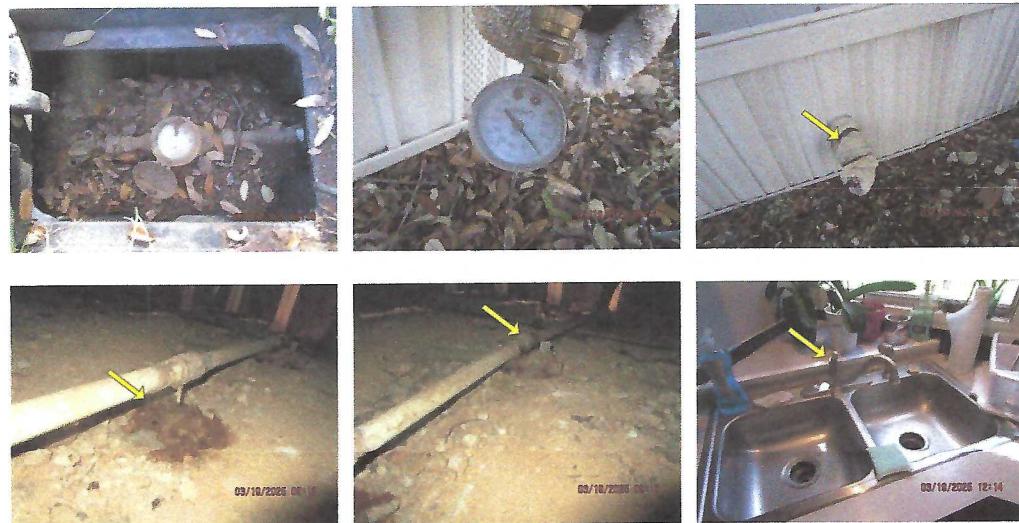
- No user water shut off valve observed; only the utility shut off is present. User shut off valves are now required in most municipalities.

- The front left exterior water faucet was not secured in place as required. I would recommend further evaluation and repair of all water supply issues by a licensed plumber.

- What appeared to be a water supply line in the crawl space was lying on the ground and had a slow leak that appeared to be leaking for a long time. Water supply lines are required to be supported above the ground. I would recommend further evaluation and repair by a licensed plumber.

- The kitchen sink faucet was inoperative and needs to be replaced. I would recommend further evaluation and repair by a licensed plumber.
- The hot and cold orientation of the guest bathtub was reversed. I would recommend further evaluation and repair by a licensed plumber.

All items in this section
will be addressed at the
licensed plumber's
recommendation

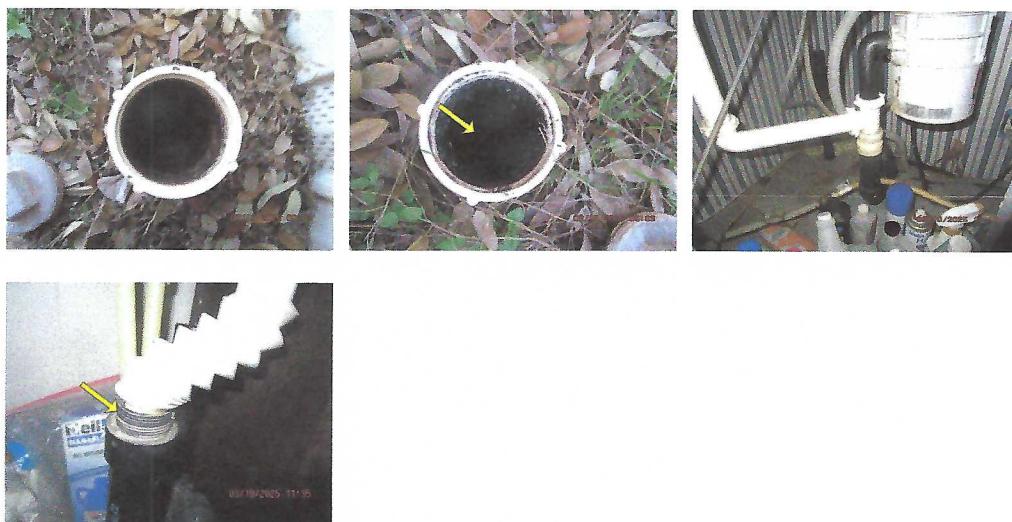
- Water was observed in the sewer cleanout near the house. This can indicate several different issues with the drainage such as a clog, improper grade, or a belly in the line holding water. I would highly recommend having the sewer line video scanned by a licensed plumber.

- The kitchen sink drain was loose and leaking. I would recommend further evaluation and repair by a licensed plumber.
- The master bathroom toilet was loose at the floor indicating that fasteners designed to secure the toilet to the floor have pulled loose. This can damage the seal below the toilet and may indicate the presence of advanced decay in the subfloor (usually a result of water damage). A variety of solutions may be available, depending on the exact nature of the problem. I would recommend further evaluation and repair by a licensed plumber.

- The flexible drain line at the guest bathroom sink was improperly installed. I would recommend further evaluation and repair by a licensed plumber. Note: flexible drain pipes are prone to clogs.
