Improper heater wiring caused boy's death while showering

Coroner's inquiry into 2016 electrocution death also finds flat's circuit breaker was faulty

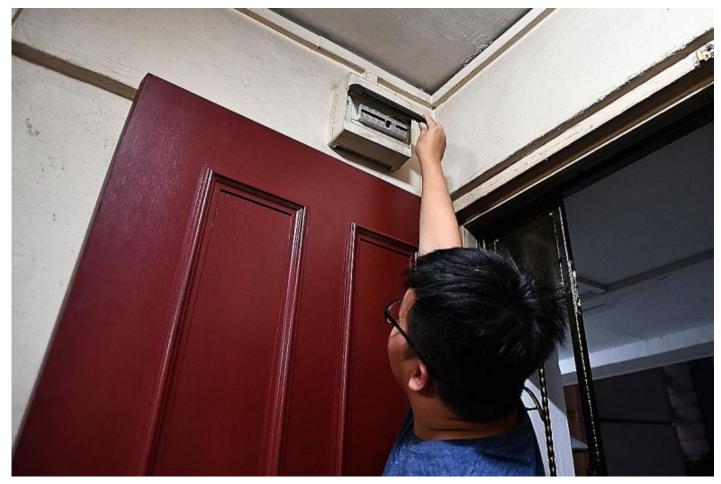
Mr Tan Qi Wei, the brother of 15-year-old Tan Yao Bin who was electrocuted while showering, showing the circuit breaker inside the family's flat yesterday. Three days after his brother's death, the family rewired the whole house and replaced the faulty circuit breaker. ST PHOTO: LIM YAOHUI

A coroner's inquiry into Tan Yao Bin's death also found that the flat's circuit breaker, which should have cut off the electrical supply to prevent the tragedy, was faulty as well.

The current flowing through Yao Bin's hand was 0.95A, which was enough to deliver a fatal electric shock. At the same time, the circuit breaker did not trip off to isolate the electricity supply to the water heater.

And home owners have also been advised to test their circuit breakers monthly by pushing its test button and seeing if it trips.

- Do not wire a three-pin plug to a water heater. Three-pin plugs can support currents of only up to 13A, and water heaters draw currents of up to 20A. Water heaters should instead be wired to a double-pole switch rated at 20A.
- Test your circuit breaker. A manual trip test can be done by pressing the test button of the circuit breaker on your home's distribution box. It should trip when the button is pressed.

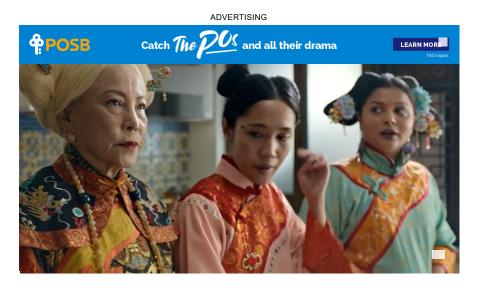
The workman connected the heater to an existing three-pin plug, which was later plugged into a normal wall socket. The worker's supervisor, Mr Ooi Kah Heong, also tested the wiring as well as the circuit breaker and found them to be in order.

During investigations, it was found that the cable connecting the neutral and earth terminals in the plug was loose, and the neutral and earth cables had melted and fused together. The earth cable was also connected to the casing of the heating tank, which was connected to the shower-head by a metallic hose.
