Agenda Supplement

April 12, 2023
HDC Meeting

RE: Inspection of windows and front door – 1512 Southwood Ave.

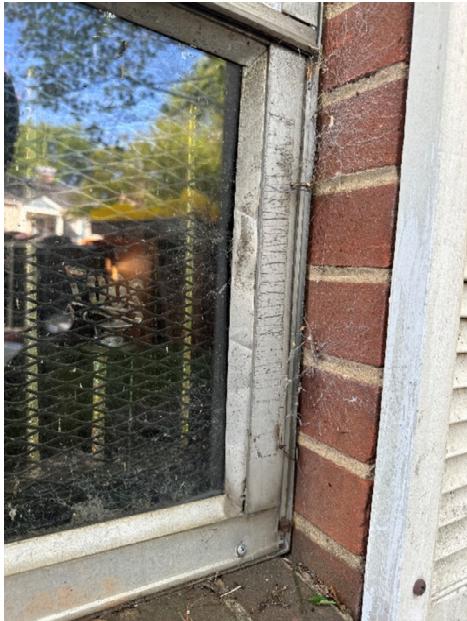
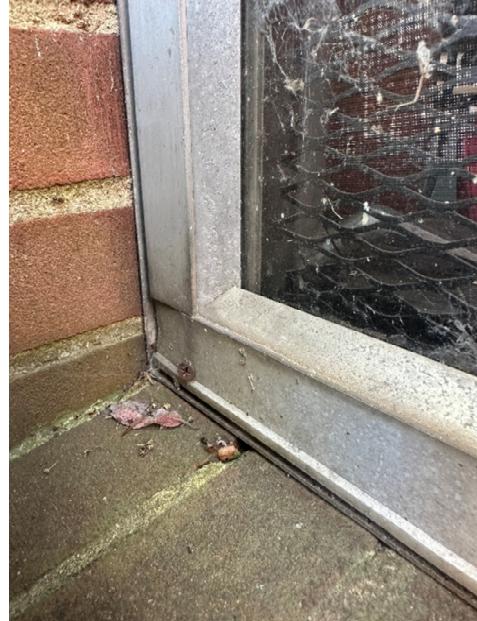
Opening 2:

Exterior frame showing aluminum fatigue and self-taping screws installed through thermal envelope.

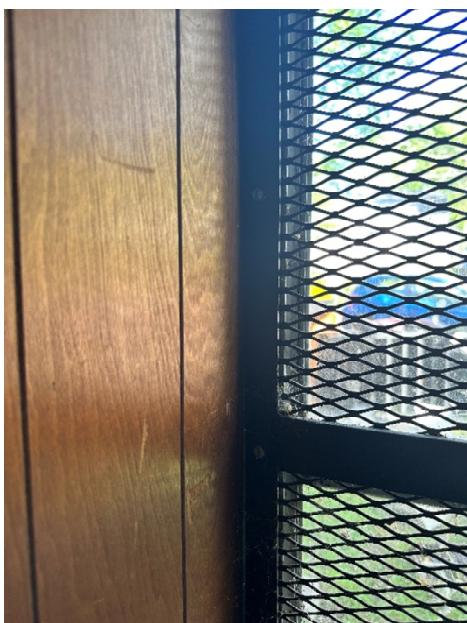
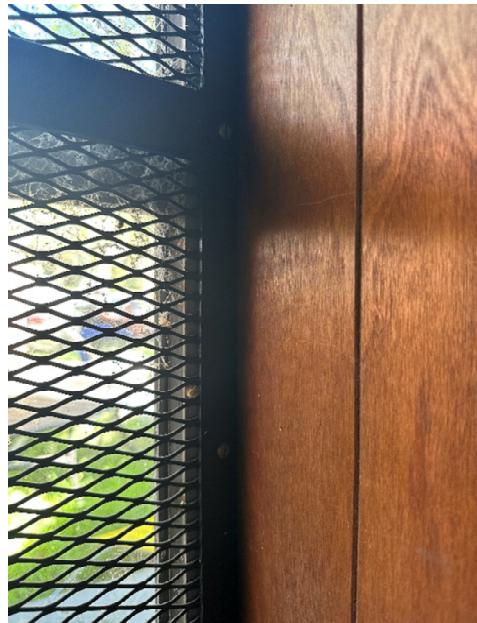
Interior: Self-taping screws used to affix mesh drilled directly into frame breaking the thermal envelope.

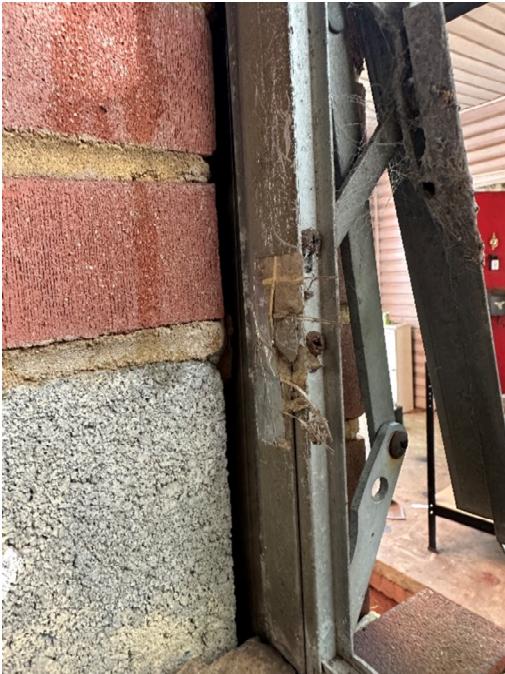
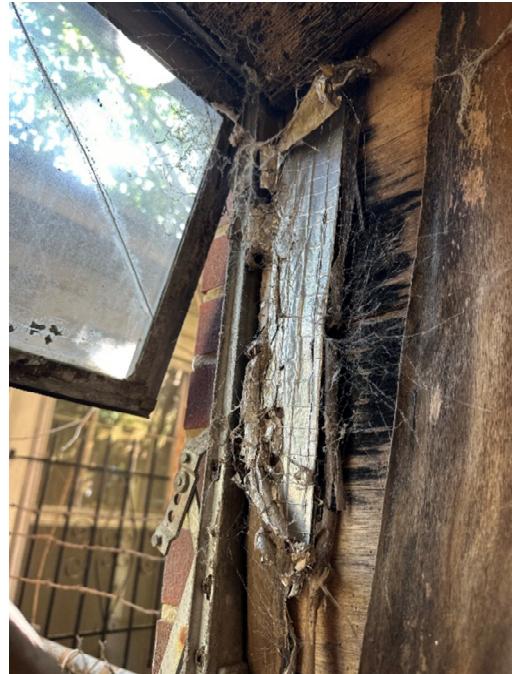
Opening 3:

Frame damage on left photo shows an already failed patch attempt with an additional piece of metal affixed at the top screw. Right photo shows the completely dismantled opening control device for this window, the frame also shows signs of aluminum corrosion and fatigue.

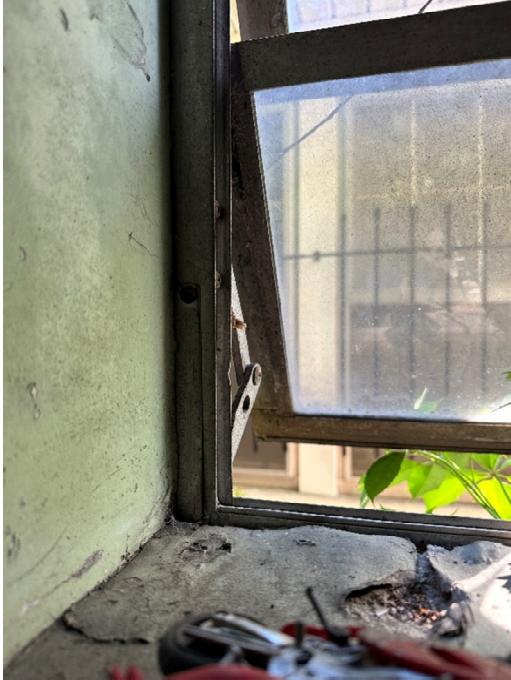
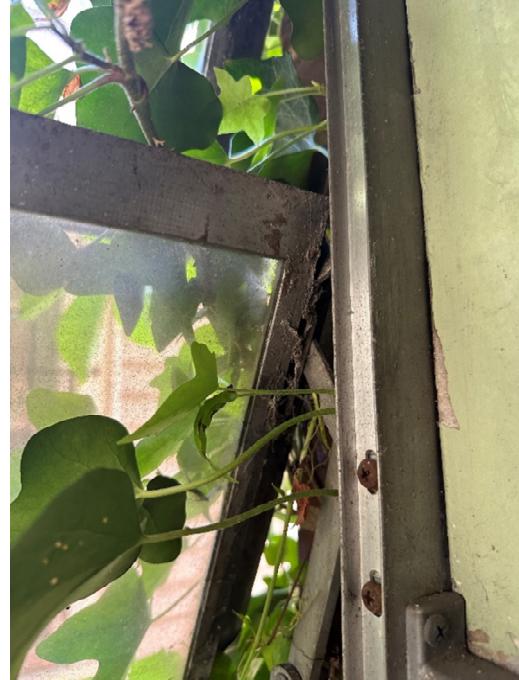
Opening 6:

Frame opening mechanism is non function and out of alignment with the frame, frame shows damage on sides. Vine growth has lodged into certain sections of the frame/building.

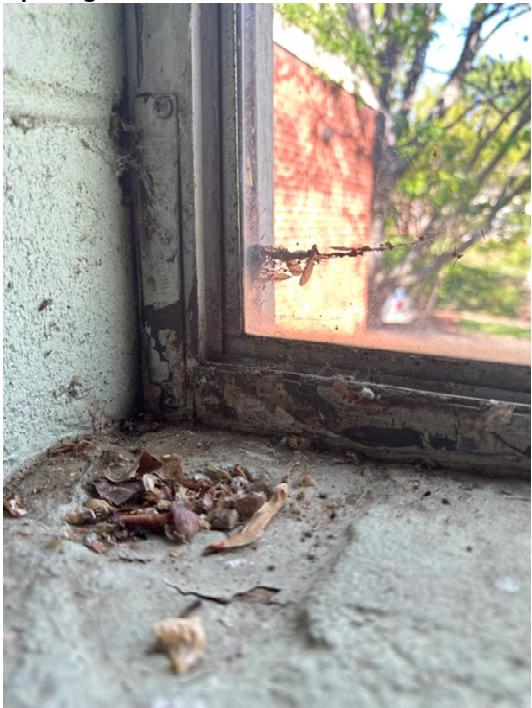
Opening 7:

Window frame shows aluminum fatigue as well as has multiple cracks that have previously attempted repairs. Previous repairs include an applied material over the damage.

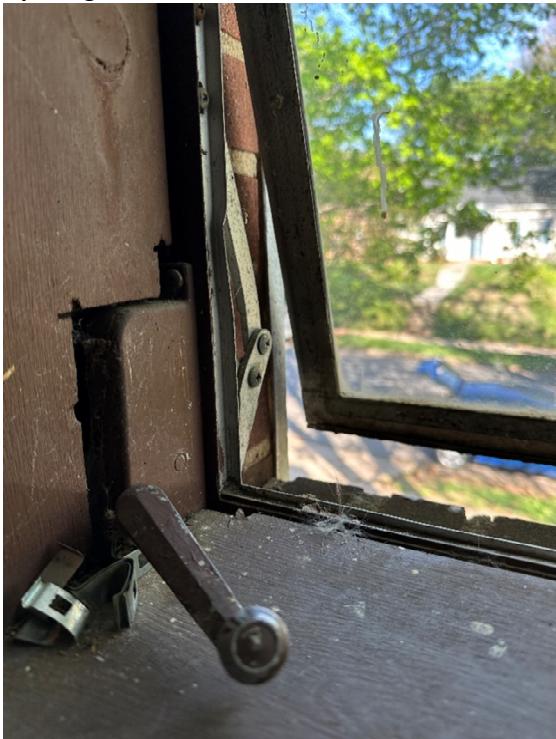
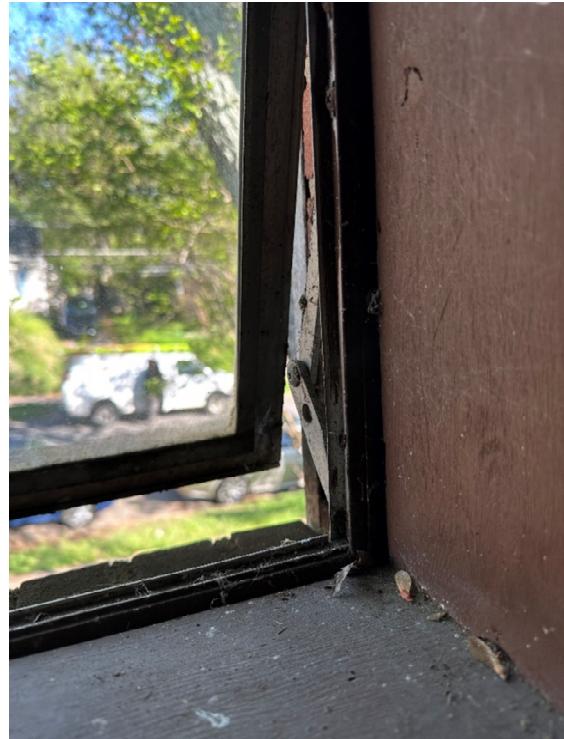
Opening 8:

Opening mechanism is broken and bent out of alignment with the frame. Frame shows damage around the edges as well as aluminum corrosion from remaining permanently open.

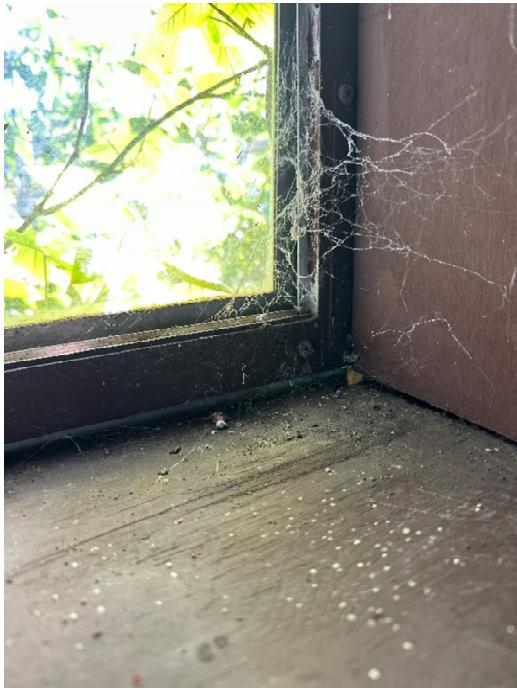
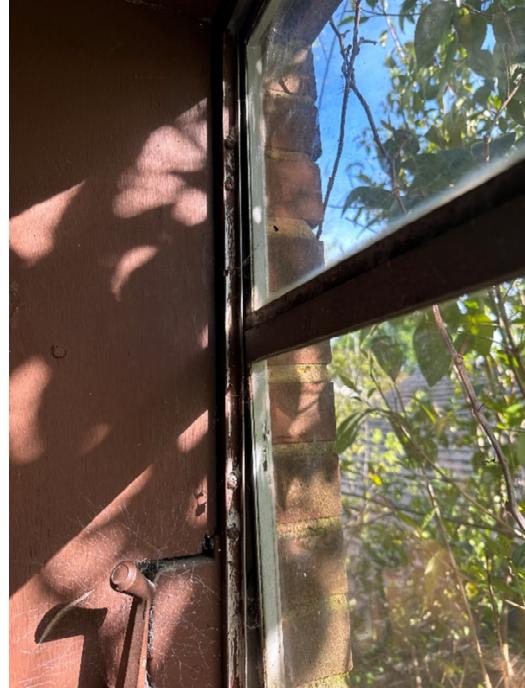
Opening 9:

Opening mechanism is non-functional, frame/lower window pane has warped from original location. Window does not sit properly in opening. On the right you can see the frame is bowed inward as well as where the frame does not sit properly and outside light is visible.

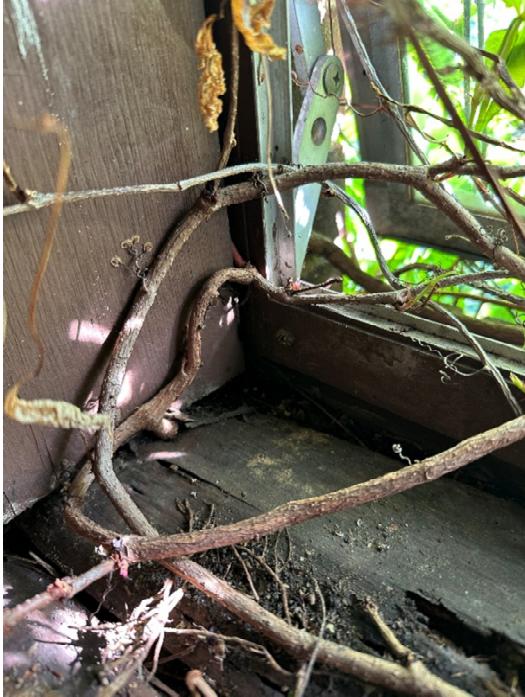
Opening 11:

Vines have grown through/around the frame damaging the frame itself as well as the operating mechanism.

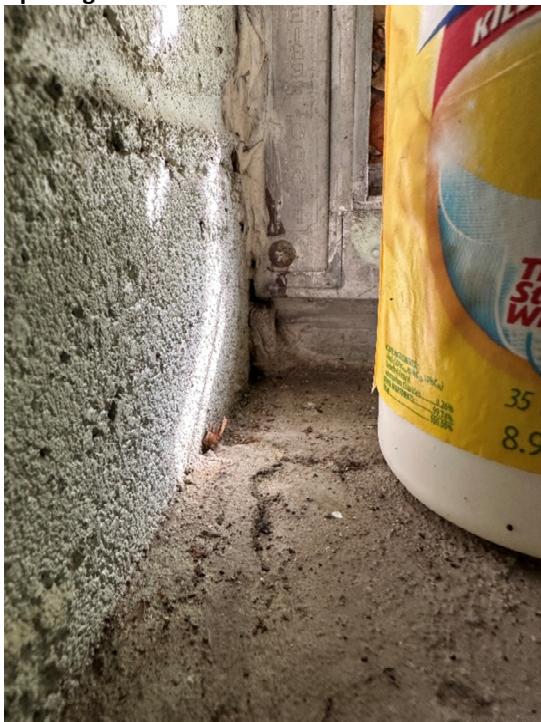
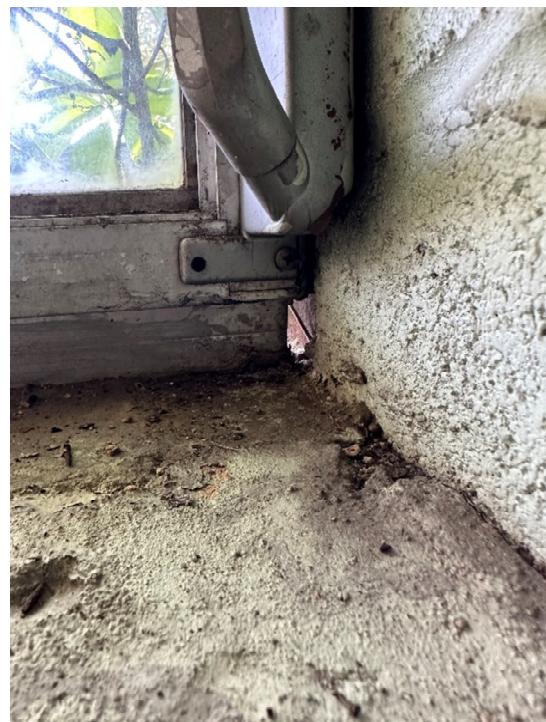
Opening 12:

Window does not fit in the opening, aluminum bar located beneath the window to raise it. Several large holes are seen between the frame and the opening as the window does not fit correctly. The aluminum has suffered fatigue and since the original submission the mechanism has completely failed.

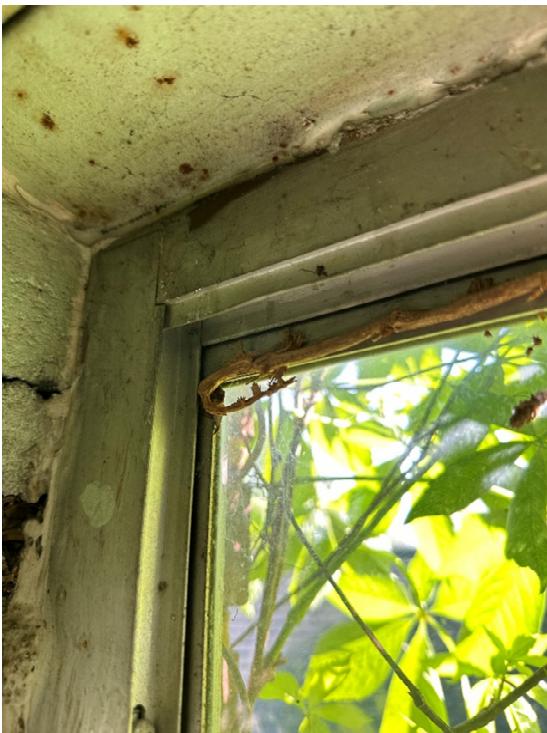
Frame shows signs of aluminum fatigue as well as stress cracking all along the frame, the sections are showing signs of separation.

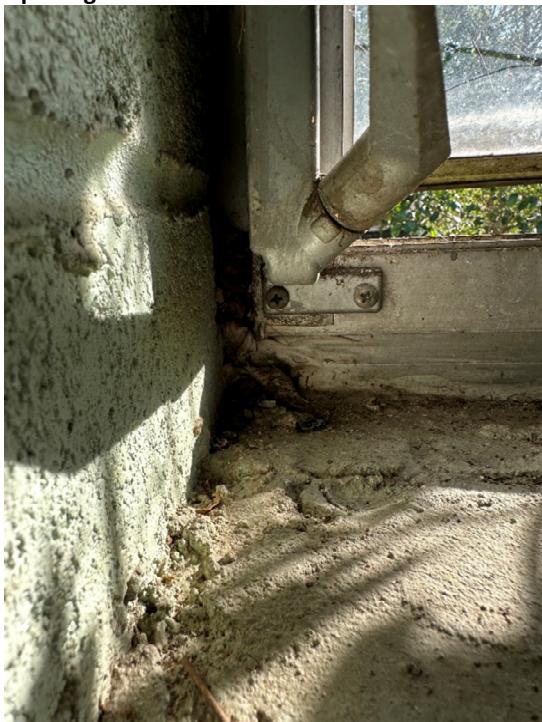
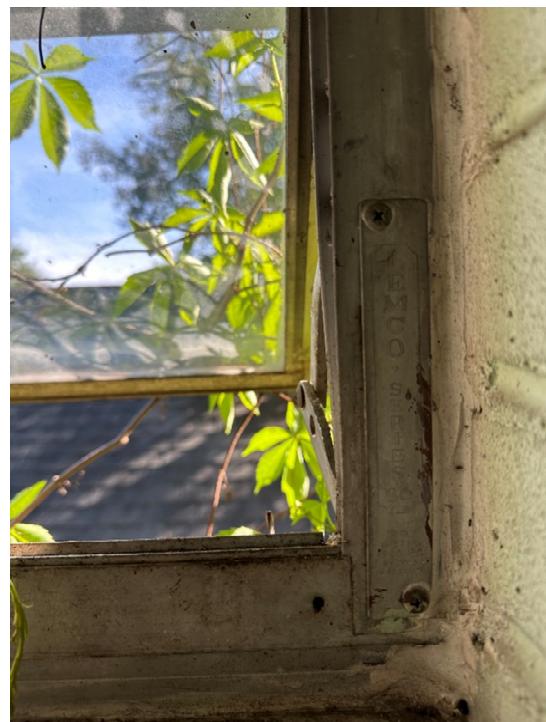
Opening 13:

Window does not fit in the opening correctly, several layers of caulk used to close openings, frame is bent around opening mechanism and is permanently jammed open.

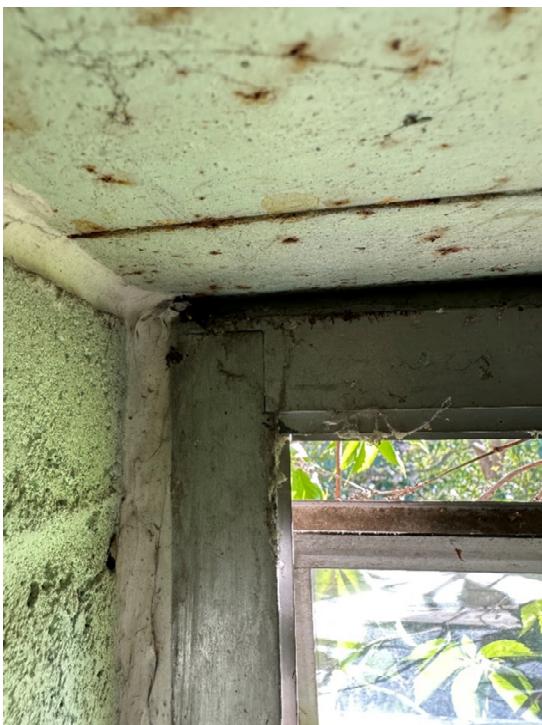
Window frame is separating between the assembled sections. The caulk joint is just shy of $\frac{3}{4}$ " as the window does not fit properly.
