# Principles Course Case Study Conclusion David Casaceli, PE

# DERAILMENT CASE STUDY

## THE TWO L / V RATIOS

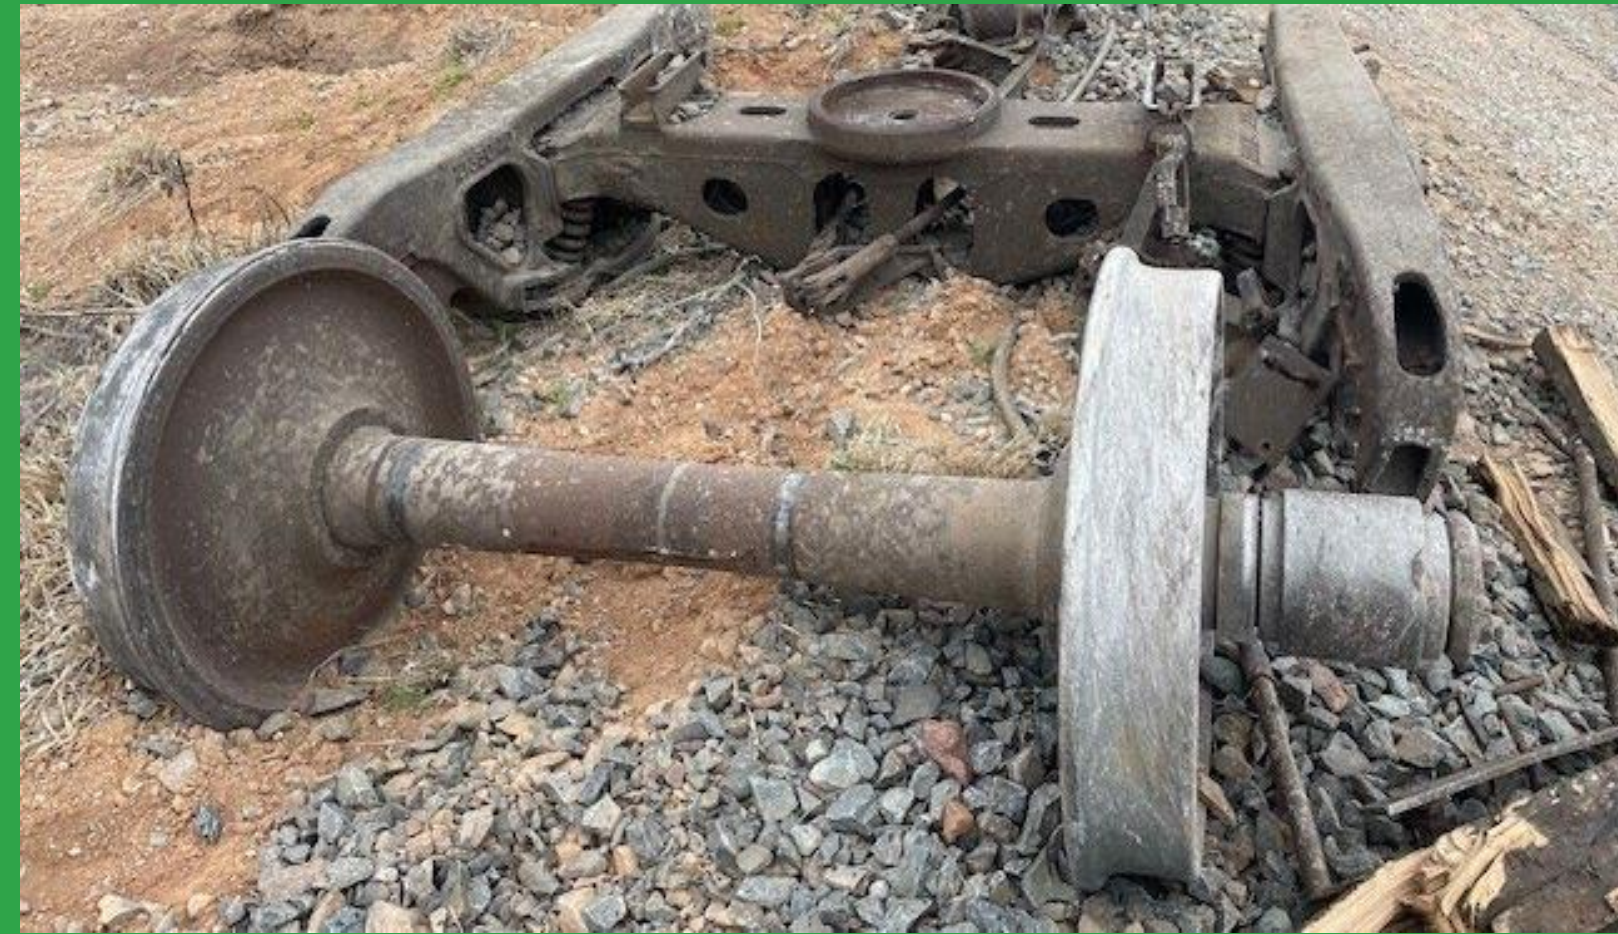
# FIRST DERAILED CAR

- Determined by amount of tread damage to be AOK 5113
- 5-pack intermodal car
- Ride Control Trucks
- **WEDGE RISE**
  - Allowable = 1.82"
  - AR = 1.5" AL = 1.2"
- **GIB WEAR**
  - One side of A Truck

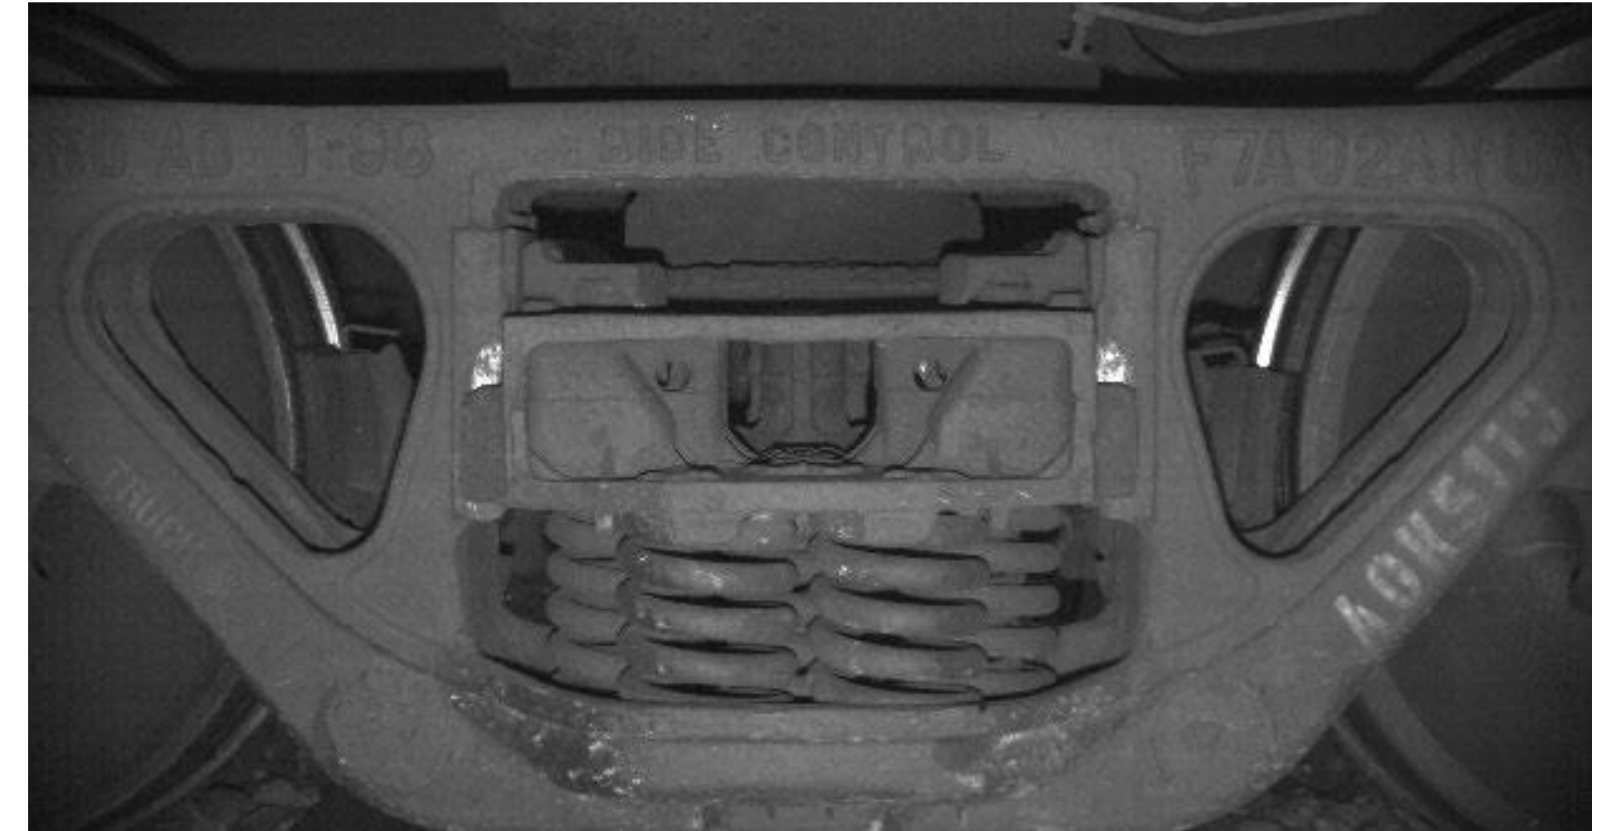
# FIRST DERAILED CAR

- ▶ **ABRASION ON SIDE FRAMES & SPRINGS**
  - Appeared 6 – 8 weeks before accident
  - On left side of all trucks on AOK 5113
  - Car not previously reported in any derailment

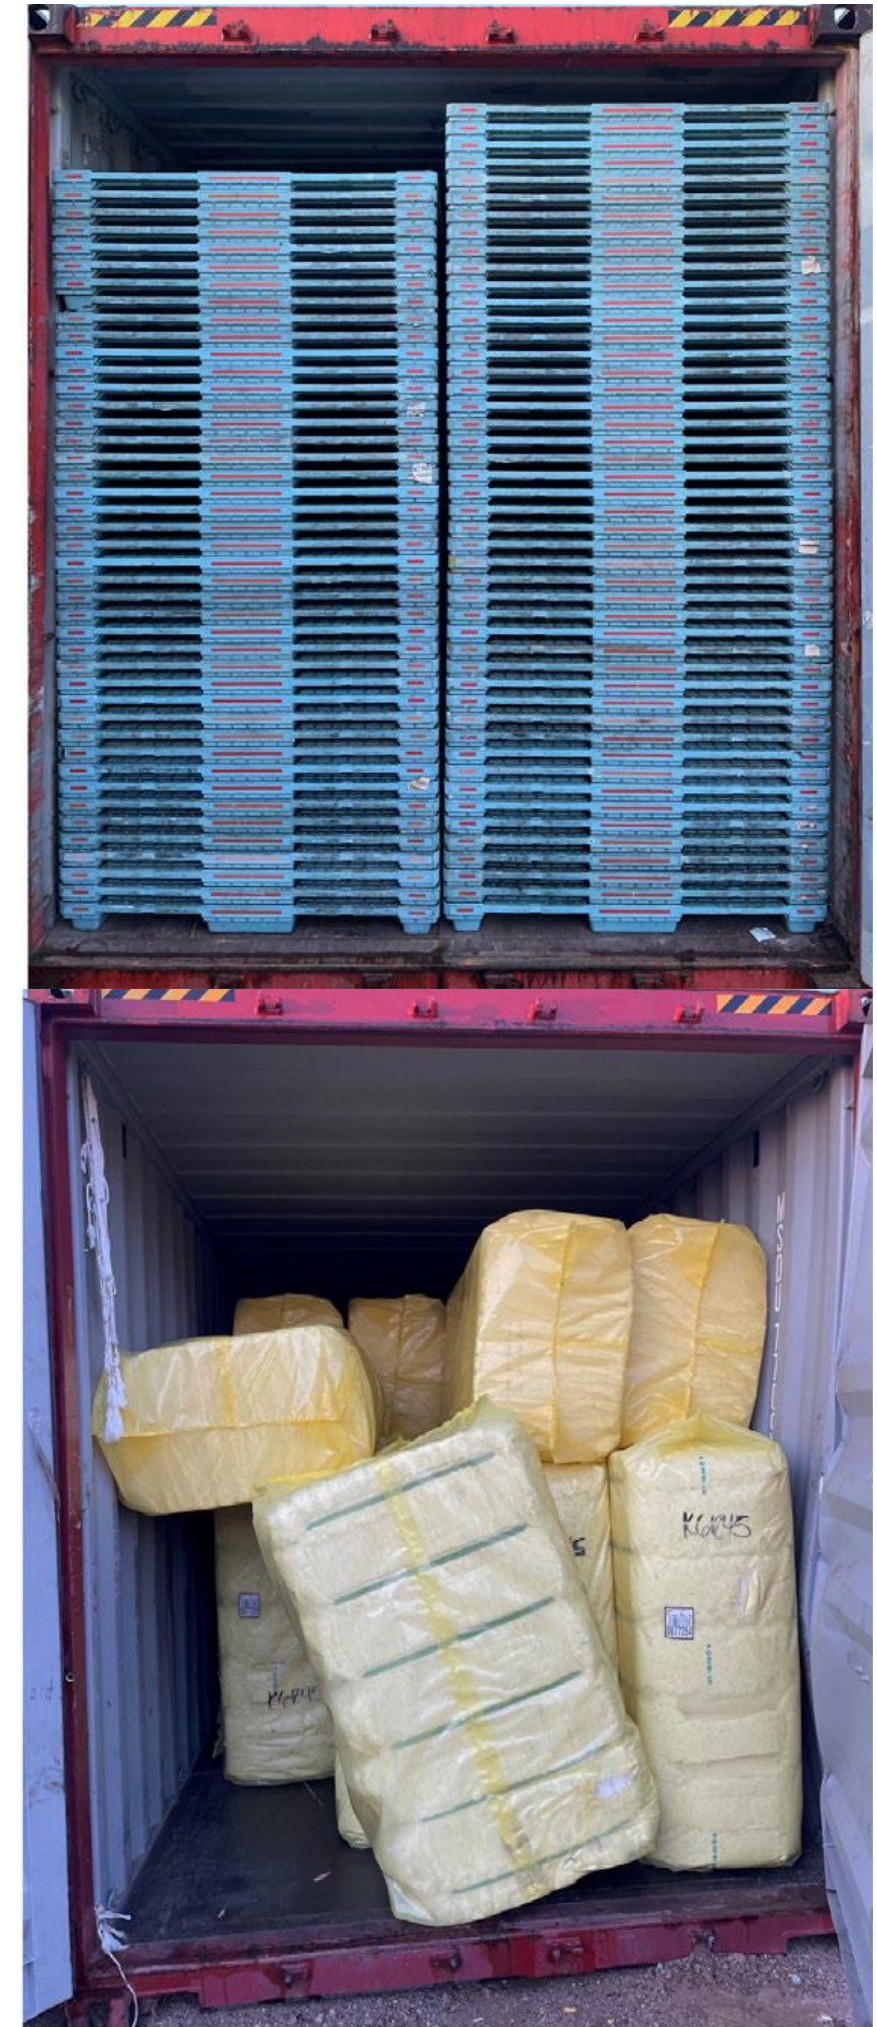
# FIRST DERAILED CAR LOADING

- ▶ **90.3" CENTER OF GRAVITY**  
AAR HIGH CG = 98"
- ▶ **IMBALANCED LOAD TO THE RIGHT (LOW SIDE OF CURVE)**

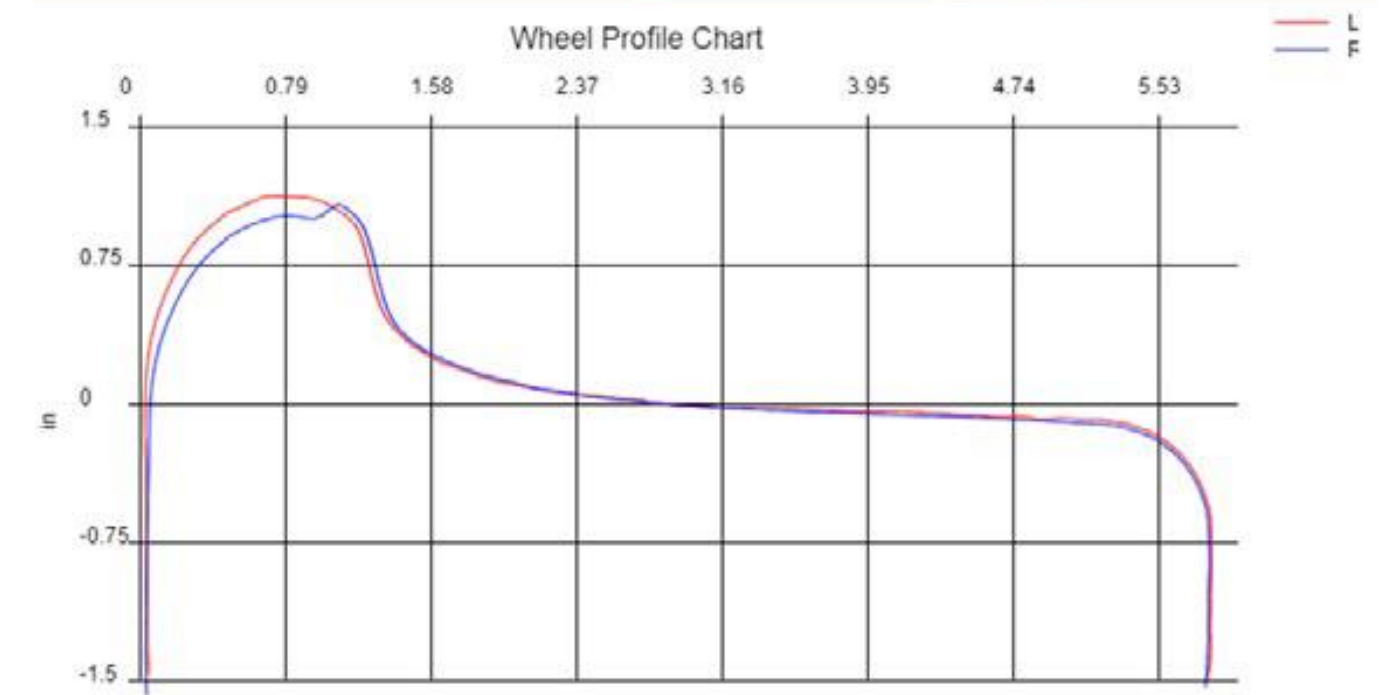
# FIRST DERAILED CAR WHEEL PROFILES

- ▶ FAIRLY SYMMETRIC WEAR
- ▶ SLIGHTLY HOLLOW on AL SIDE  
2.5mm (4mm Allowed)

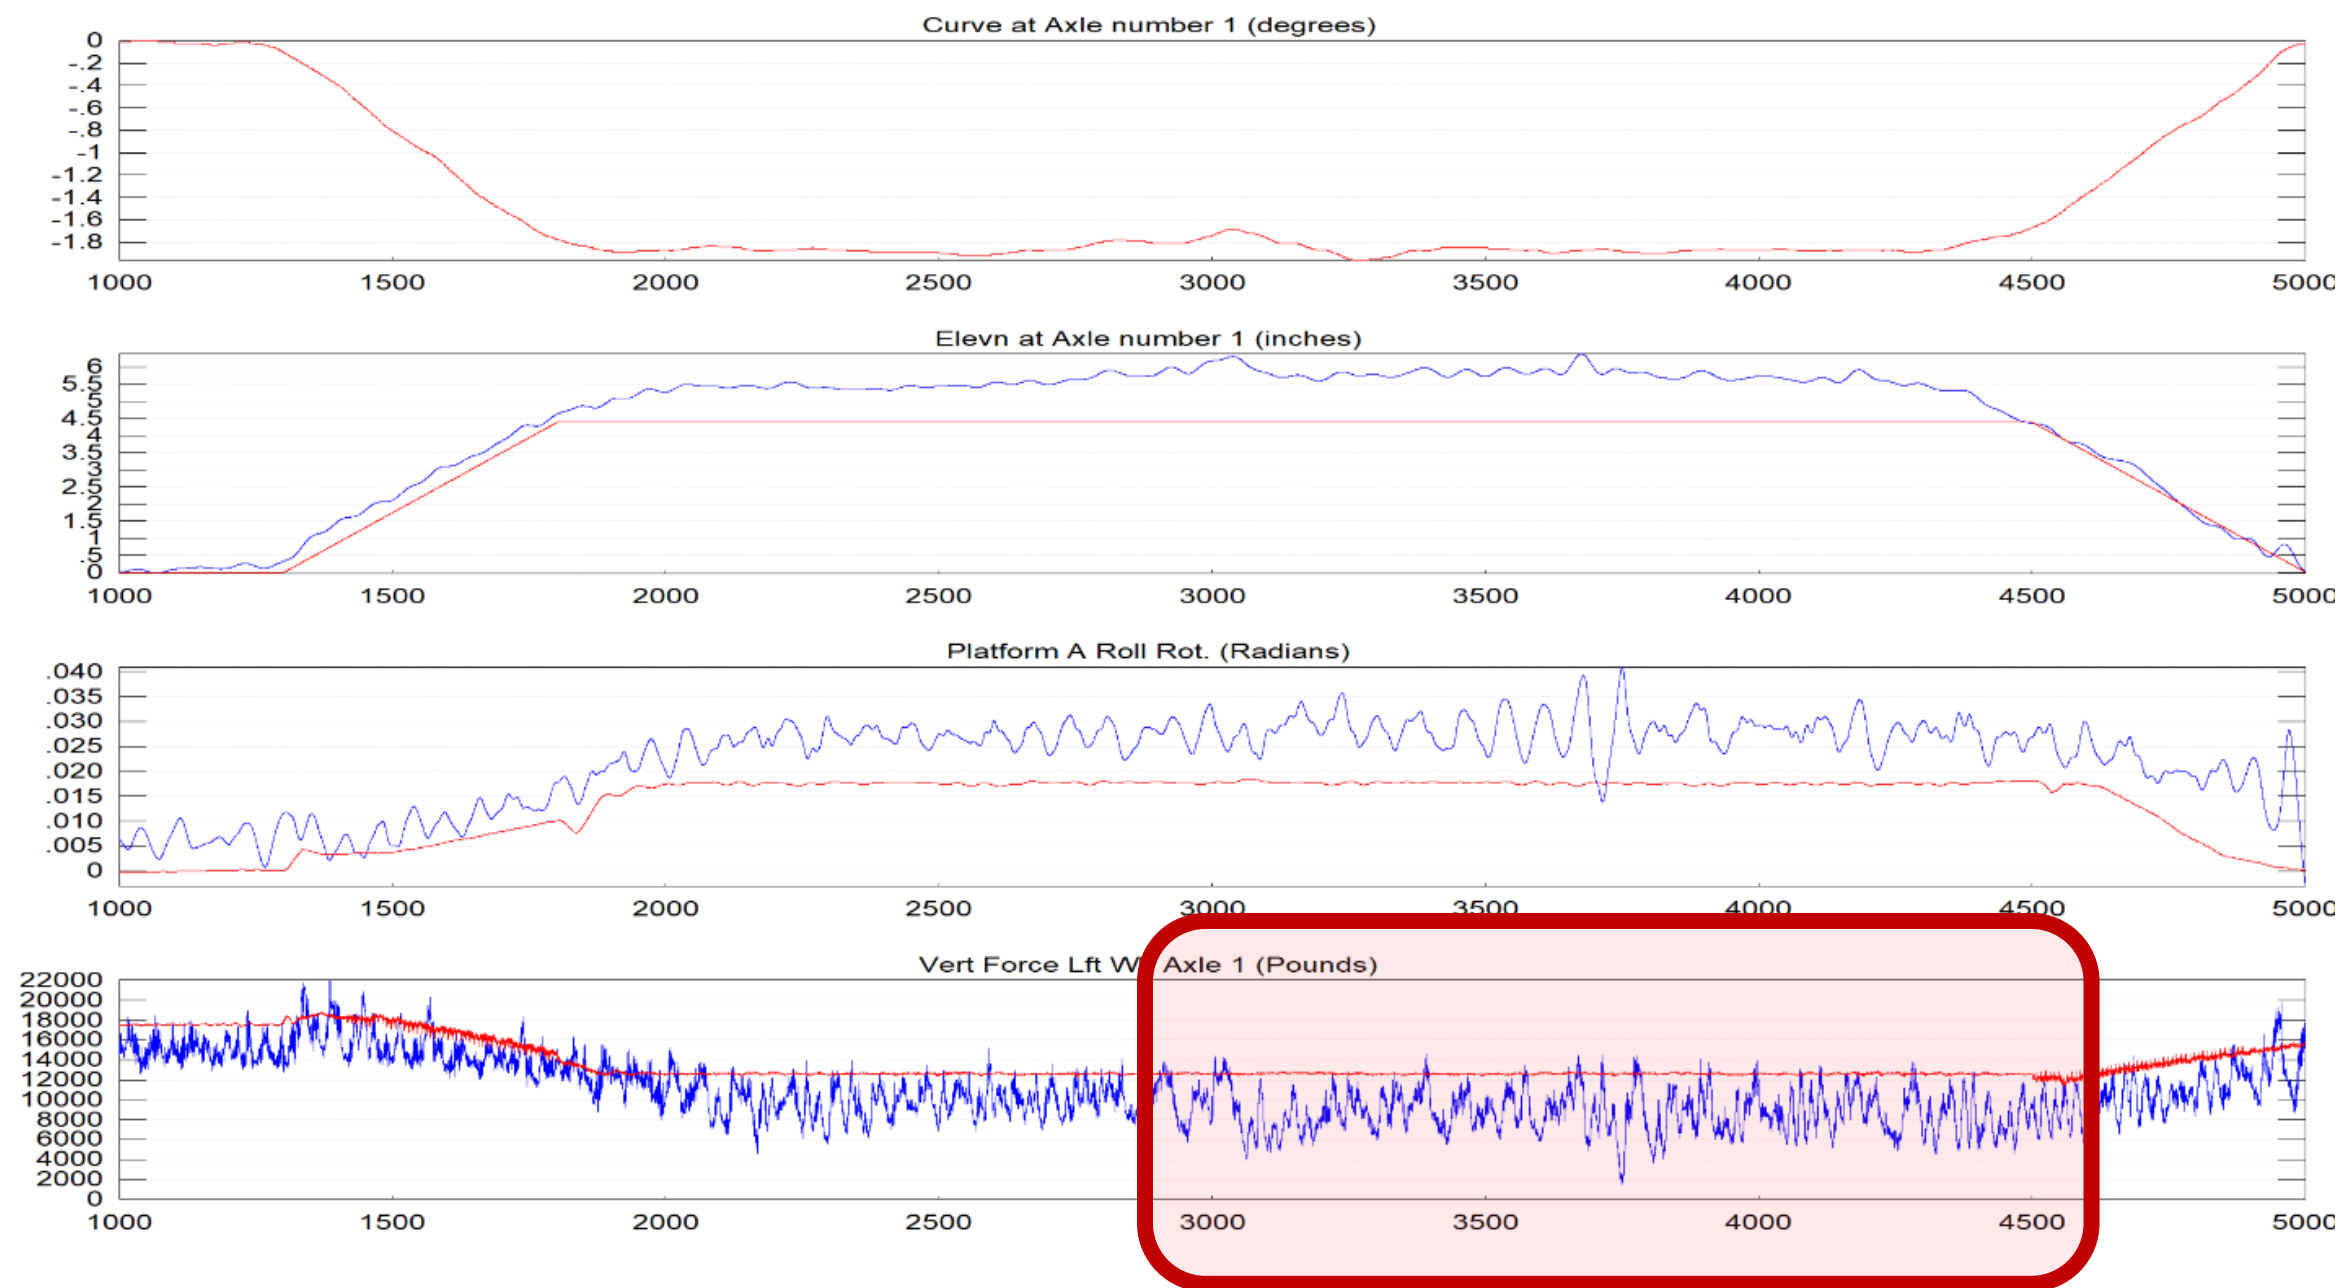
# VEHICLE DYNAMIC SIMULATIONS

▶ **Track Surface** and **Excess Elevation** had the greatest impact on vertical wheel load, but not sufficient to cause derailment.

▶ Elevated risk of wheel climb **required** the load shift **and** truck suspension/steering degradation.

▶ Derailment likely **required conditions not simulated. Such as:** Additional load shift, track surface degradation, or truck performance degradation.
