## **Wheel–Rail Interaction Challenges and Grinding-Based Rehabilitation on Africa’s Cape Gauge Heavy Haul Network: The NACALA Experience**

**Mr. B. P. Awasthi, Head & COO, Nacala Logistics, Mozambique**  
**Co-Speaker: Mr. Yash Sehgal, Director, Vandhana International**

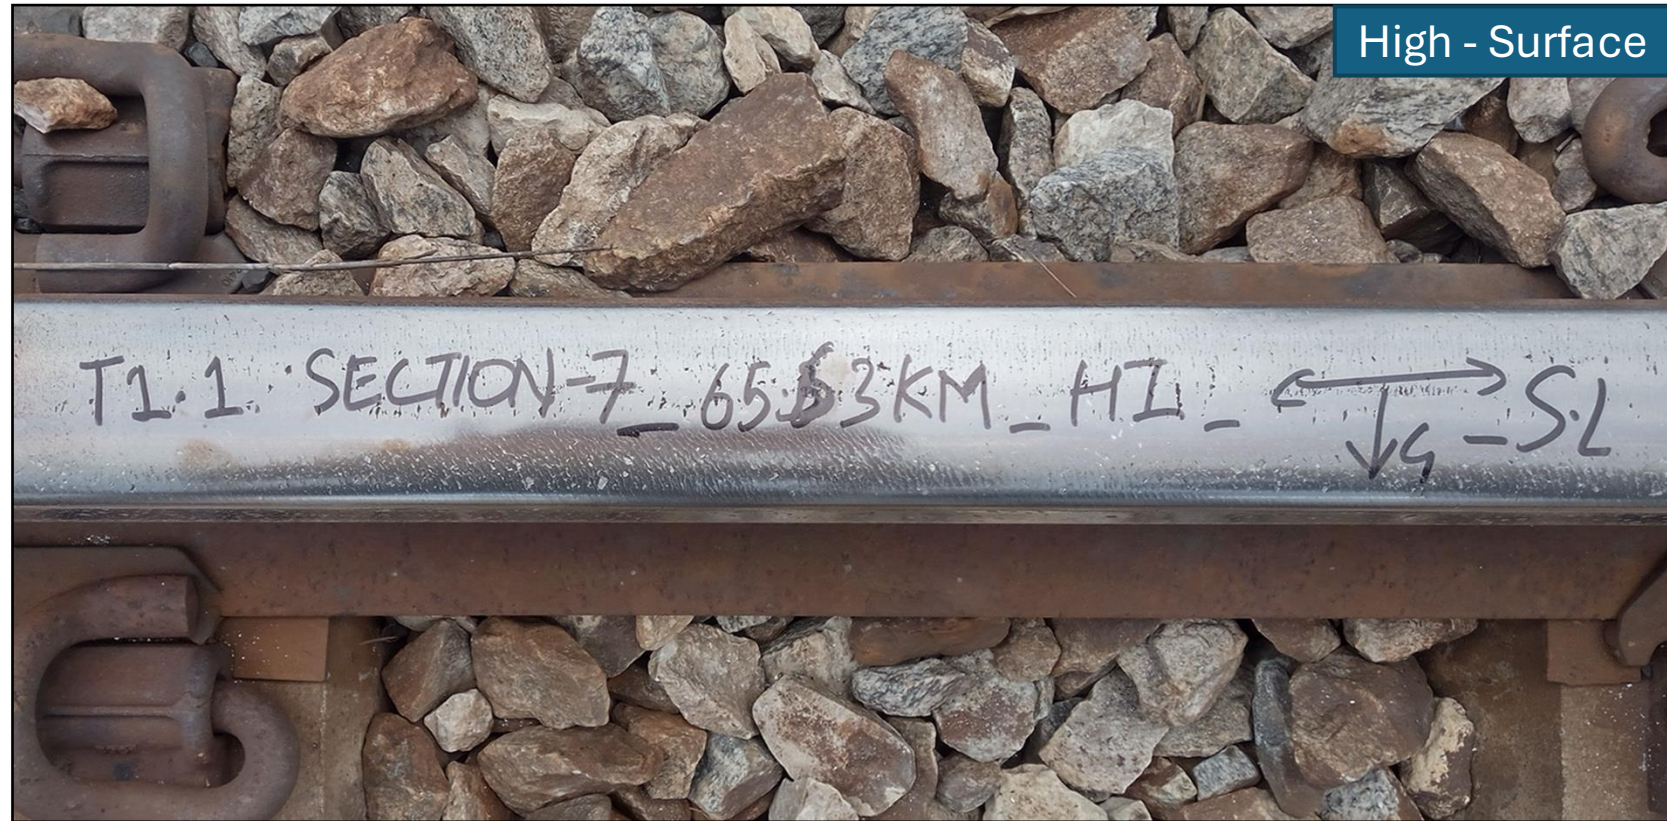
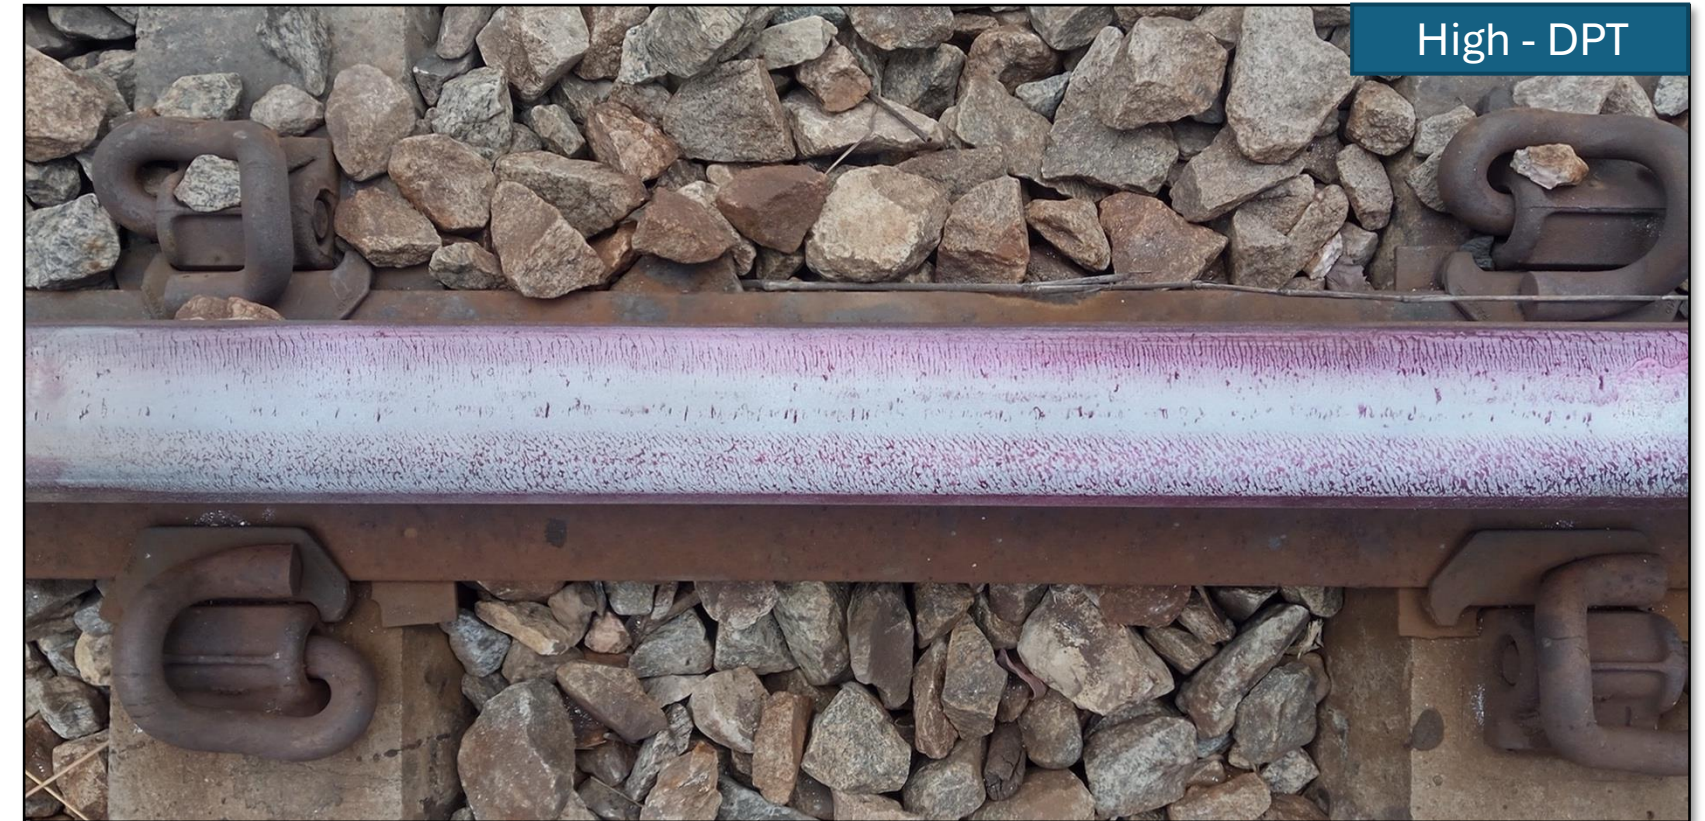
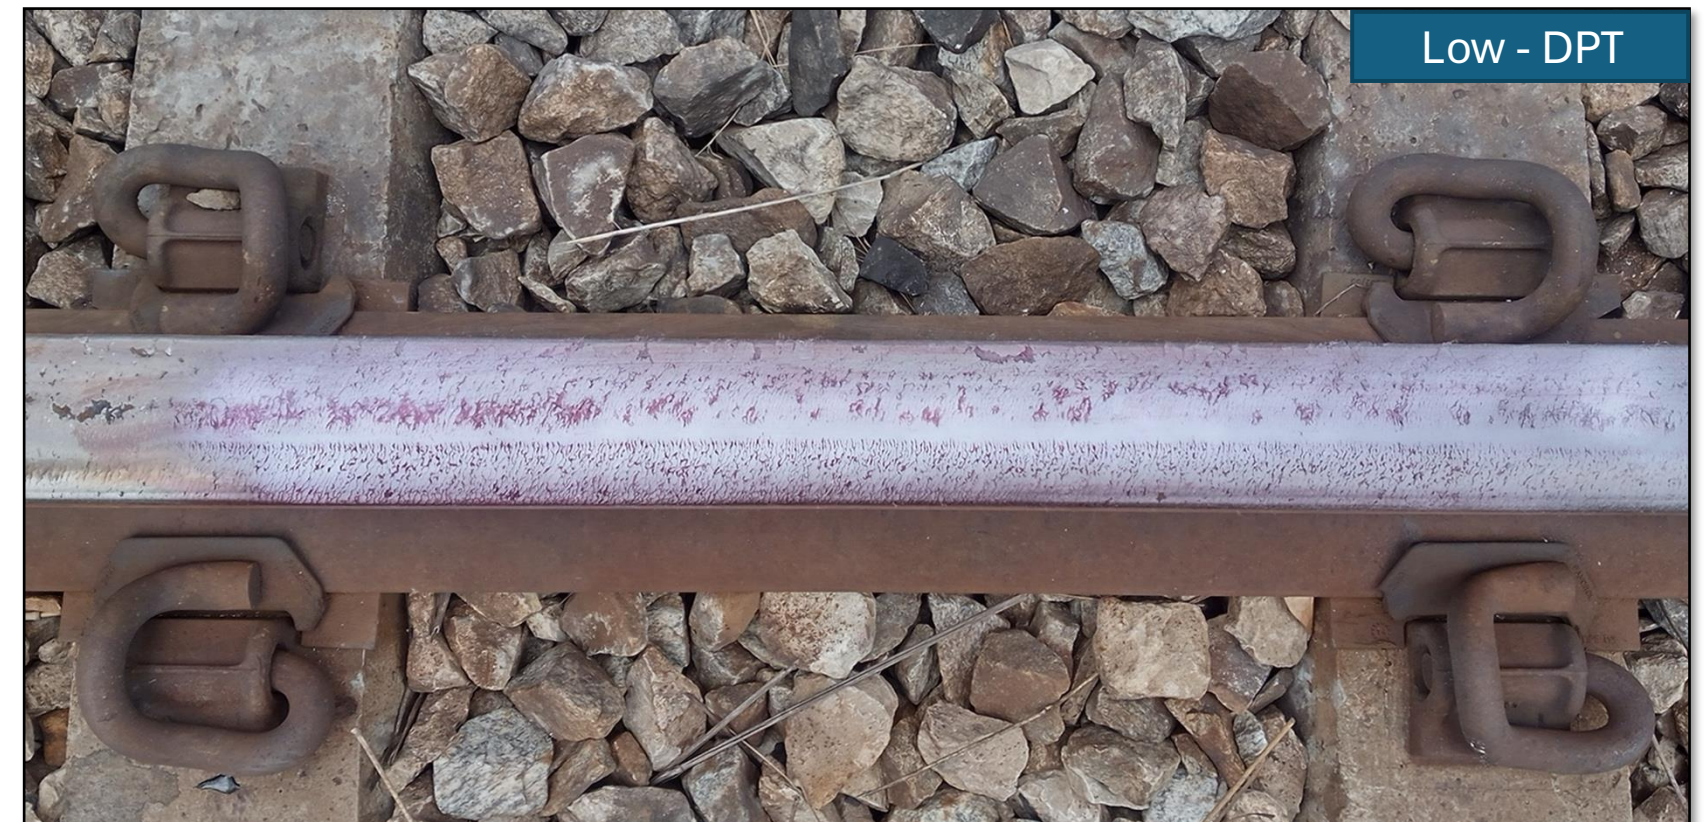
# Condition of Rail

- Excessive wear is observed on both rails.
- The low rail is predominantly experiencing vertical wear.
- The high rail is subjected to significant lateral wear.
- This level of wear is notable considering that only **118 GMT** has accumulated till Nov 2024.
- The trend indicates accelerated deterioration

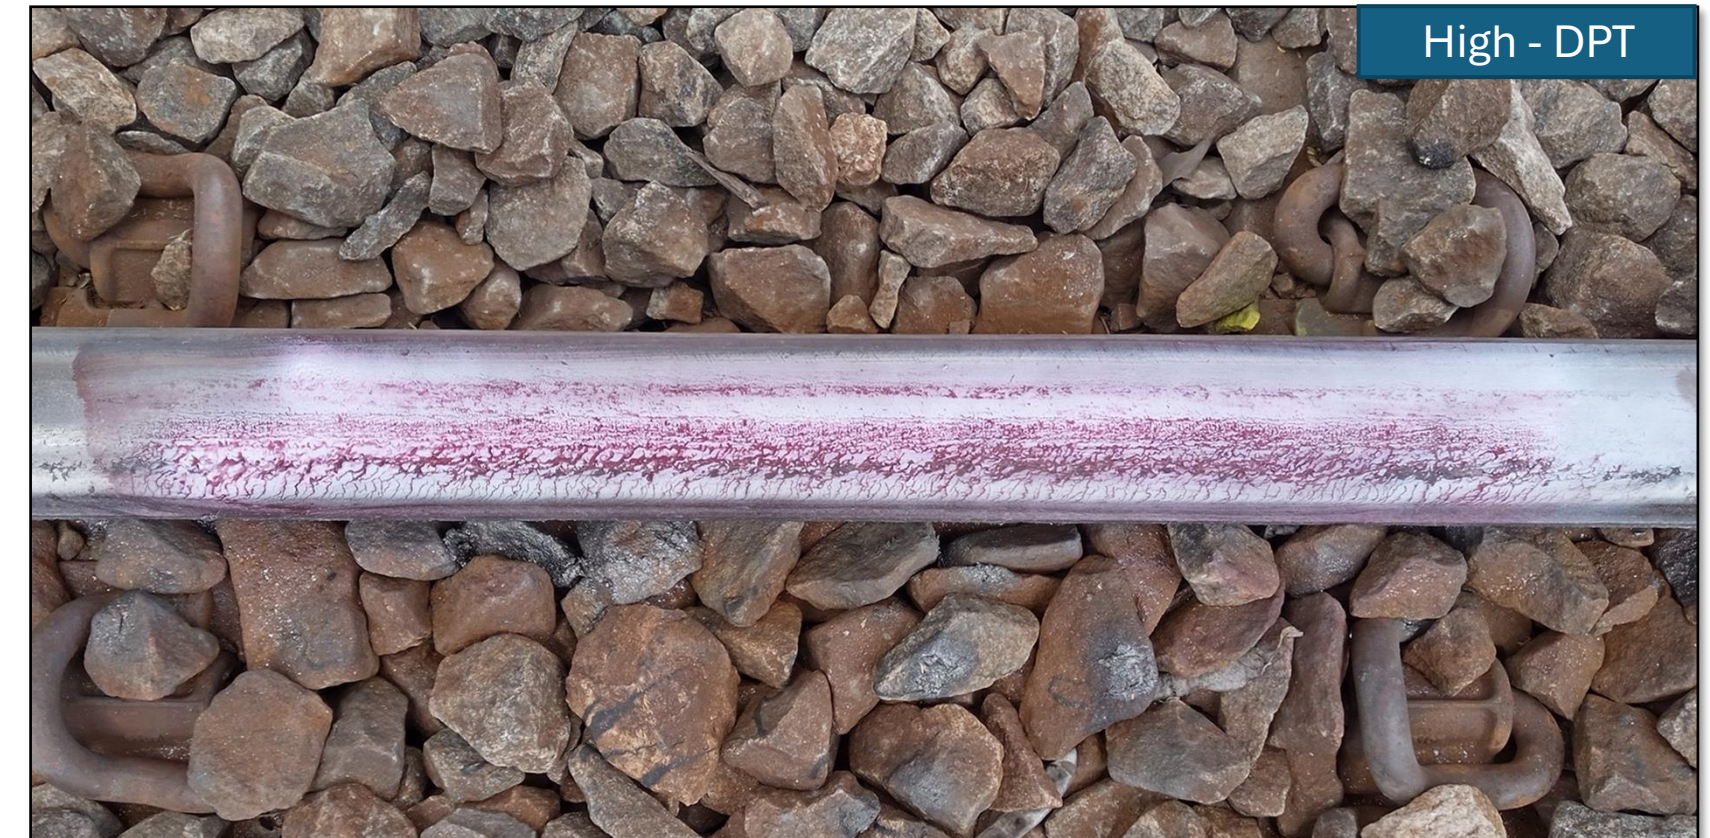
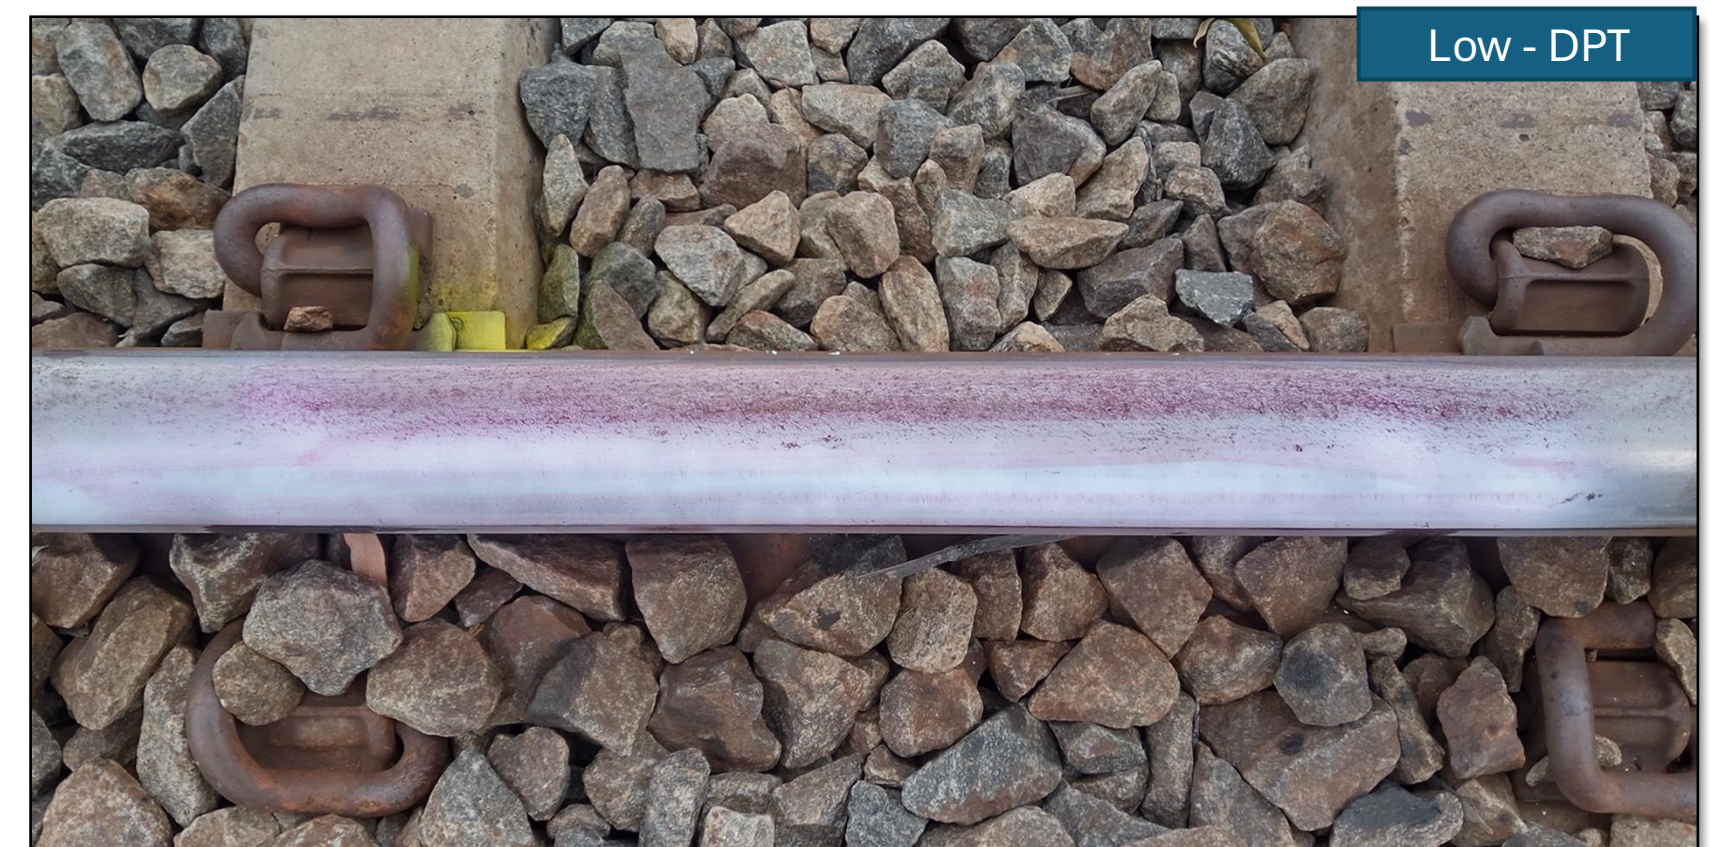
# Condition of Rail

- Excessive wear is observed on both rails.
- The low rail is predominantly experiencing vertical wear.
- The high rail is subjected to significant lateral wear.
- This level of wear is notable considering that only **118 GMT** has accumulated till Nov 2024.
- The trend indicates accelerated deterioration
