# Back Rim Thermal Crack Research

Huseyin Guzel, BNSF Railway  
Alicia Lollar, BNSF Railway

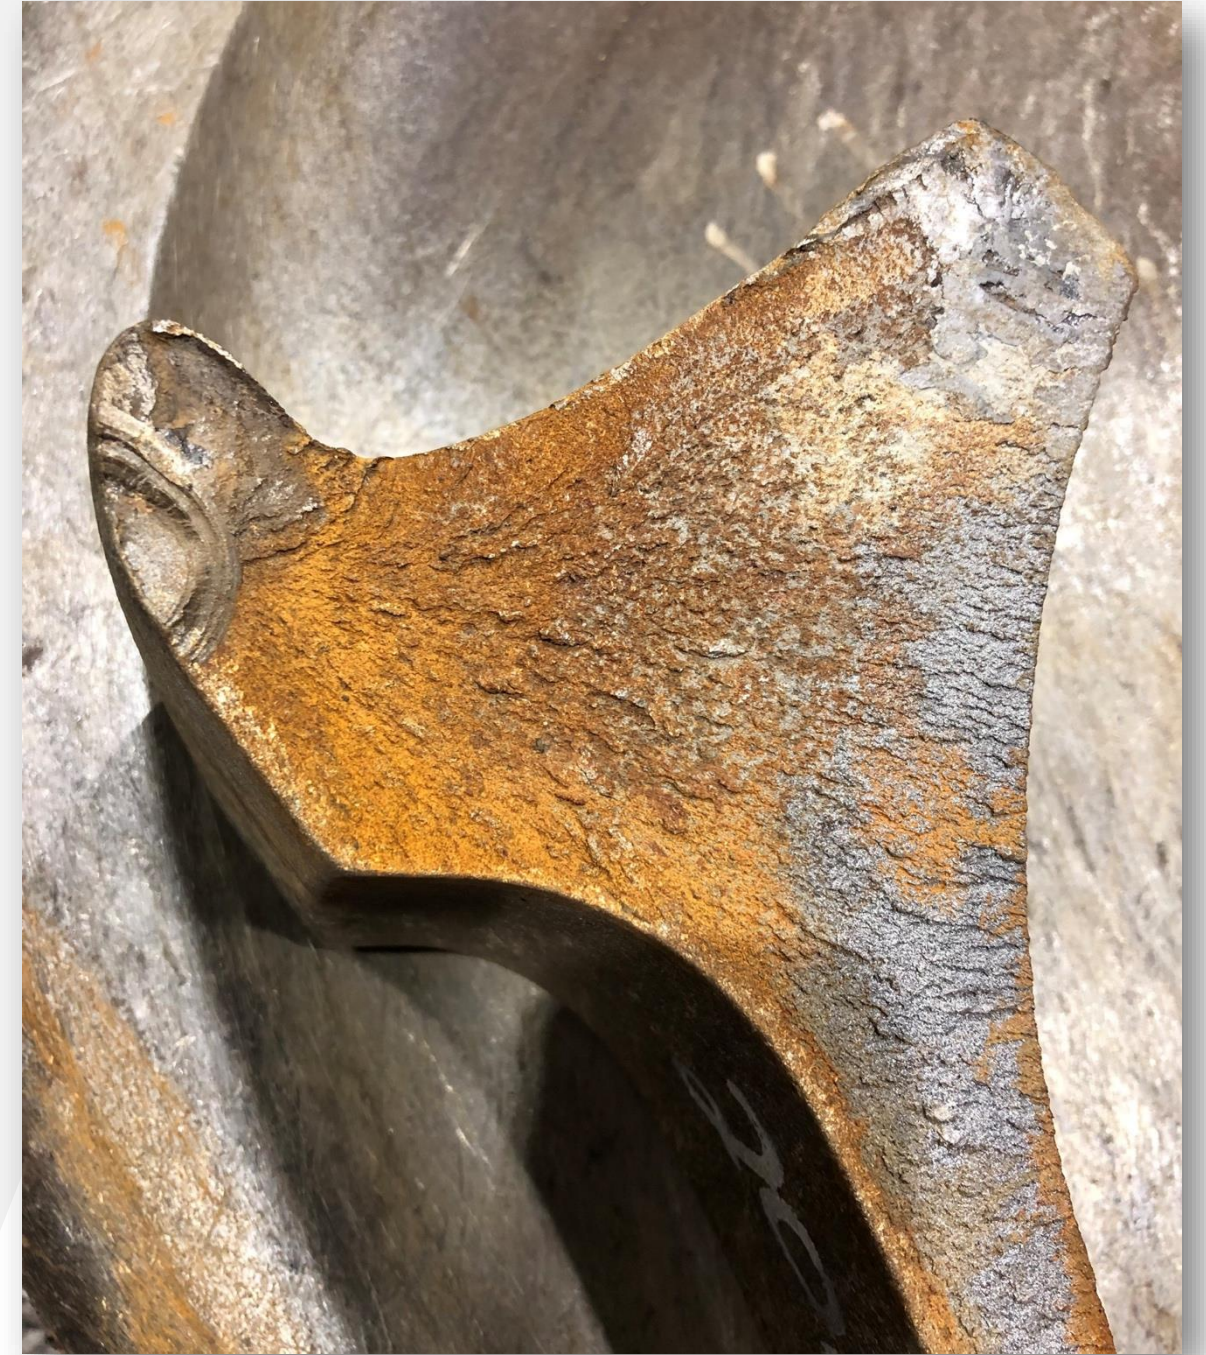
# Categorization of Failed Wheels

Data was collected for seven of these failures:

- All the failures occurred in either 33 or 38-inch wheels
- Five out of seven cars were intermodal cars. The two most recent failures were on a box and a gondola car
- All the failures originated from scraping on the back rim
- All the wheelsets contained uneven wear between the failed and mate wheels, with the failed wheels showing more wear
- Only one of the wheelsets was reconditioned
- All but one of the failed wheels were on the left side of the car
- Both cast and forged wheels from different manufacturers experienced this type of failure
- Other Class 1 railroads have also experienced this failure

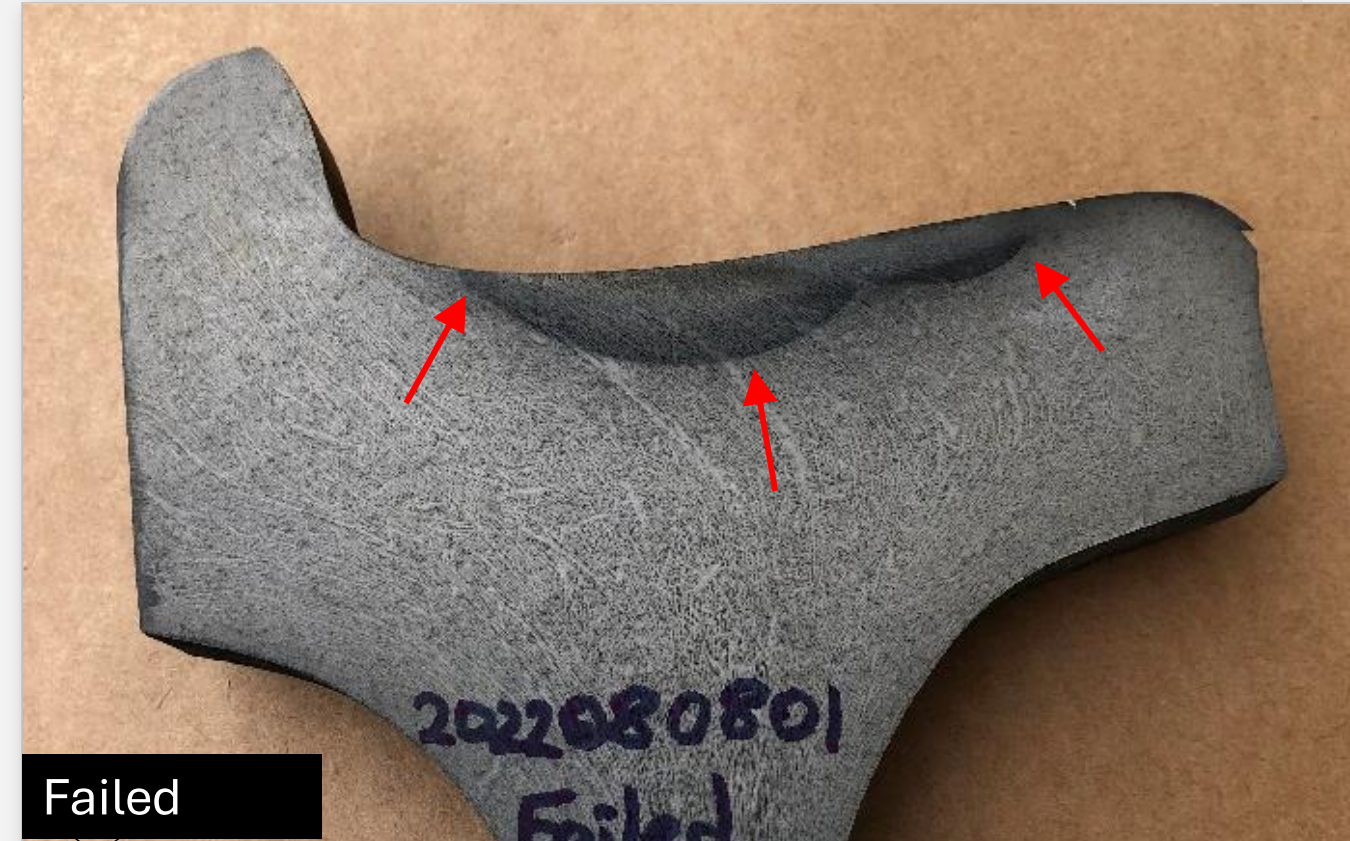
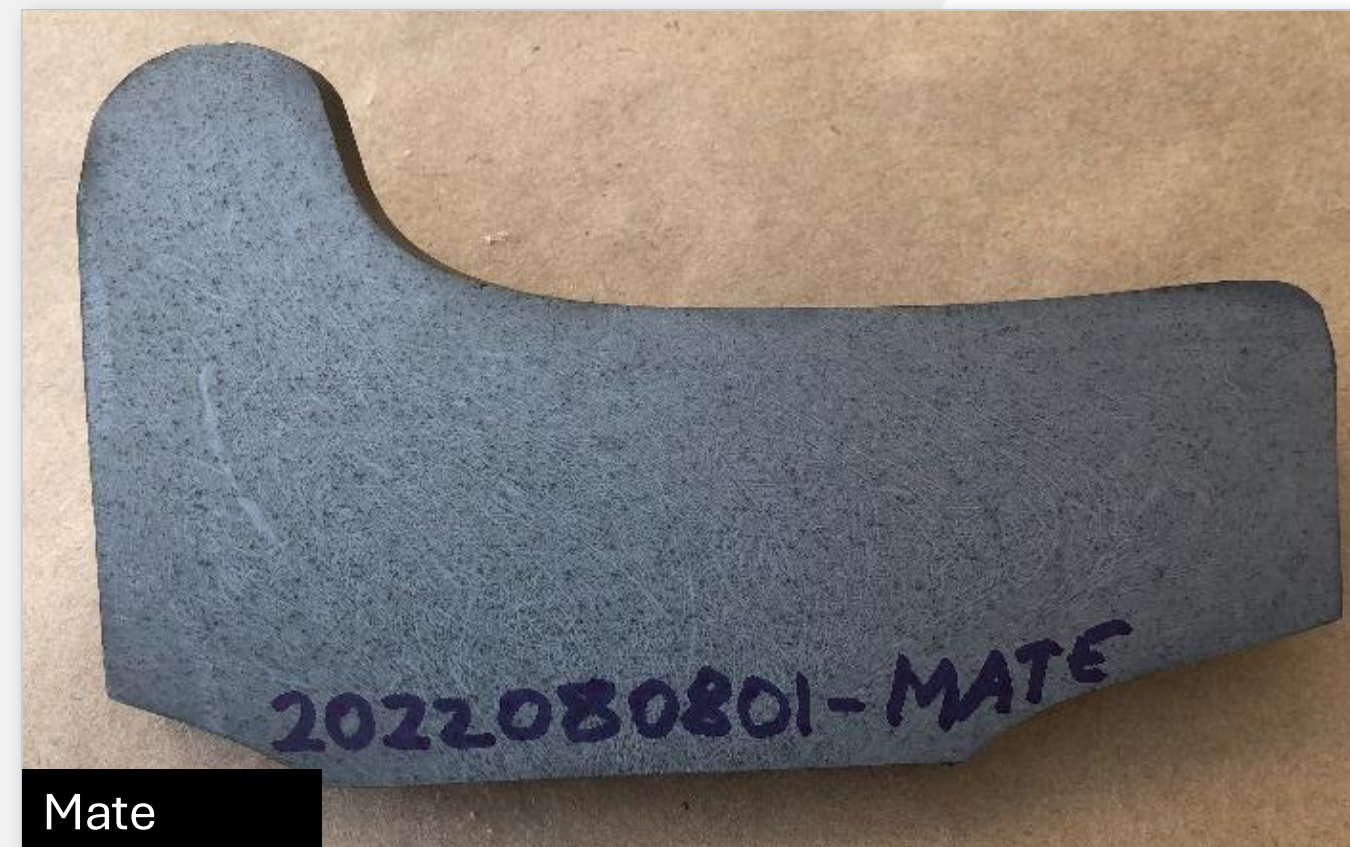
## Failed Wheel vs. Mate Wheel – Macroetched Rim Cross Sections

- Macroetch examination of full rim cross sections of the failed wheels (top image) revealed heat damage due to excessive and/or unusual braking, indicating possible issues with the brakes of the rail car
- Macroetch examination of full rim cross sections of the mate wheels (bottom image) did not show heat damage from brakes
- Wheels are heat treated by the manufacturers to induce beneficial compressive hoop stresses in the rim of the wheels. Excessive heat damage may relieve some or all of the compressive hoop stresses

- Industry standards and regulations should be revised to eliminate/reduce the potential for interference between the wheelset back-to-back spacing and guard face gage
- Brake rigging arrangements should be reviewed to eliminate excessive braking
- Further research should be conducted on crack detection methods within the back rim surface of wheels and the mechanisms of their formation and propagation

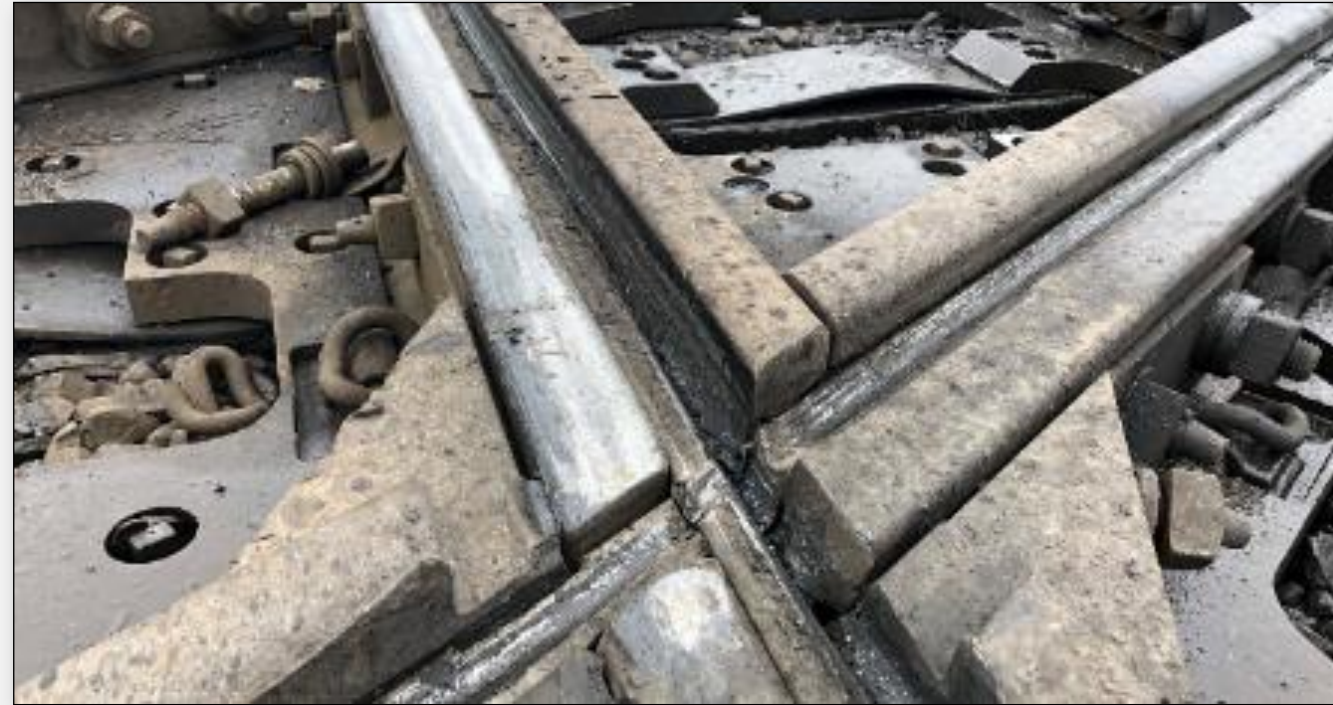
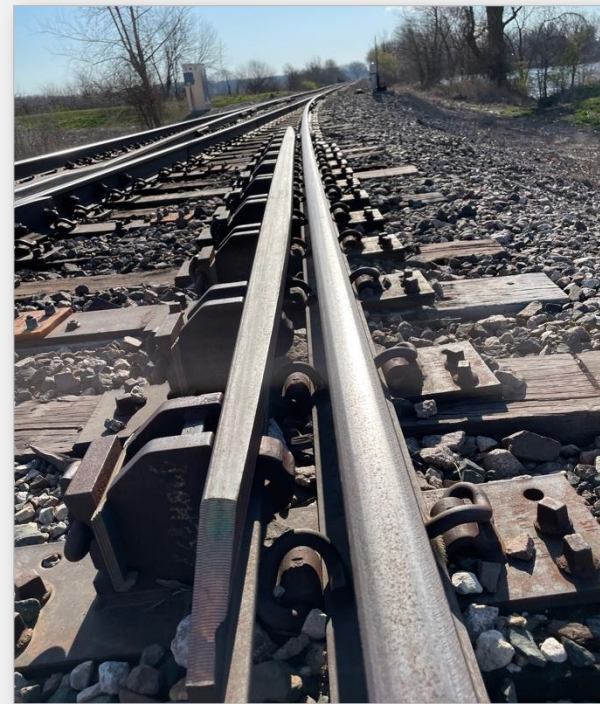
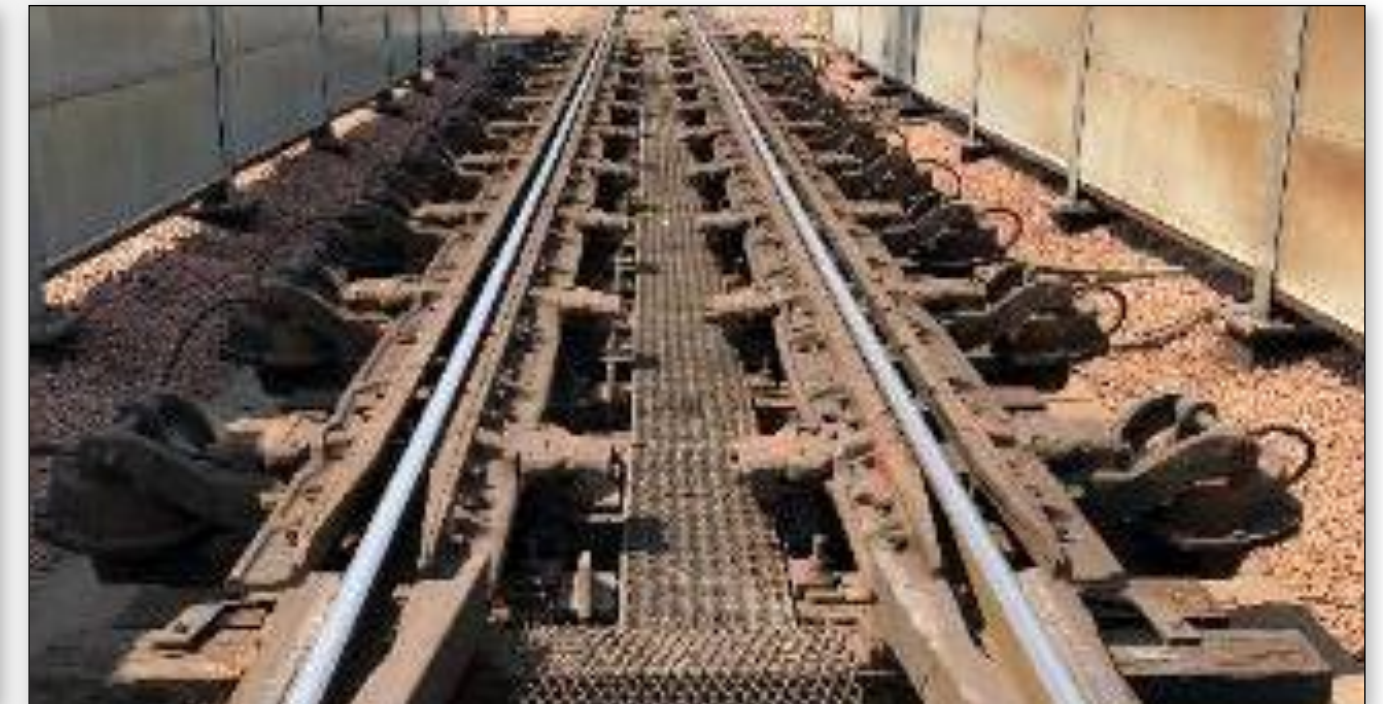
## Components Contacting Back Rim

- When wheels travel through guard rails, diamonds, spring frogs, and retarders, the back rim of the wheels make contact with the track components
