# Current North American Railroad Wheel Service Issues – The Rise of Broken Flanges and the Importance of Wheel Handling to Prevent Plate Failures

Cameron Lonsdale  
VP – Industry Relations

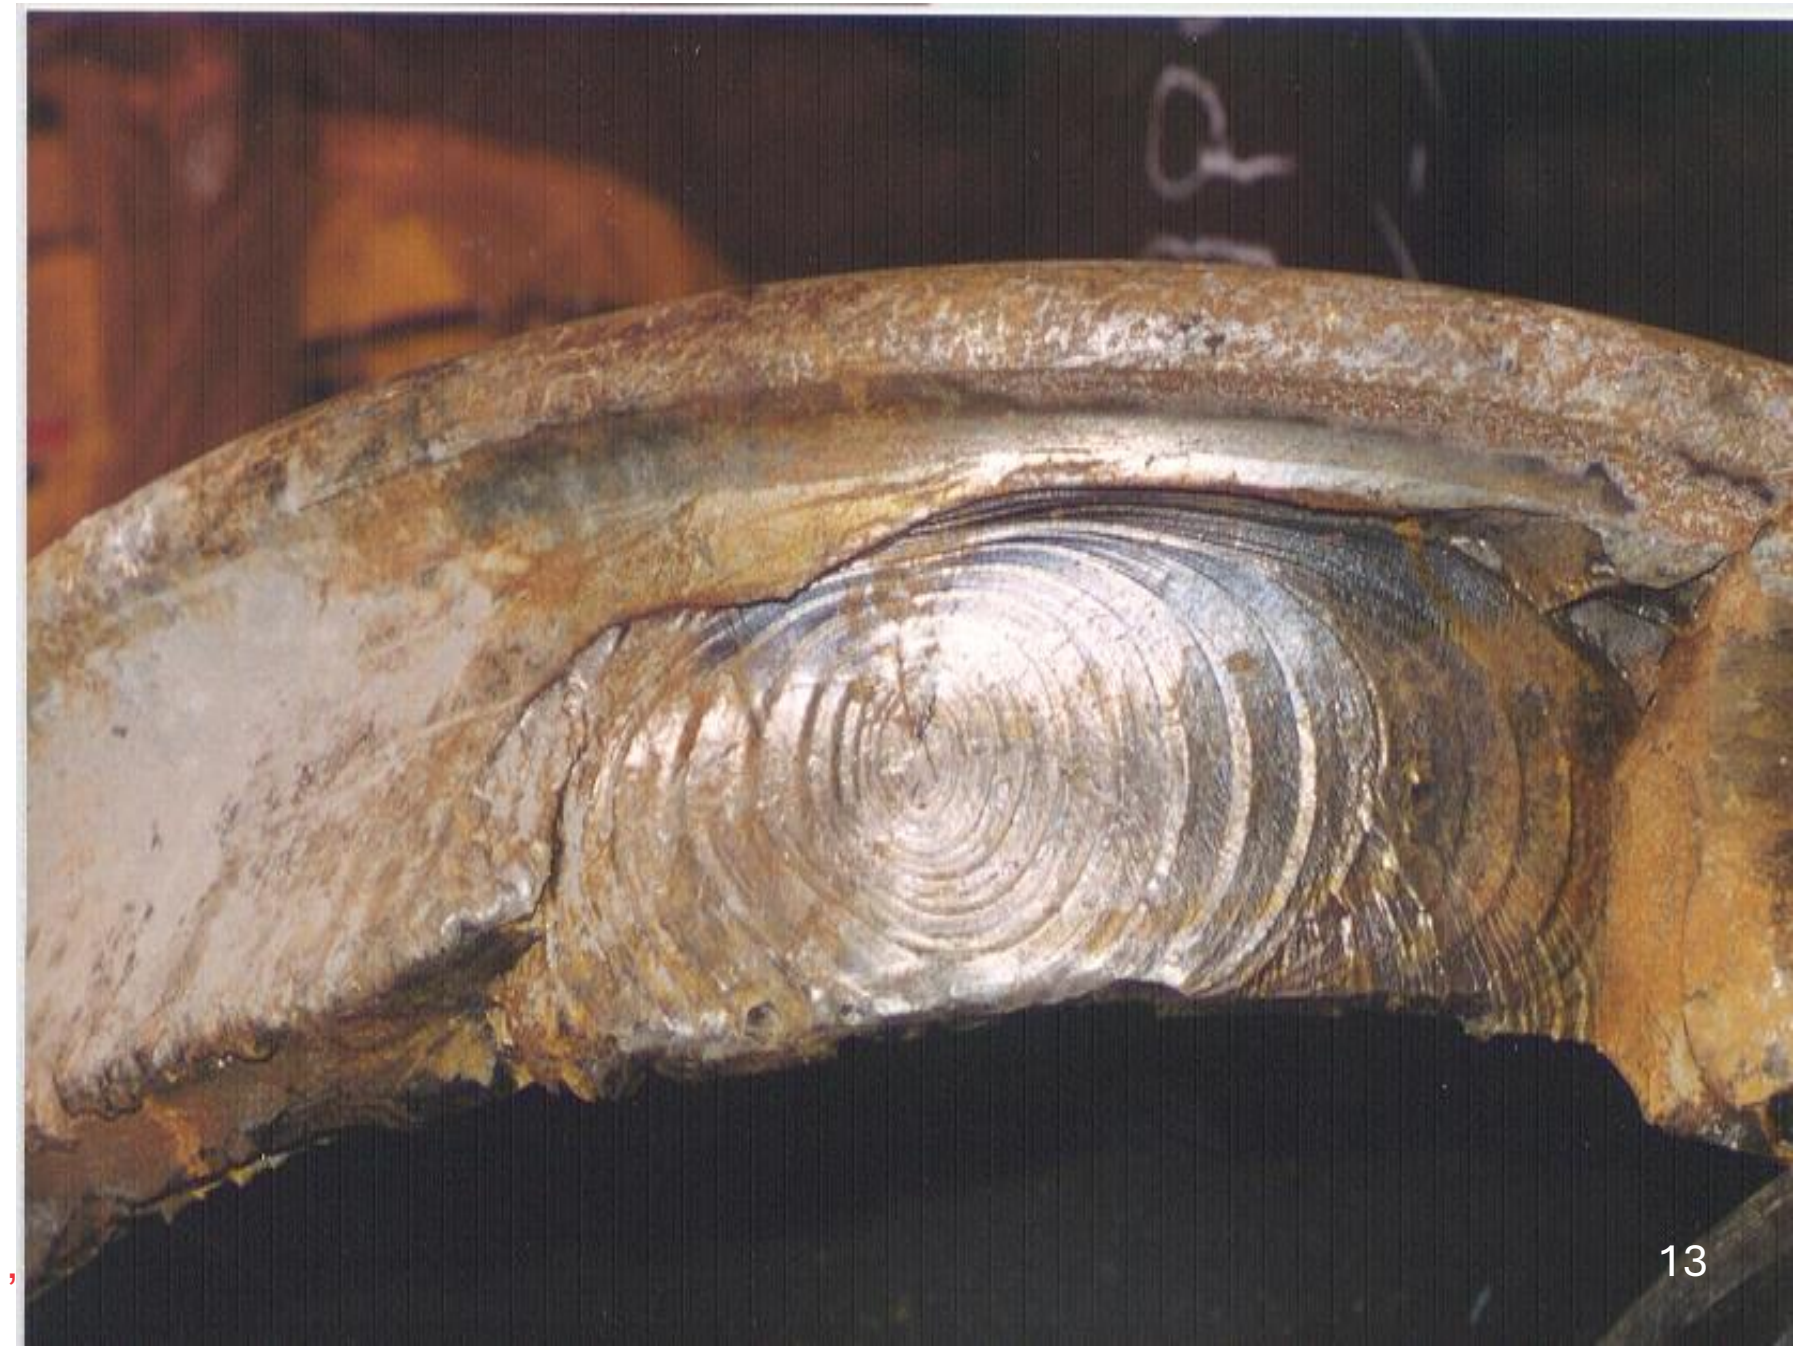
Shattered Rims WM 71 – Caused by subsurface porosity in cast wheels, and inclusions in forged wheels. Classic fatigue failures. This WM Code has decreased due to tighter AAR UT testing, adding a riser to cast 36” wheels (mid-1990’s), argon shrouding, and clean steel efforts by wheel manufacturers.

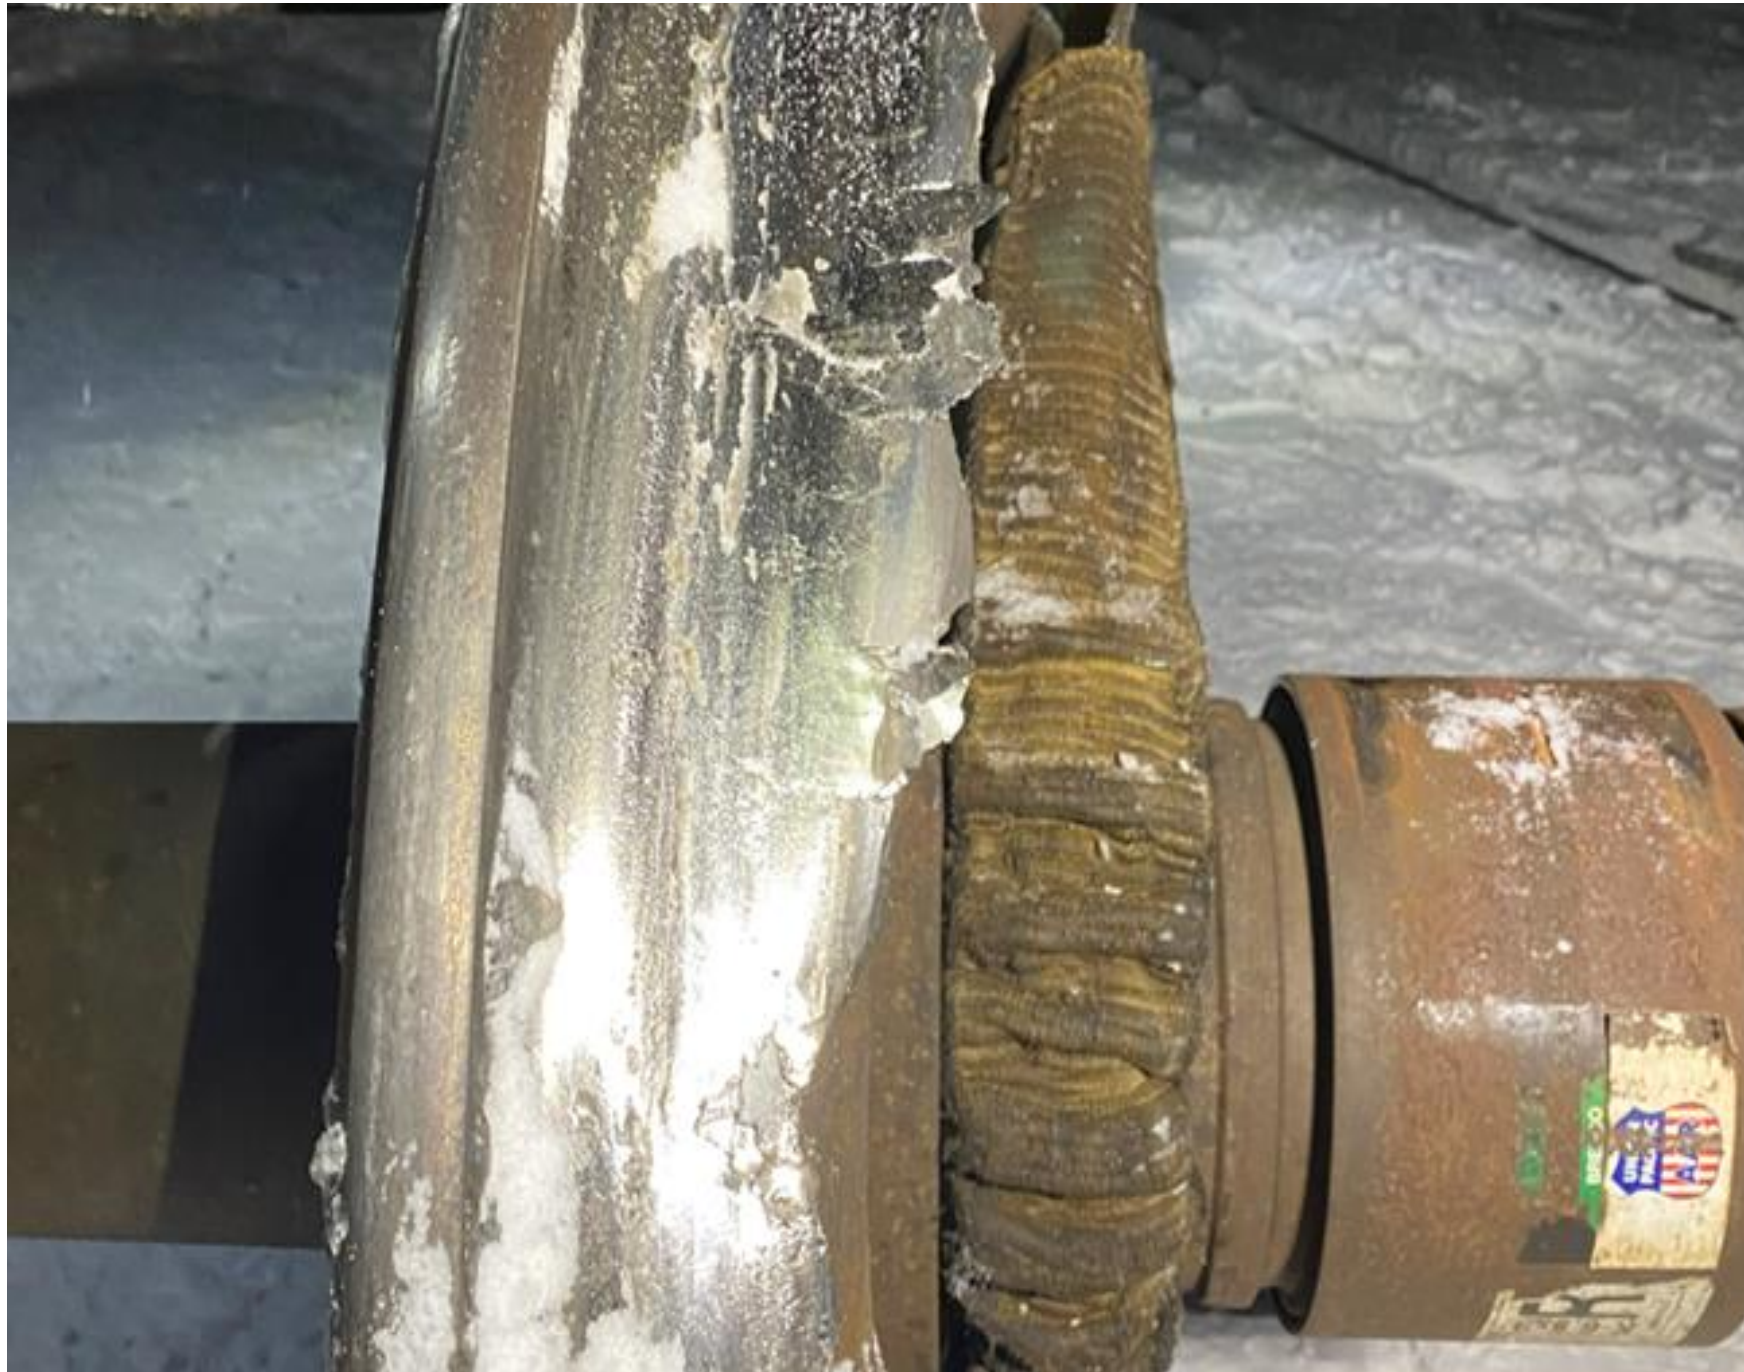
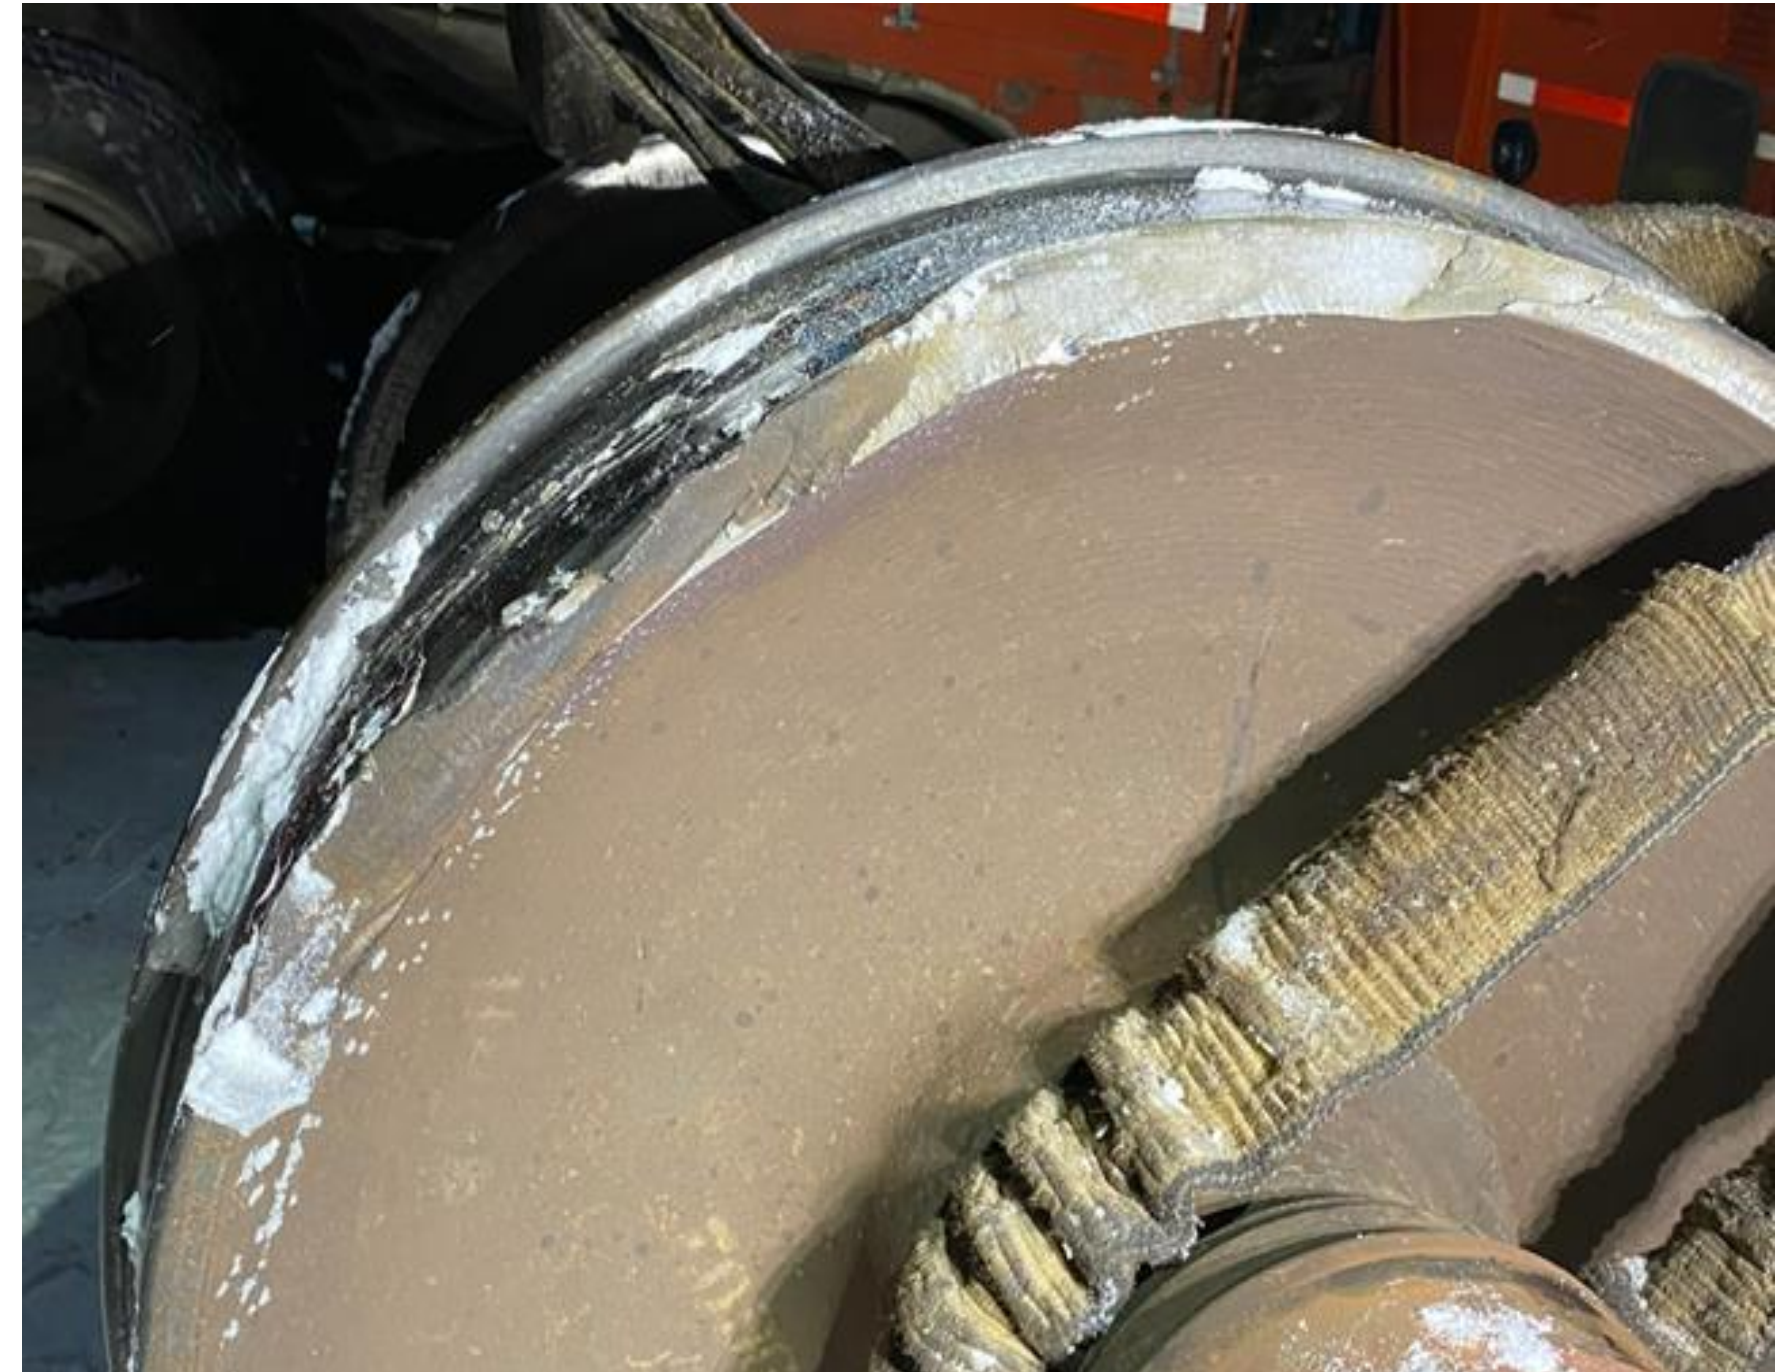
Vertical Split Rims – A portion of the front rim face, or back rim face, fractures off the wheel. Tread damage is often associated with these failures.

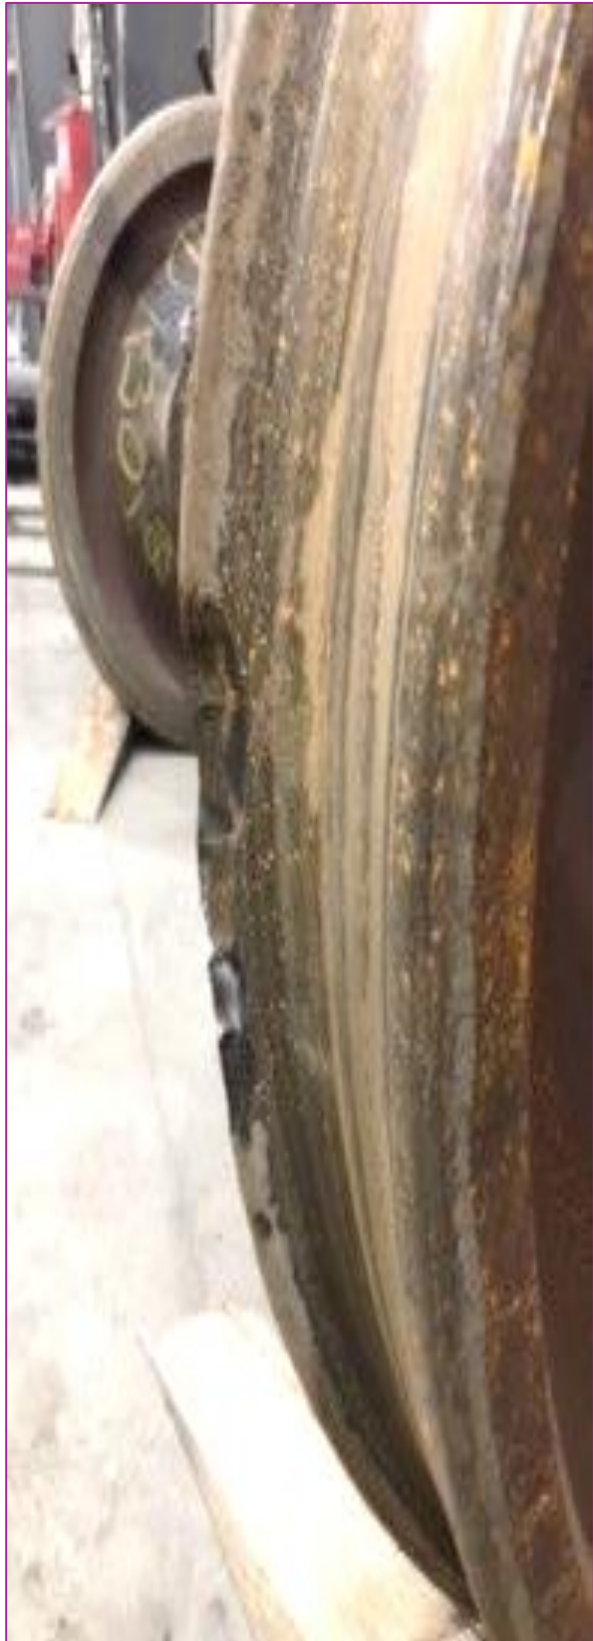
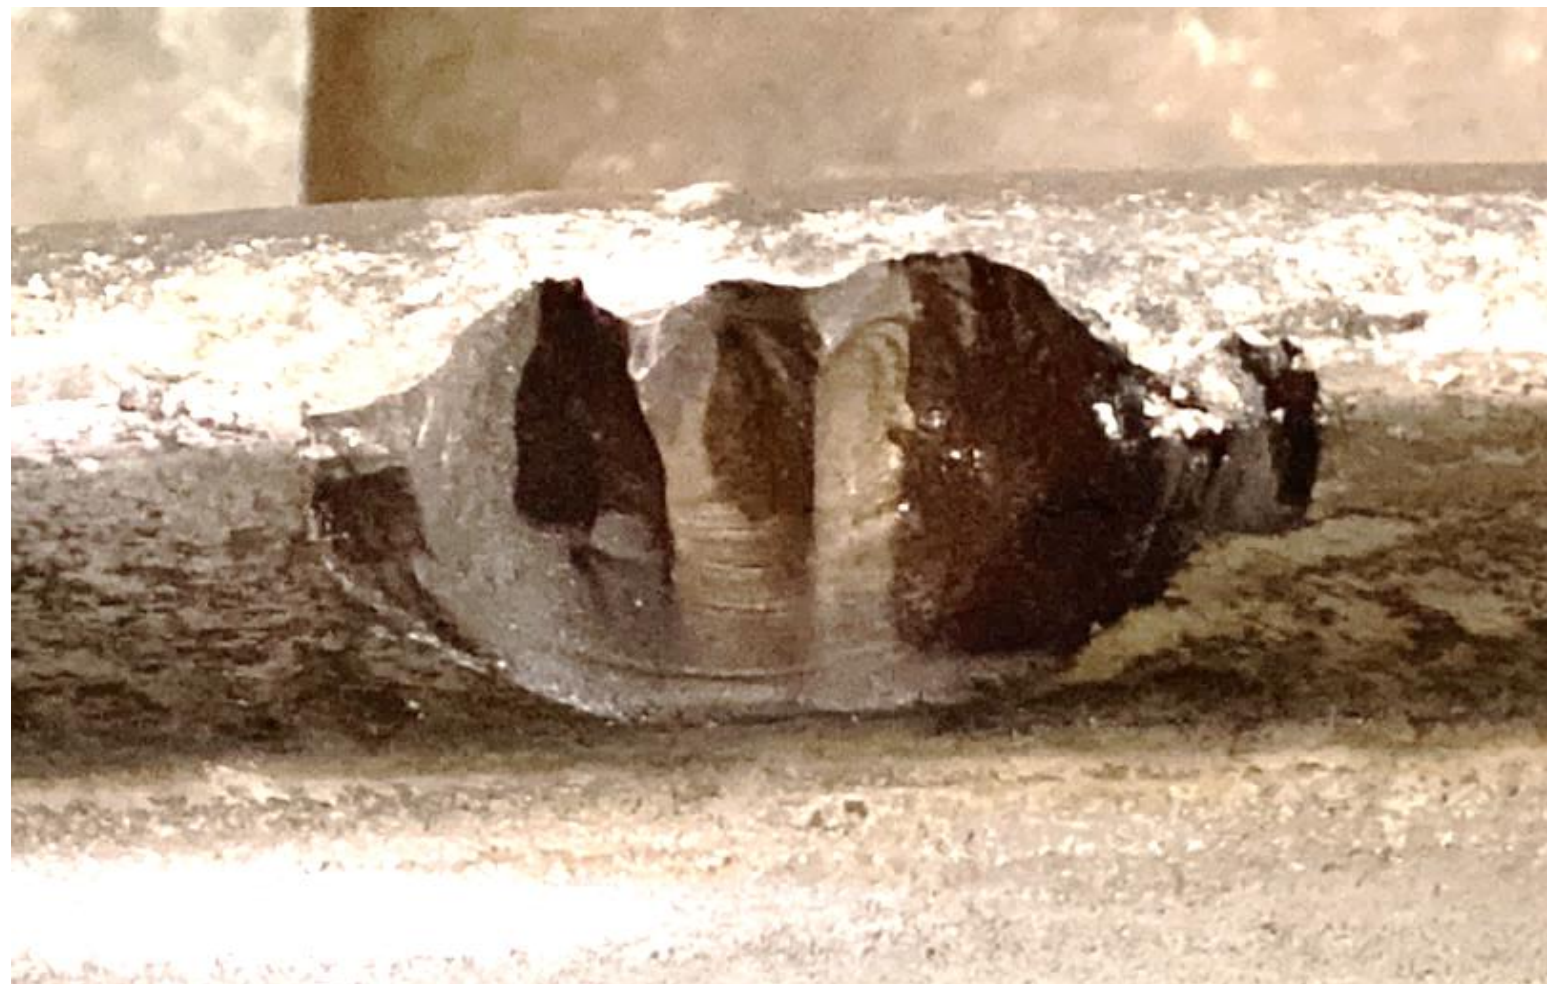
- WM 66 - “Flange Shell” initiated beneath the flange face
- TTCI identified these during 1999 FAST operations
- Main factors:
  - “Dry” FAST operation (rail lubrication halted)
  - High curve service
  - Closed loop
  - RCF / Plastic deformation on the flange face
  - 2-point wheel – rail profile, high force at flange face

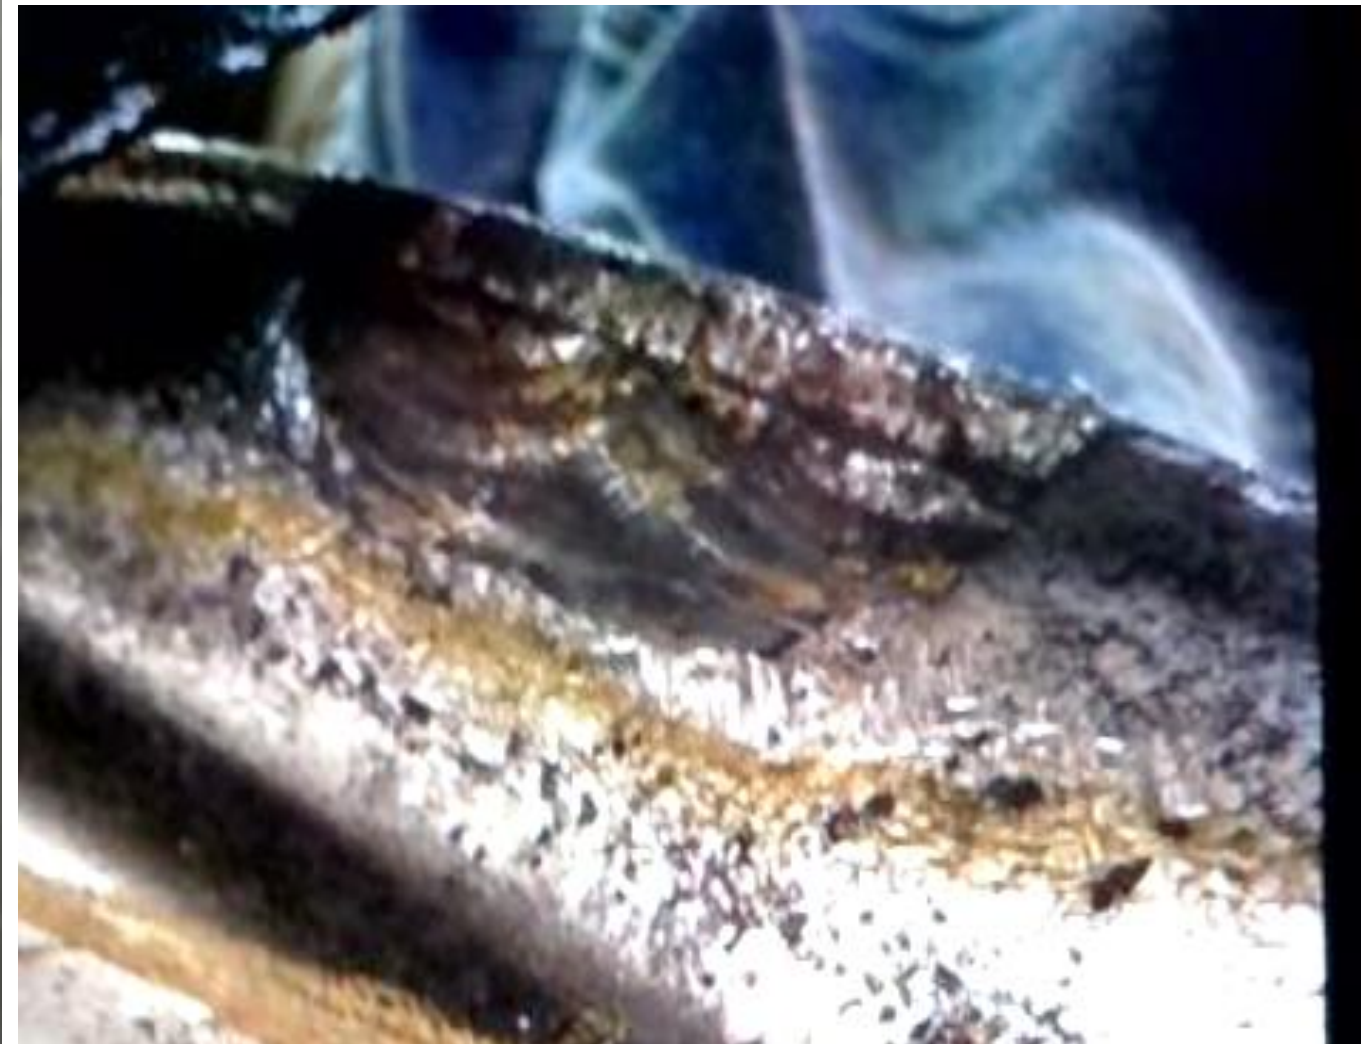
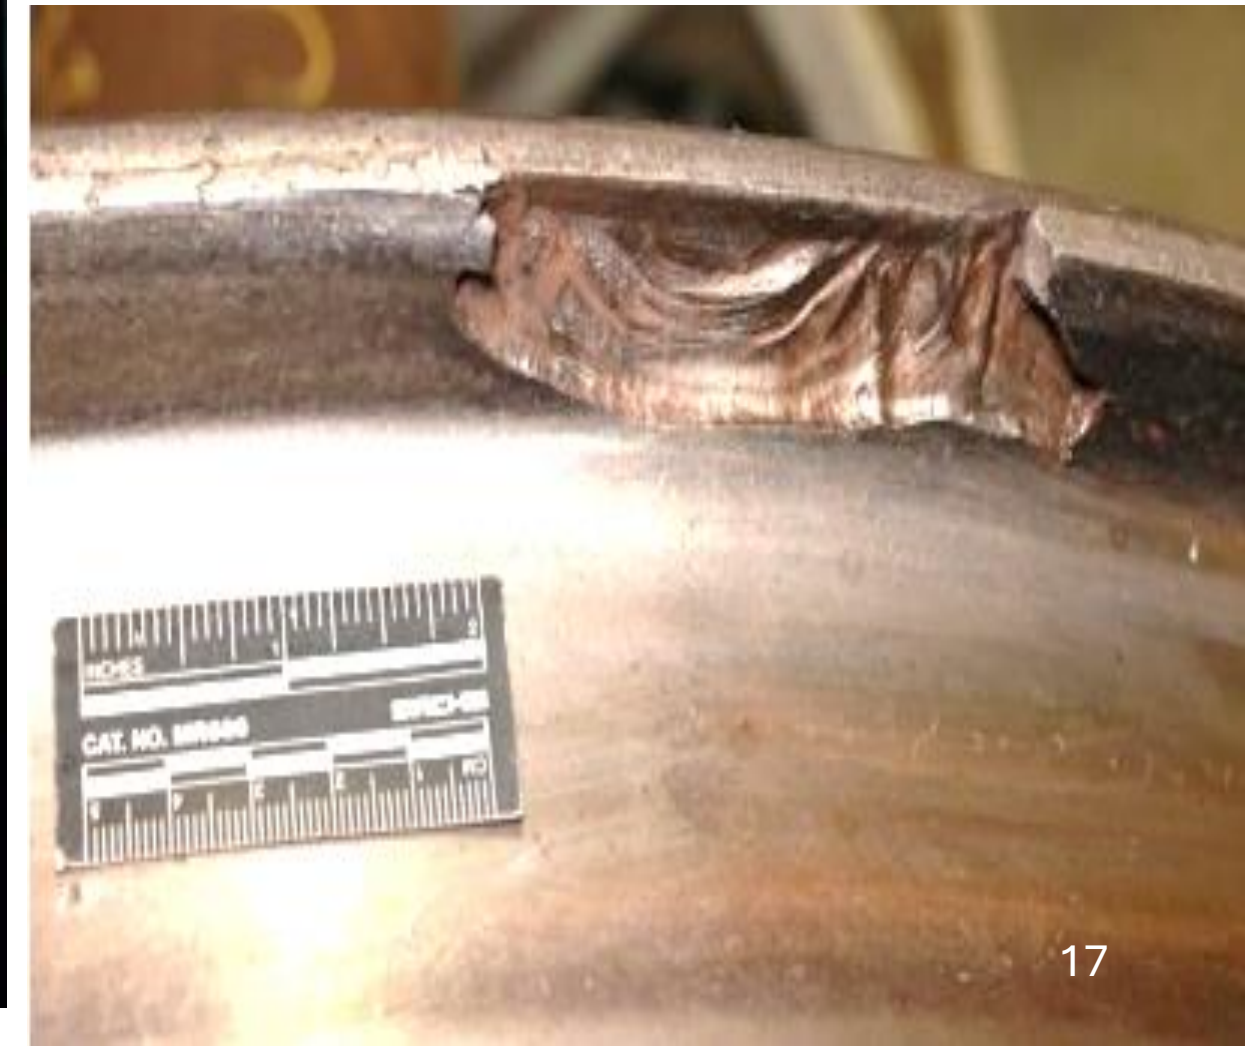
## Flange Apex Failures

- WM 66 as a failure initiating at the flange apex
- Likely loading at the apex
- Contribution of flange bearing frogs, diamonds?
- Rolled/damaged material at the apex provides a notch for fatigue by both apex and flange face contact fatigue

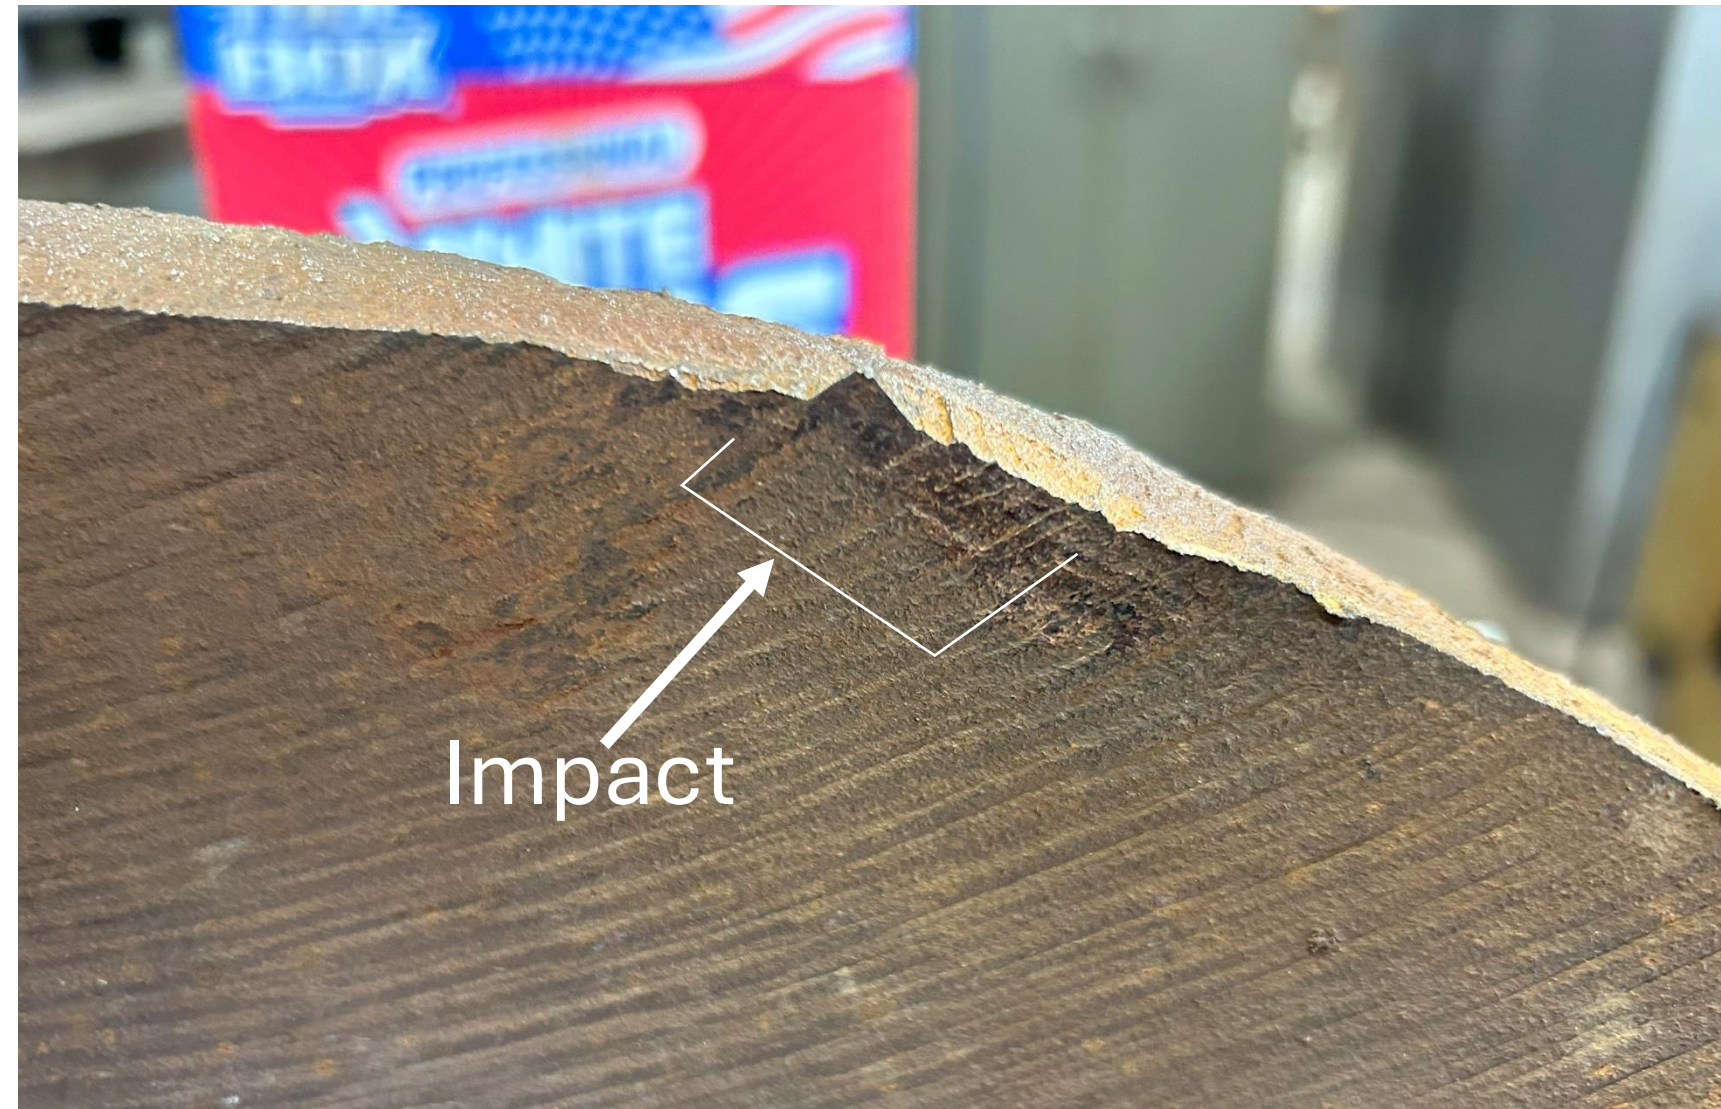
# Damage To Wheel Plates Leading to Failure

Note the “pressed in” look to the damaged area in above photo. Difficult to Detect. What is causing this?

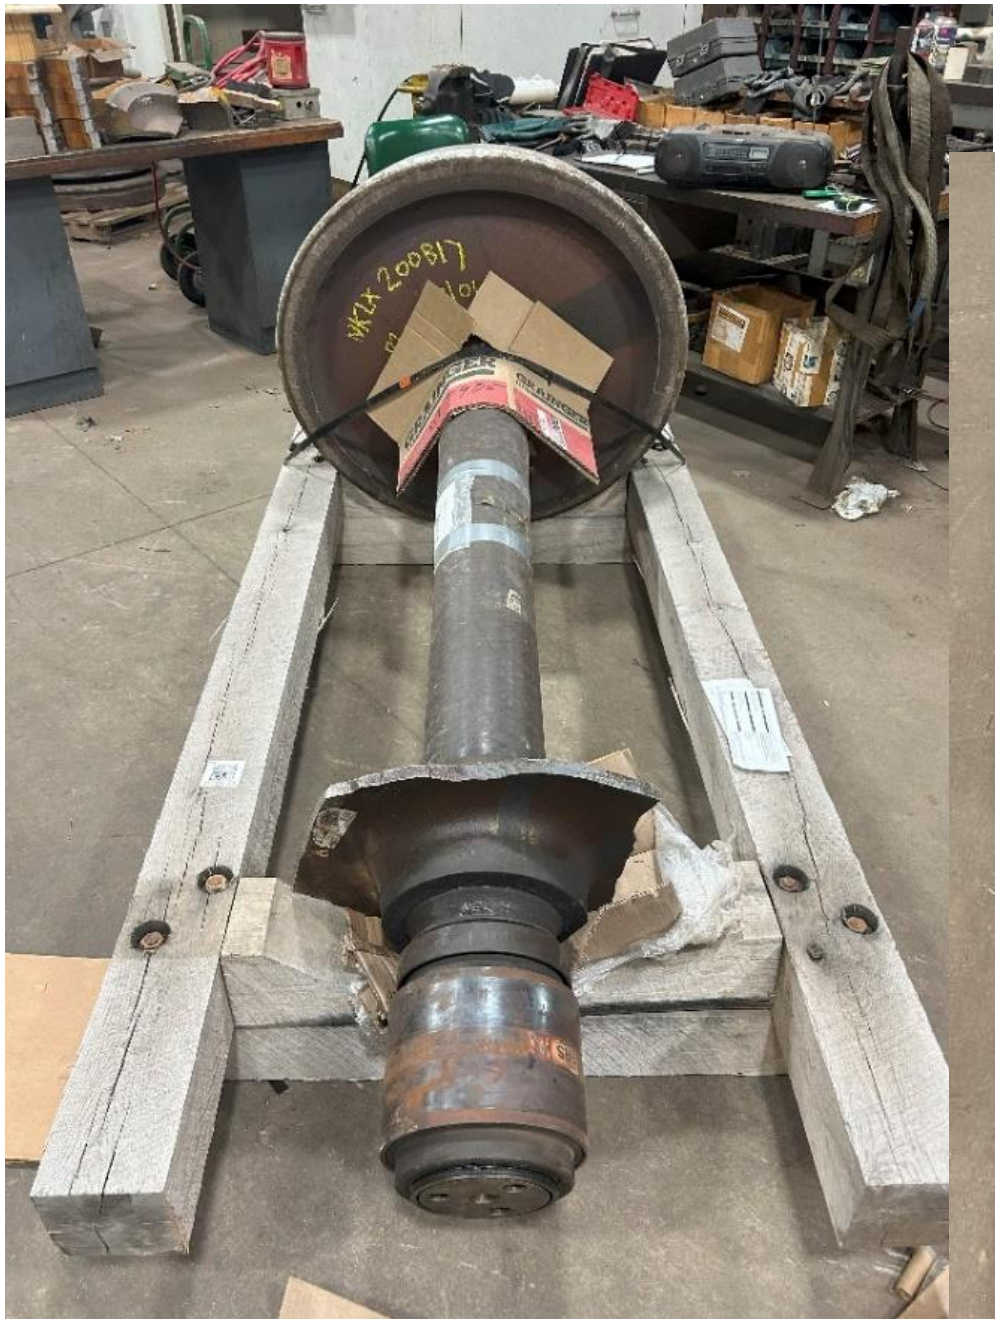
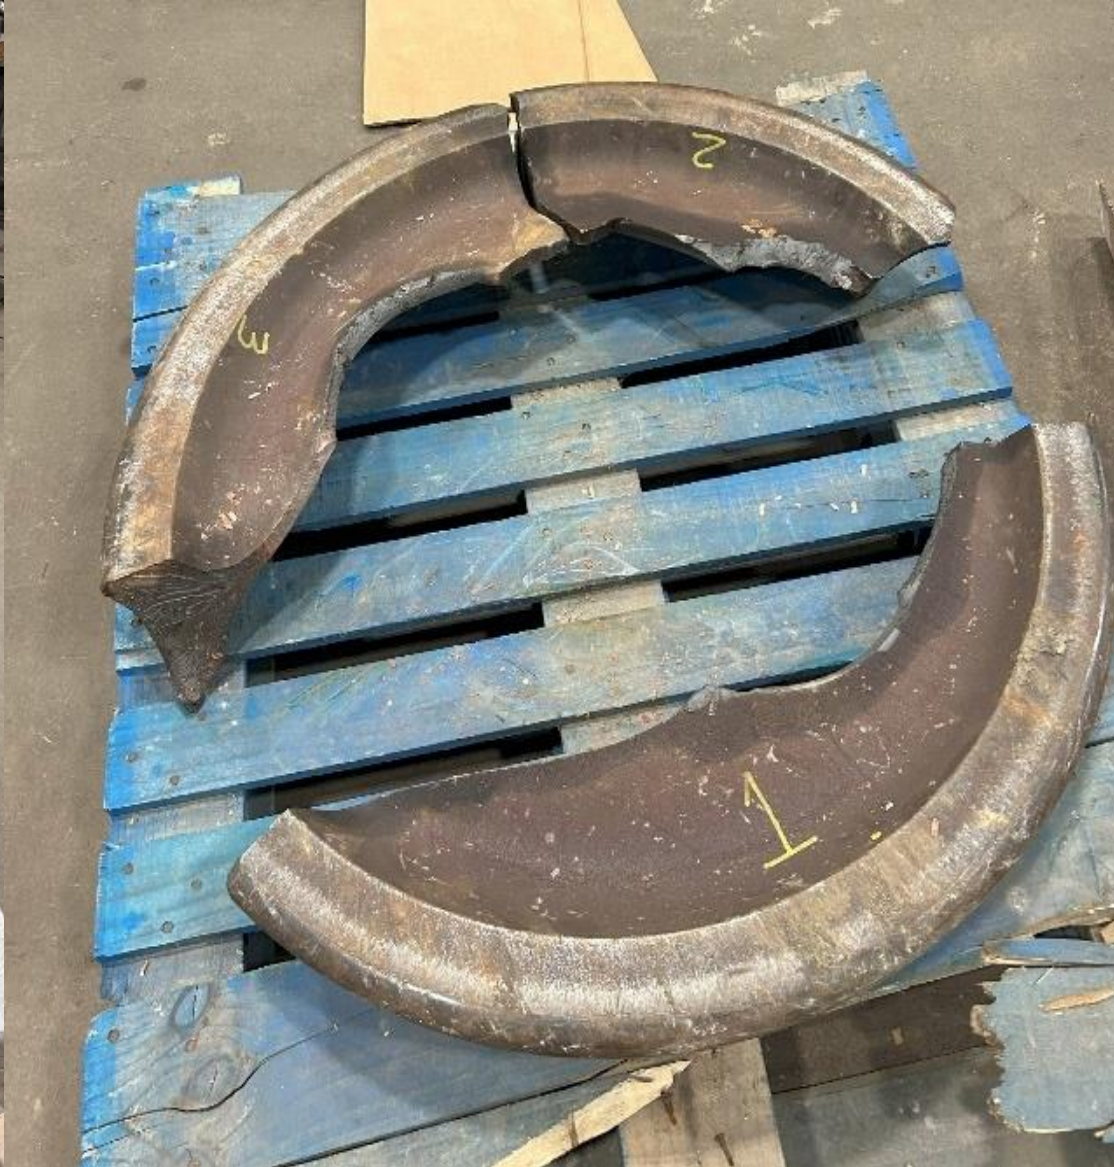
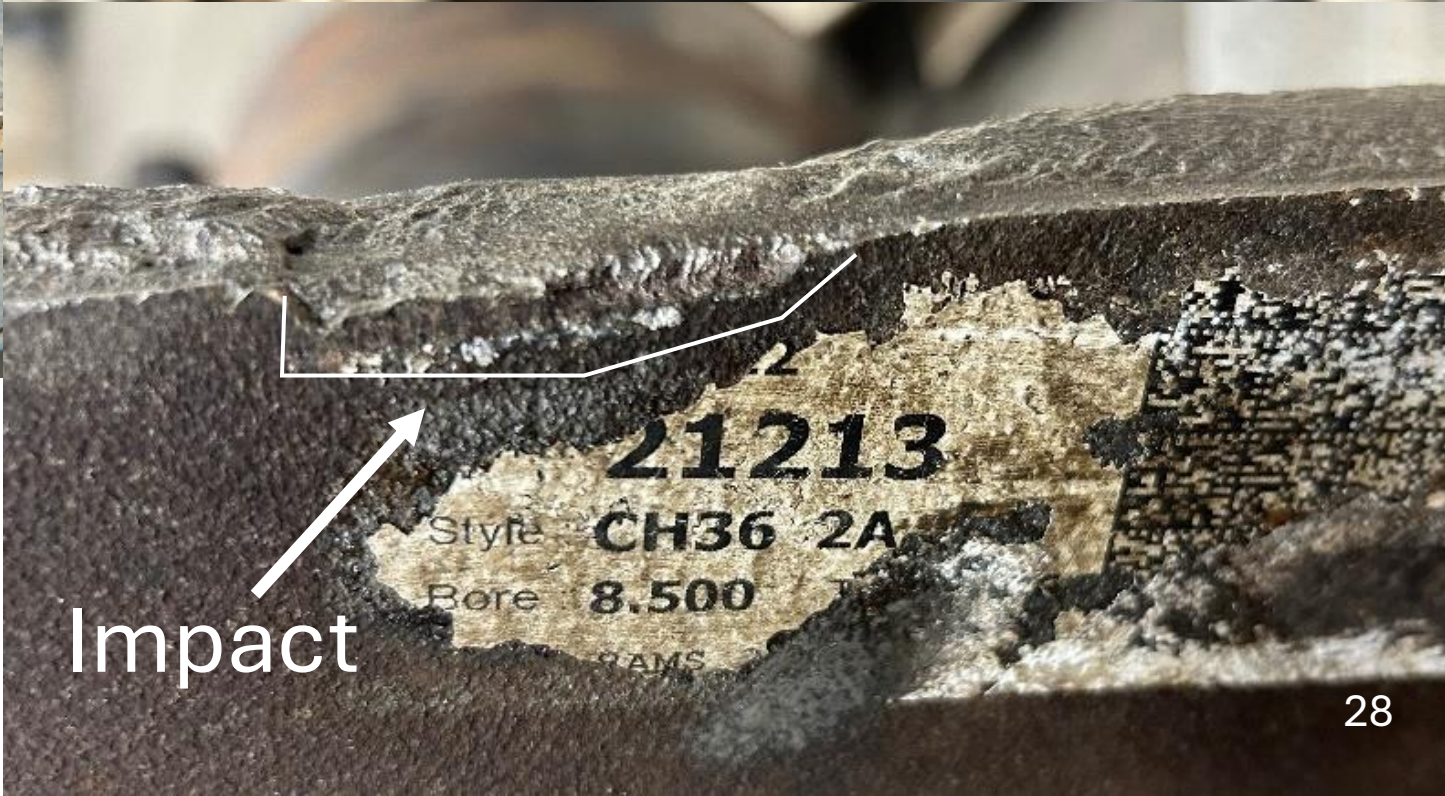
# Another Example - Plate Failure Due To Impact

Plate Failures End In Derailment –  
Very Dangerous

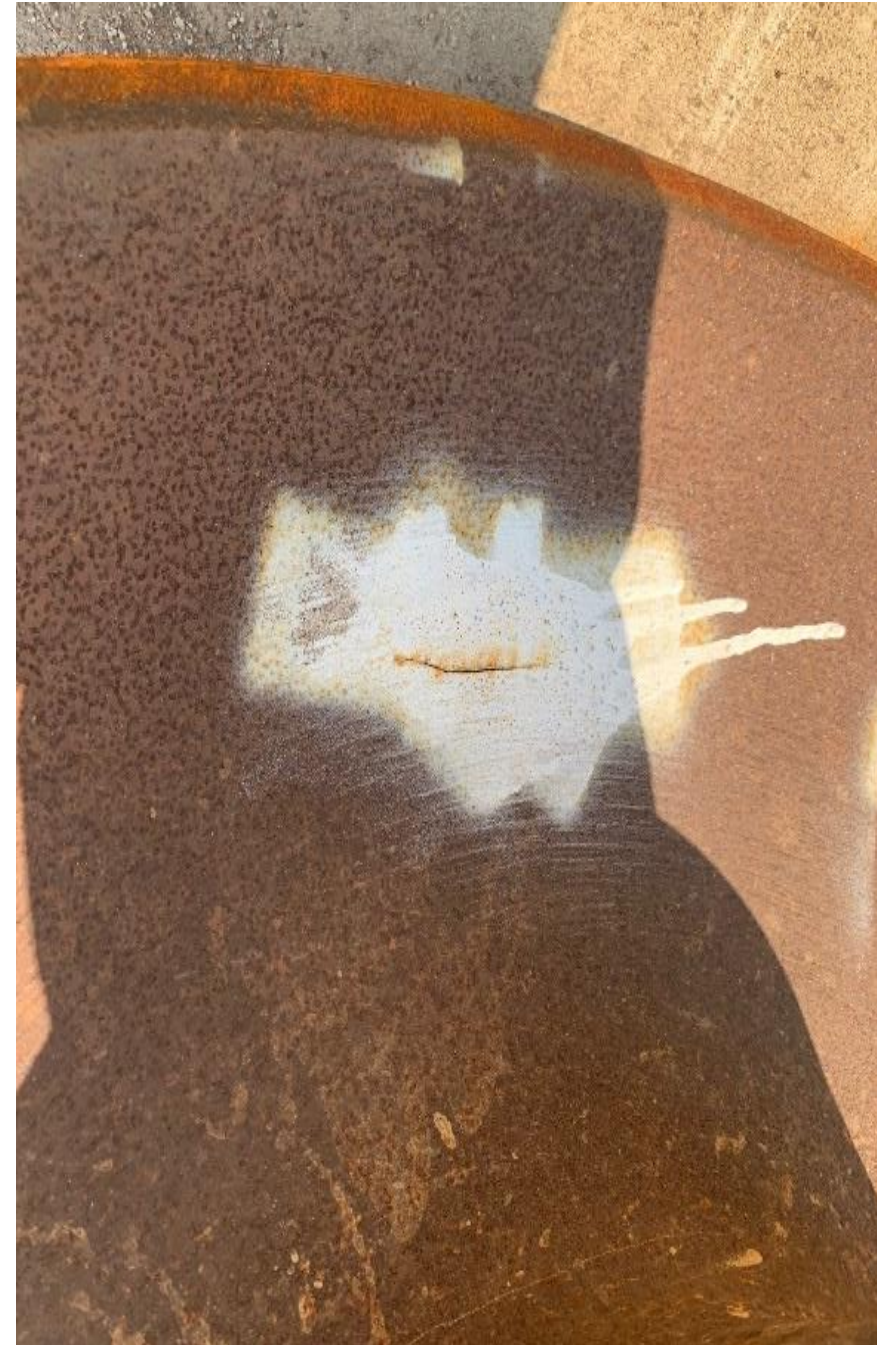
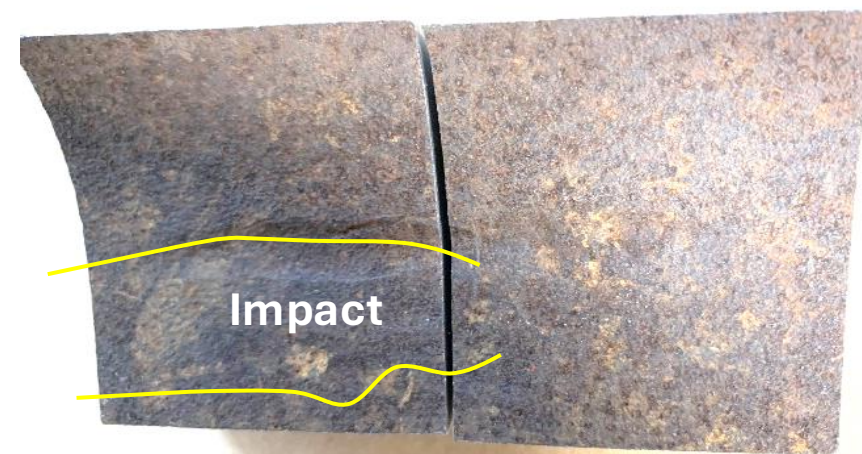
**Service- Returned Wheel  
GI #22153 Cast 10/03**

# Further Analysis – Plate Failure

**Front Plate Surface**

**Cross-Section**

**Back Plate Surface**

**De-Carburization  
Absent Along Crack**
