# Current North American Railroad Wheel Service Issues – The Rise of Broken Flanges and the Importance of Wheel Handling to Prevent Plate Failures

Cameron Lonsdale  
VP – Industry Relations

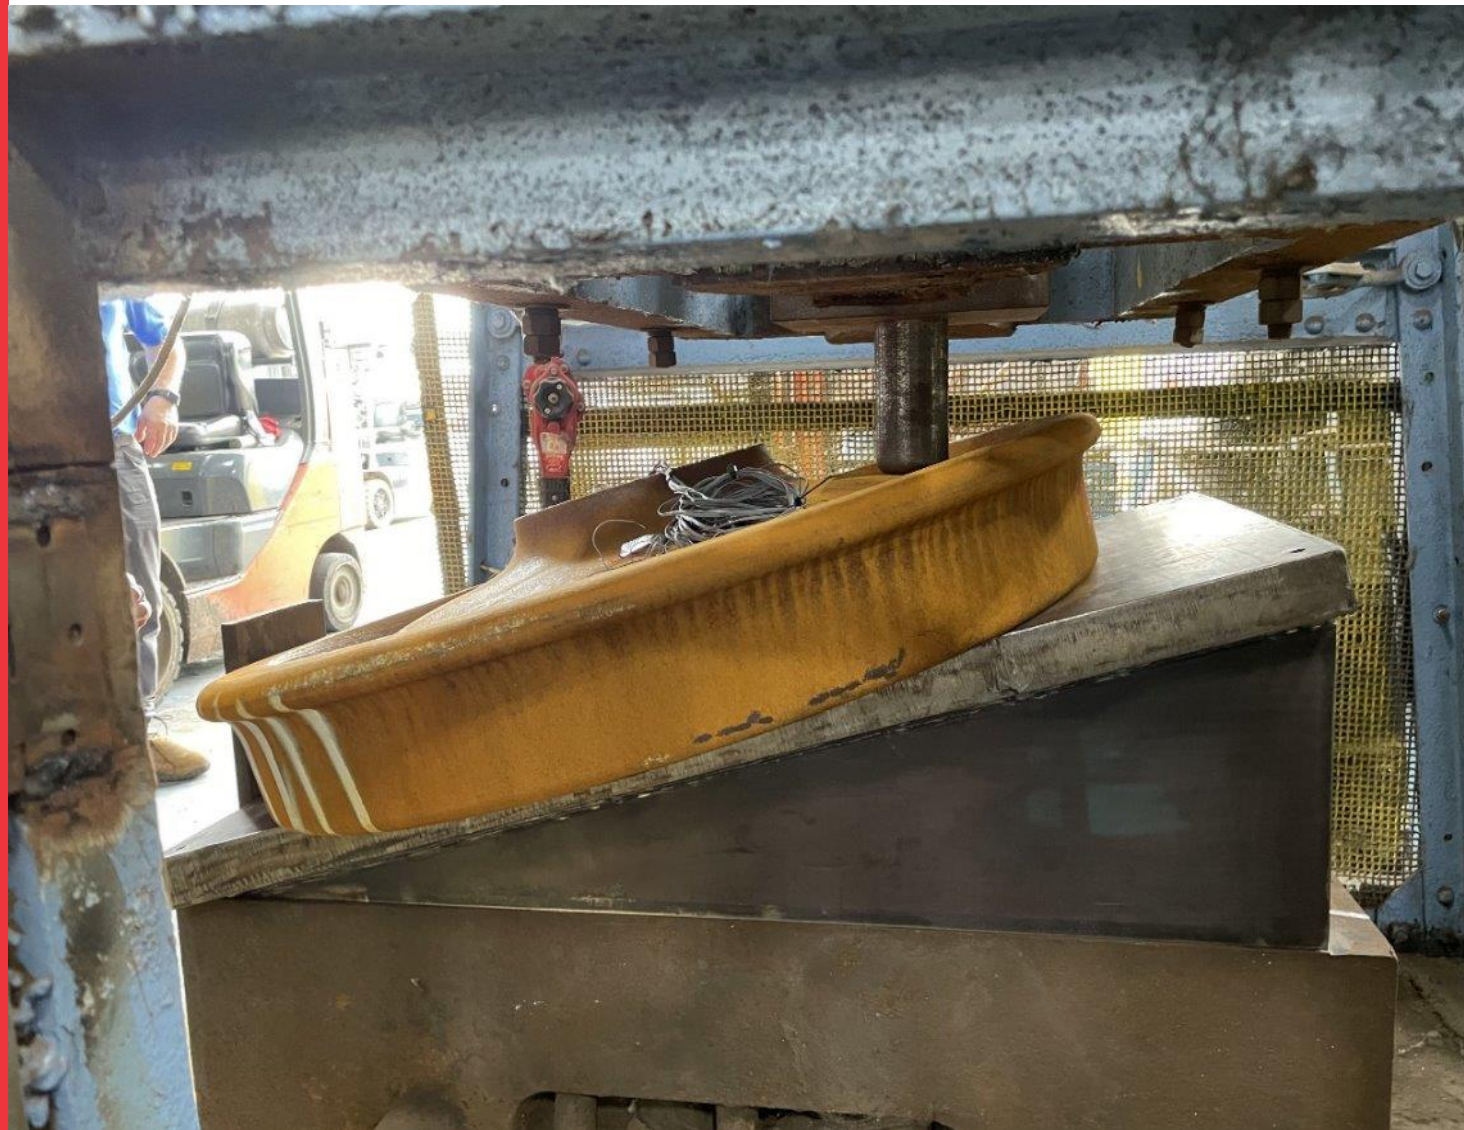
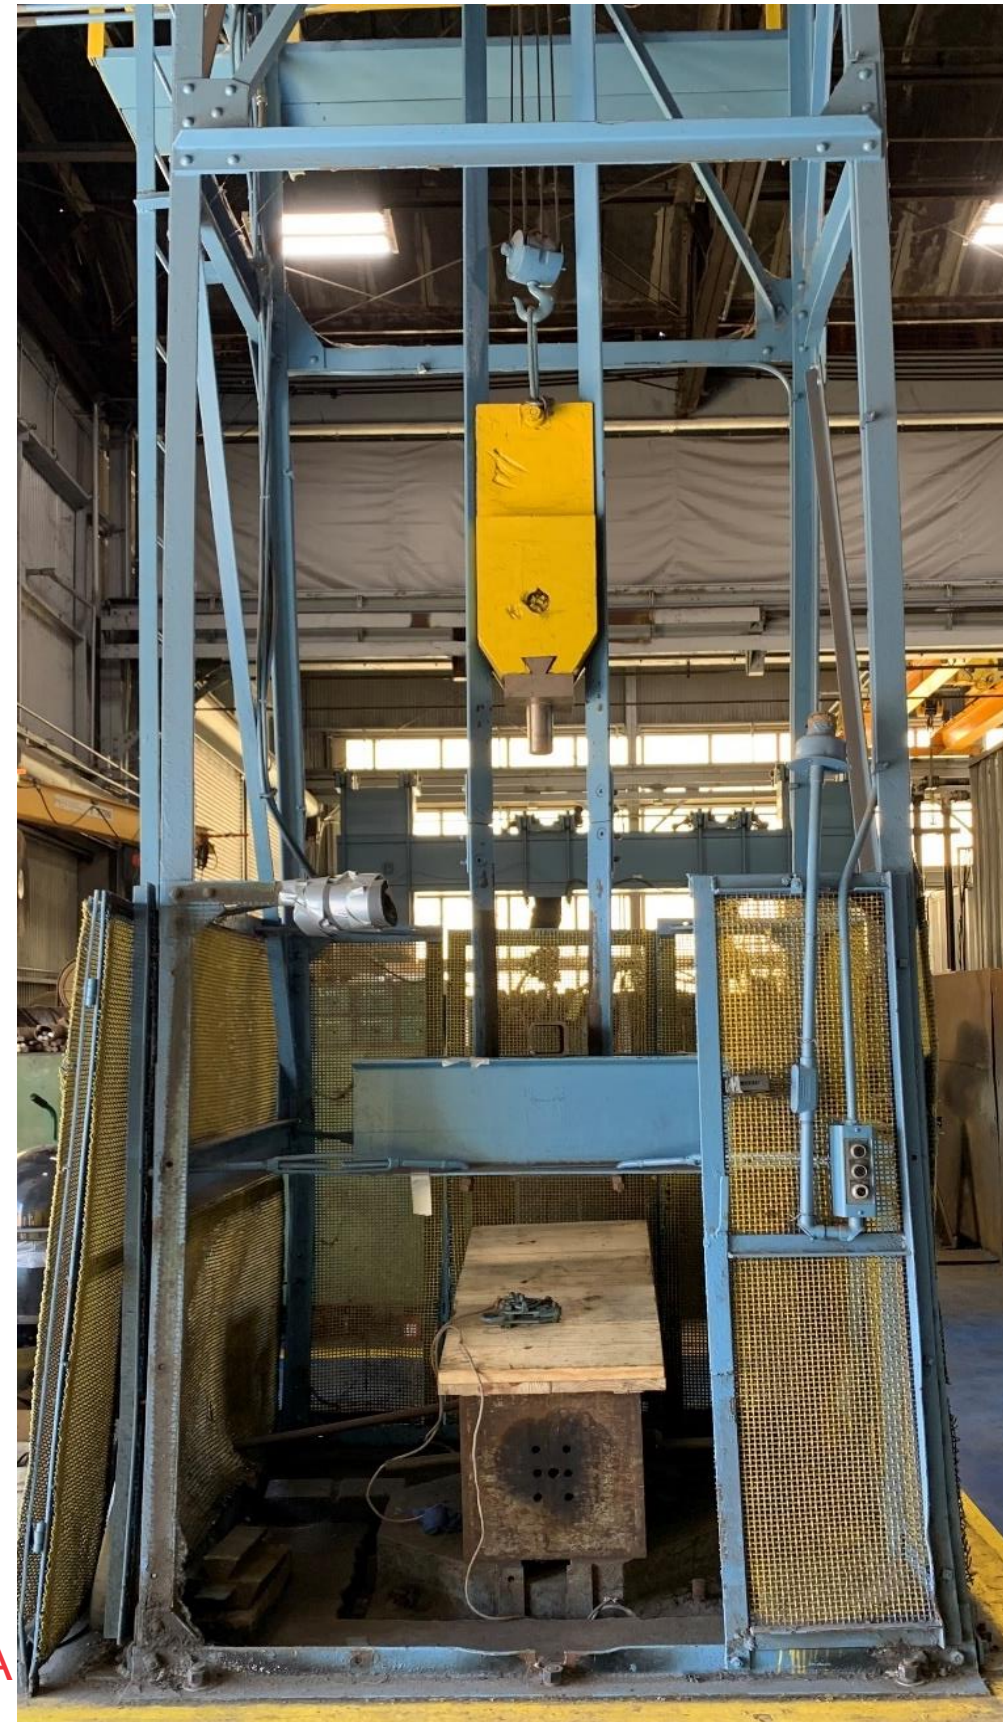
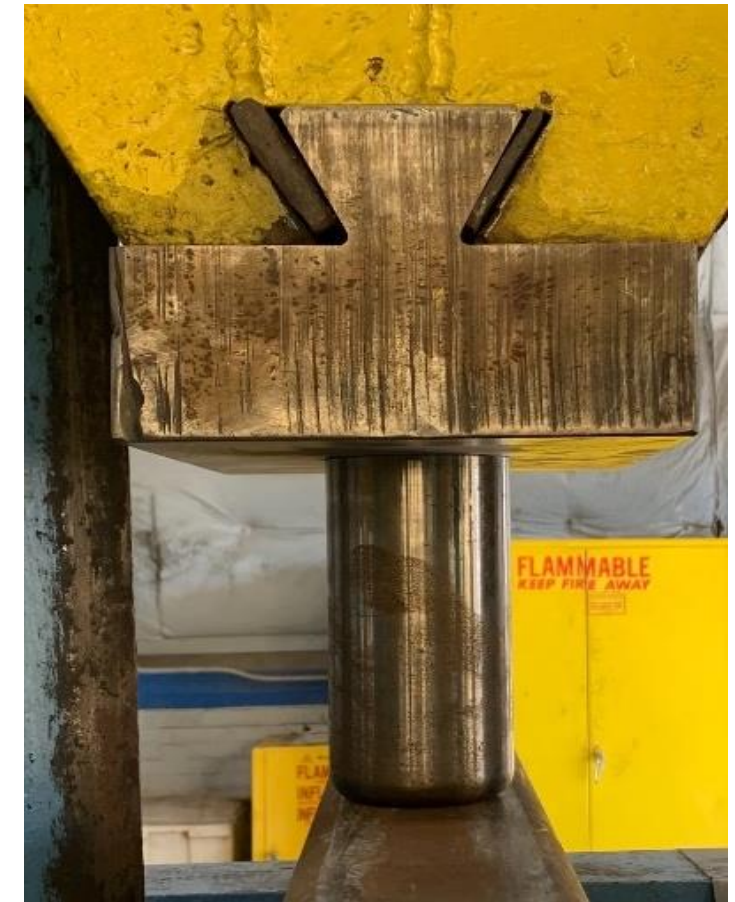
# Wheel Plate Failures - Impact Testing

Impact Testing Plates  
at Granite City, IL

Wheel Support Platform Prototype

Drop Hammer

2-in Striker

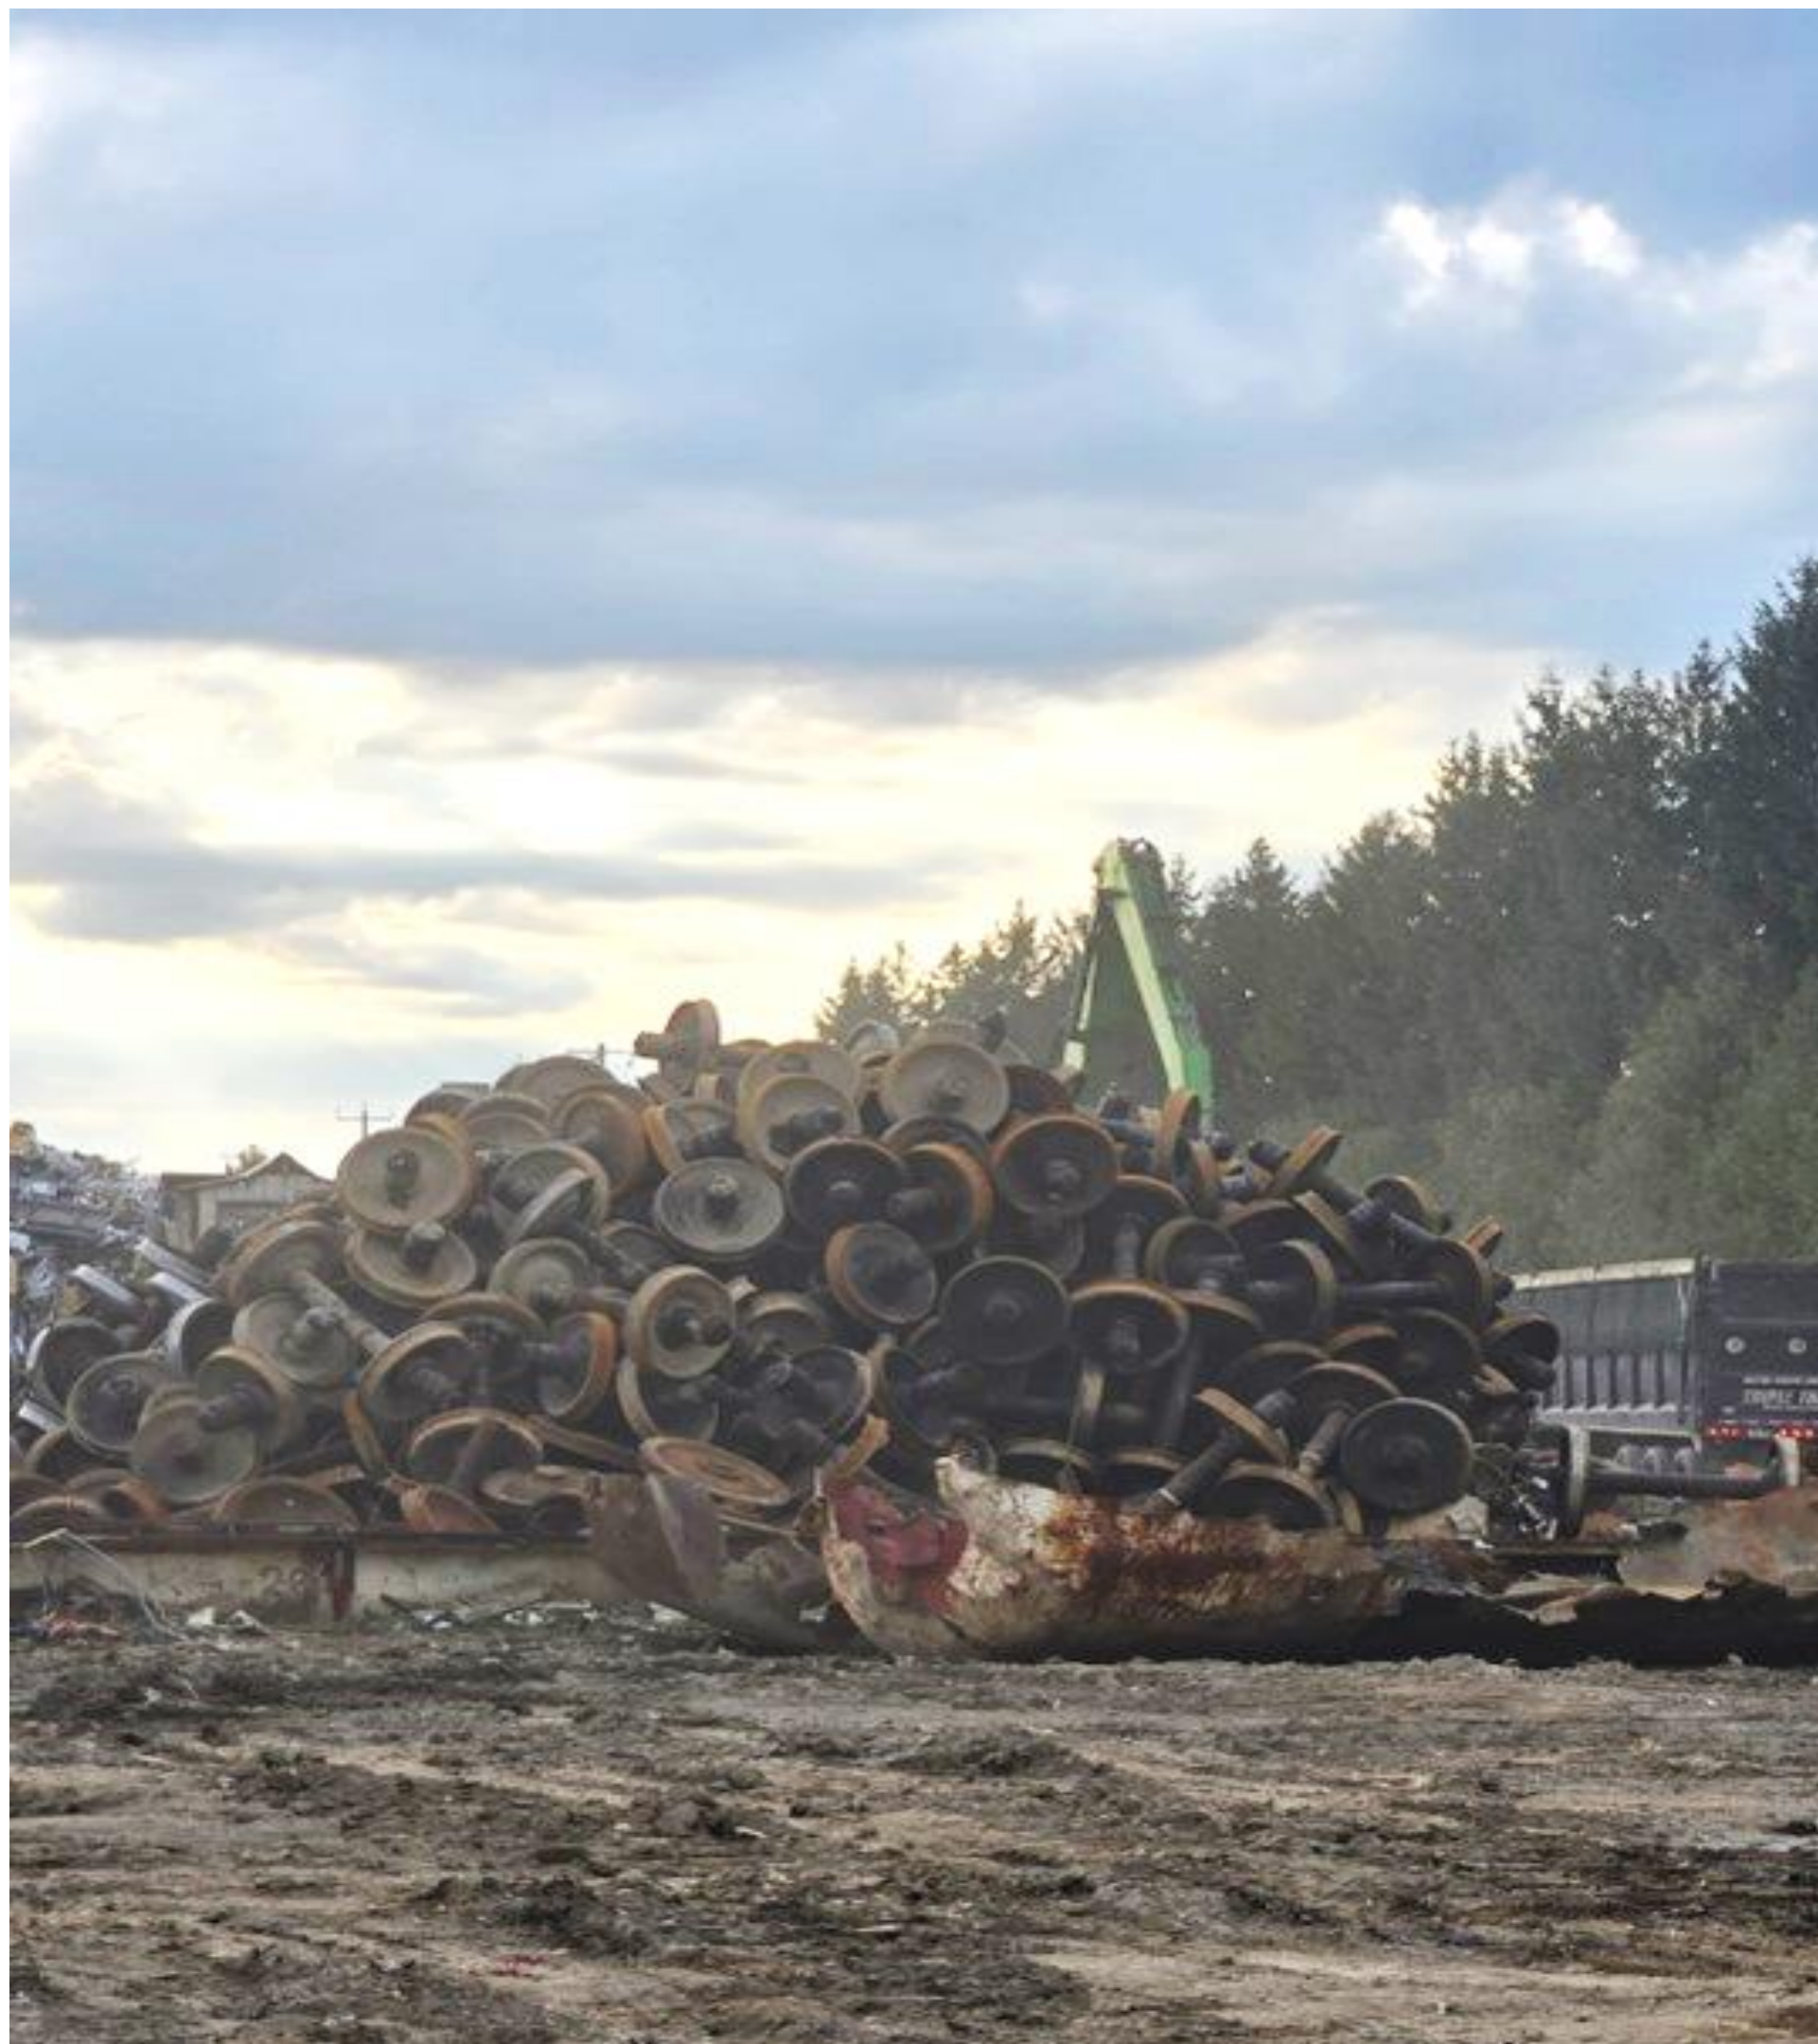
Locations where “Purchased Core” wheelsets are being harvested? The photo to the left reportedly is such a location.

WABL is planning to look at requirements for purchased cores, to improve safety of Wheels, Axles and Bearings.

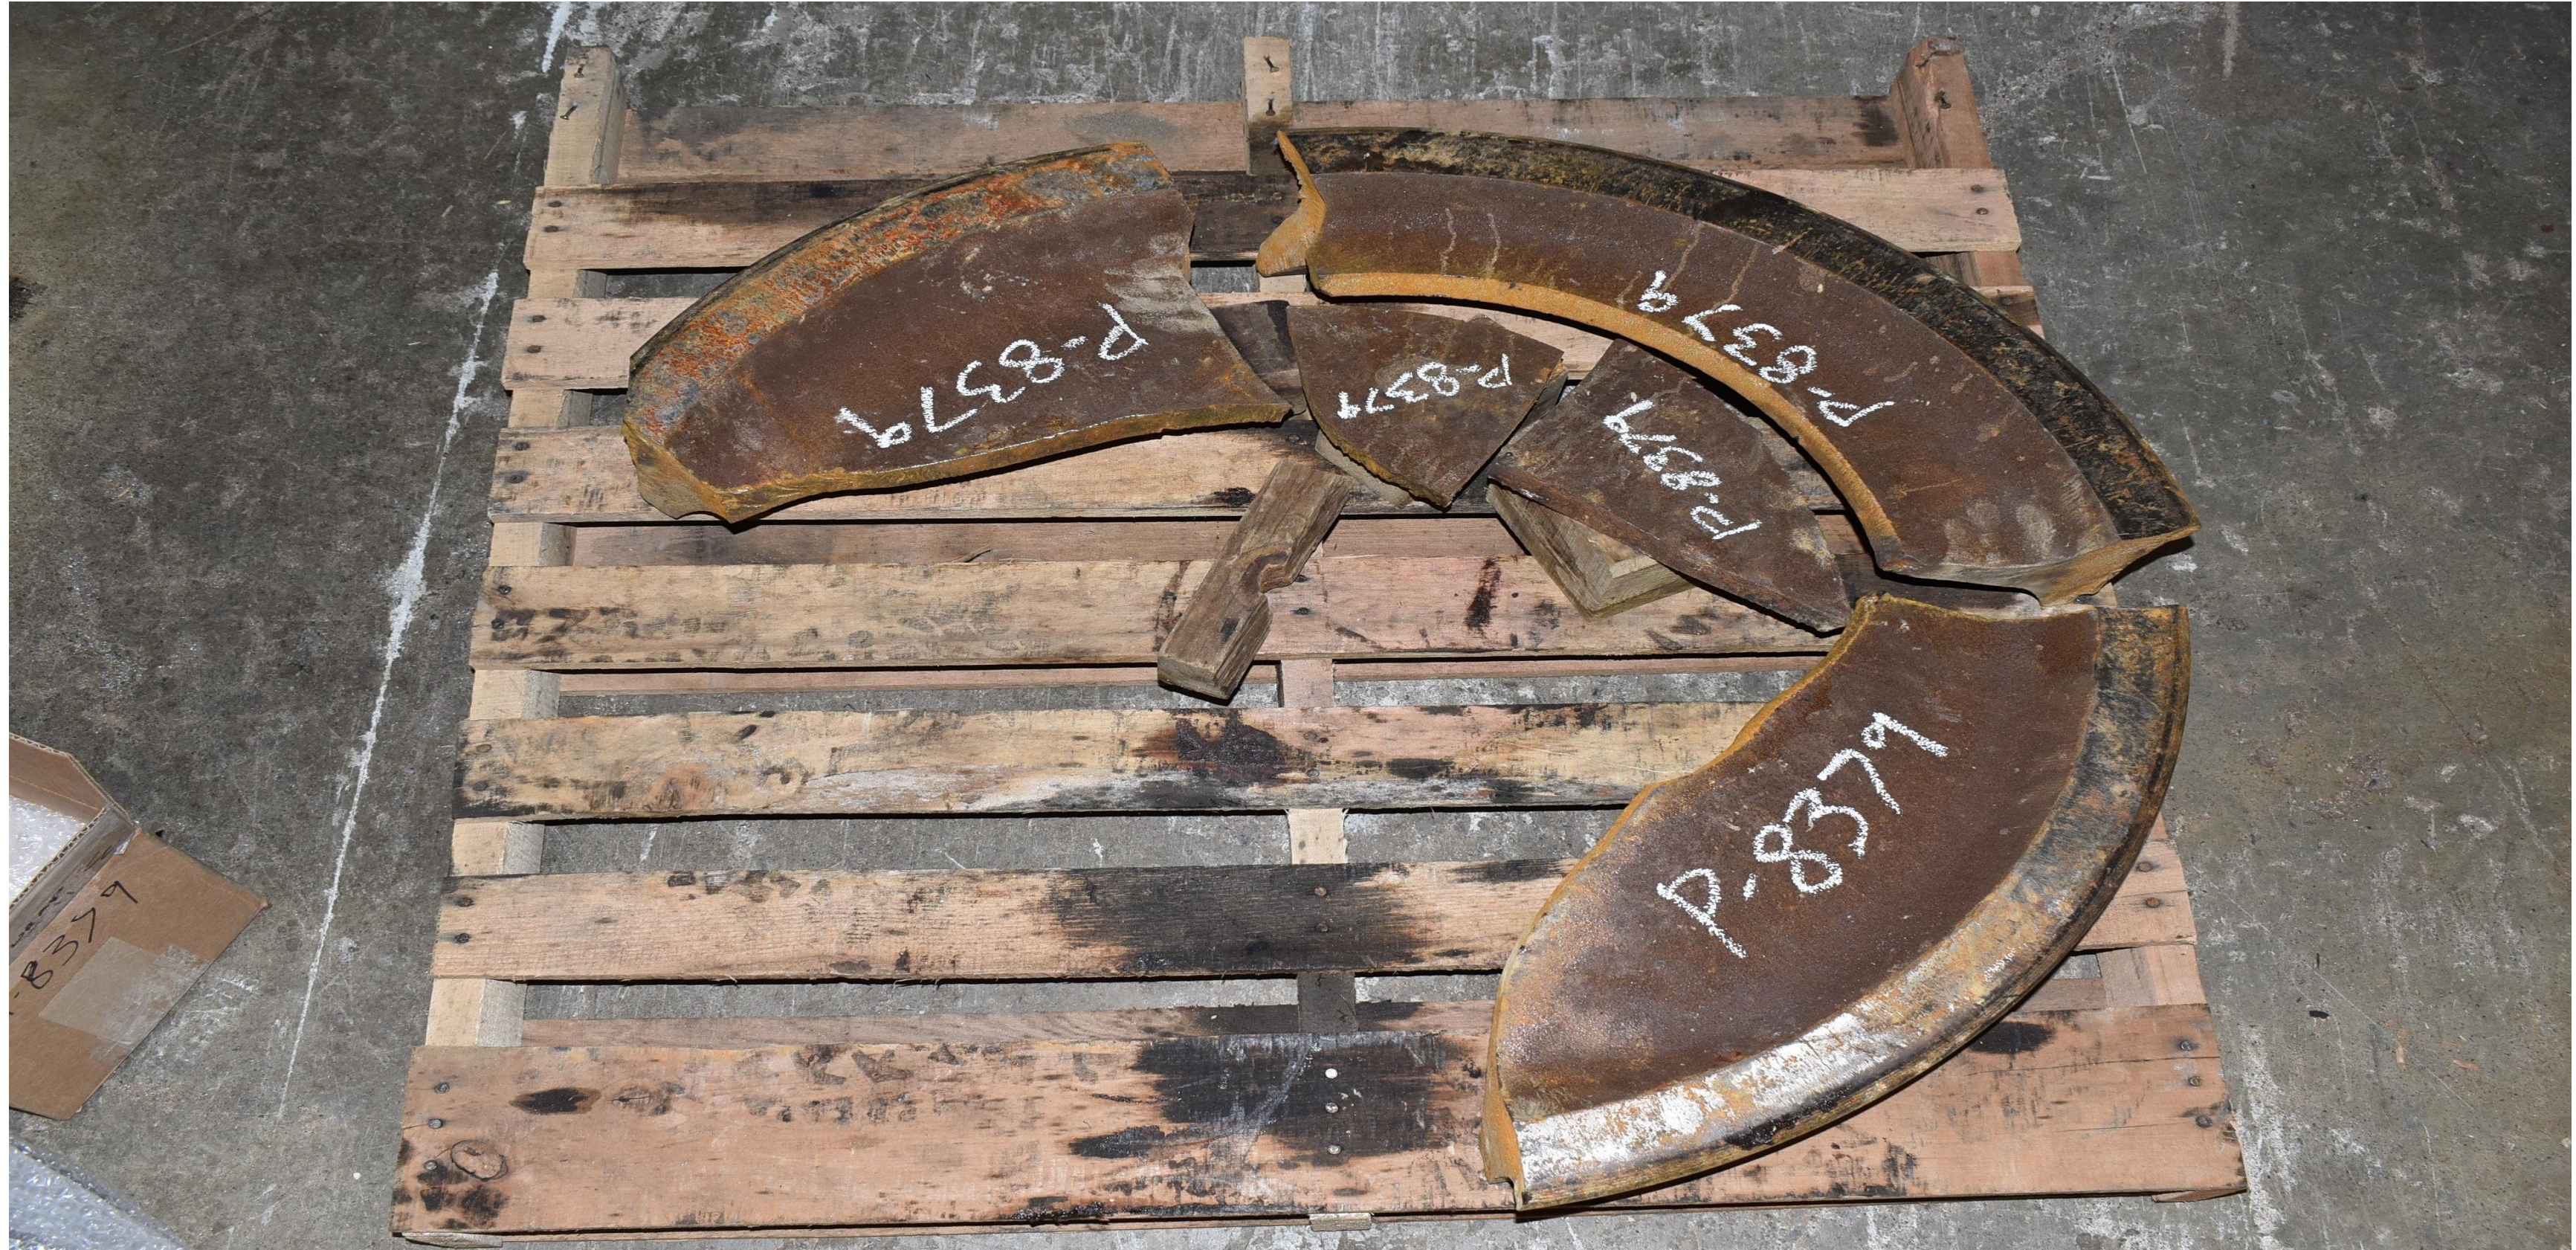
## Broken Plate Due To Weld Arc Strike

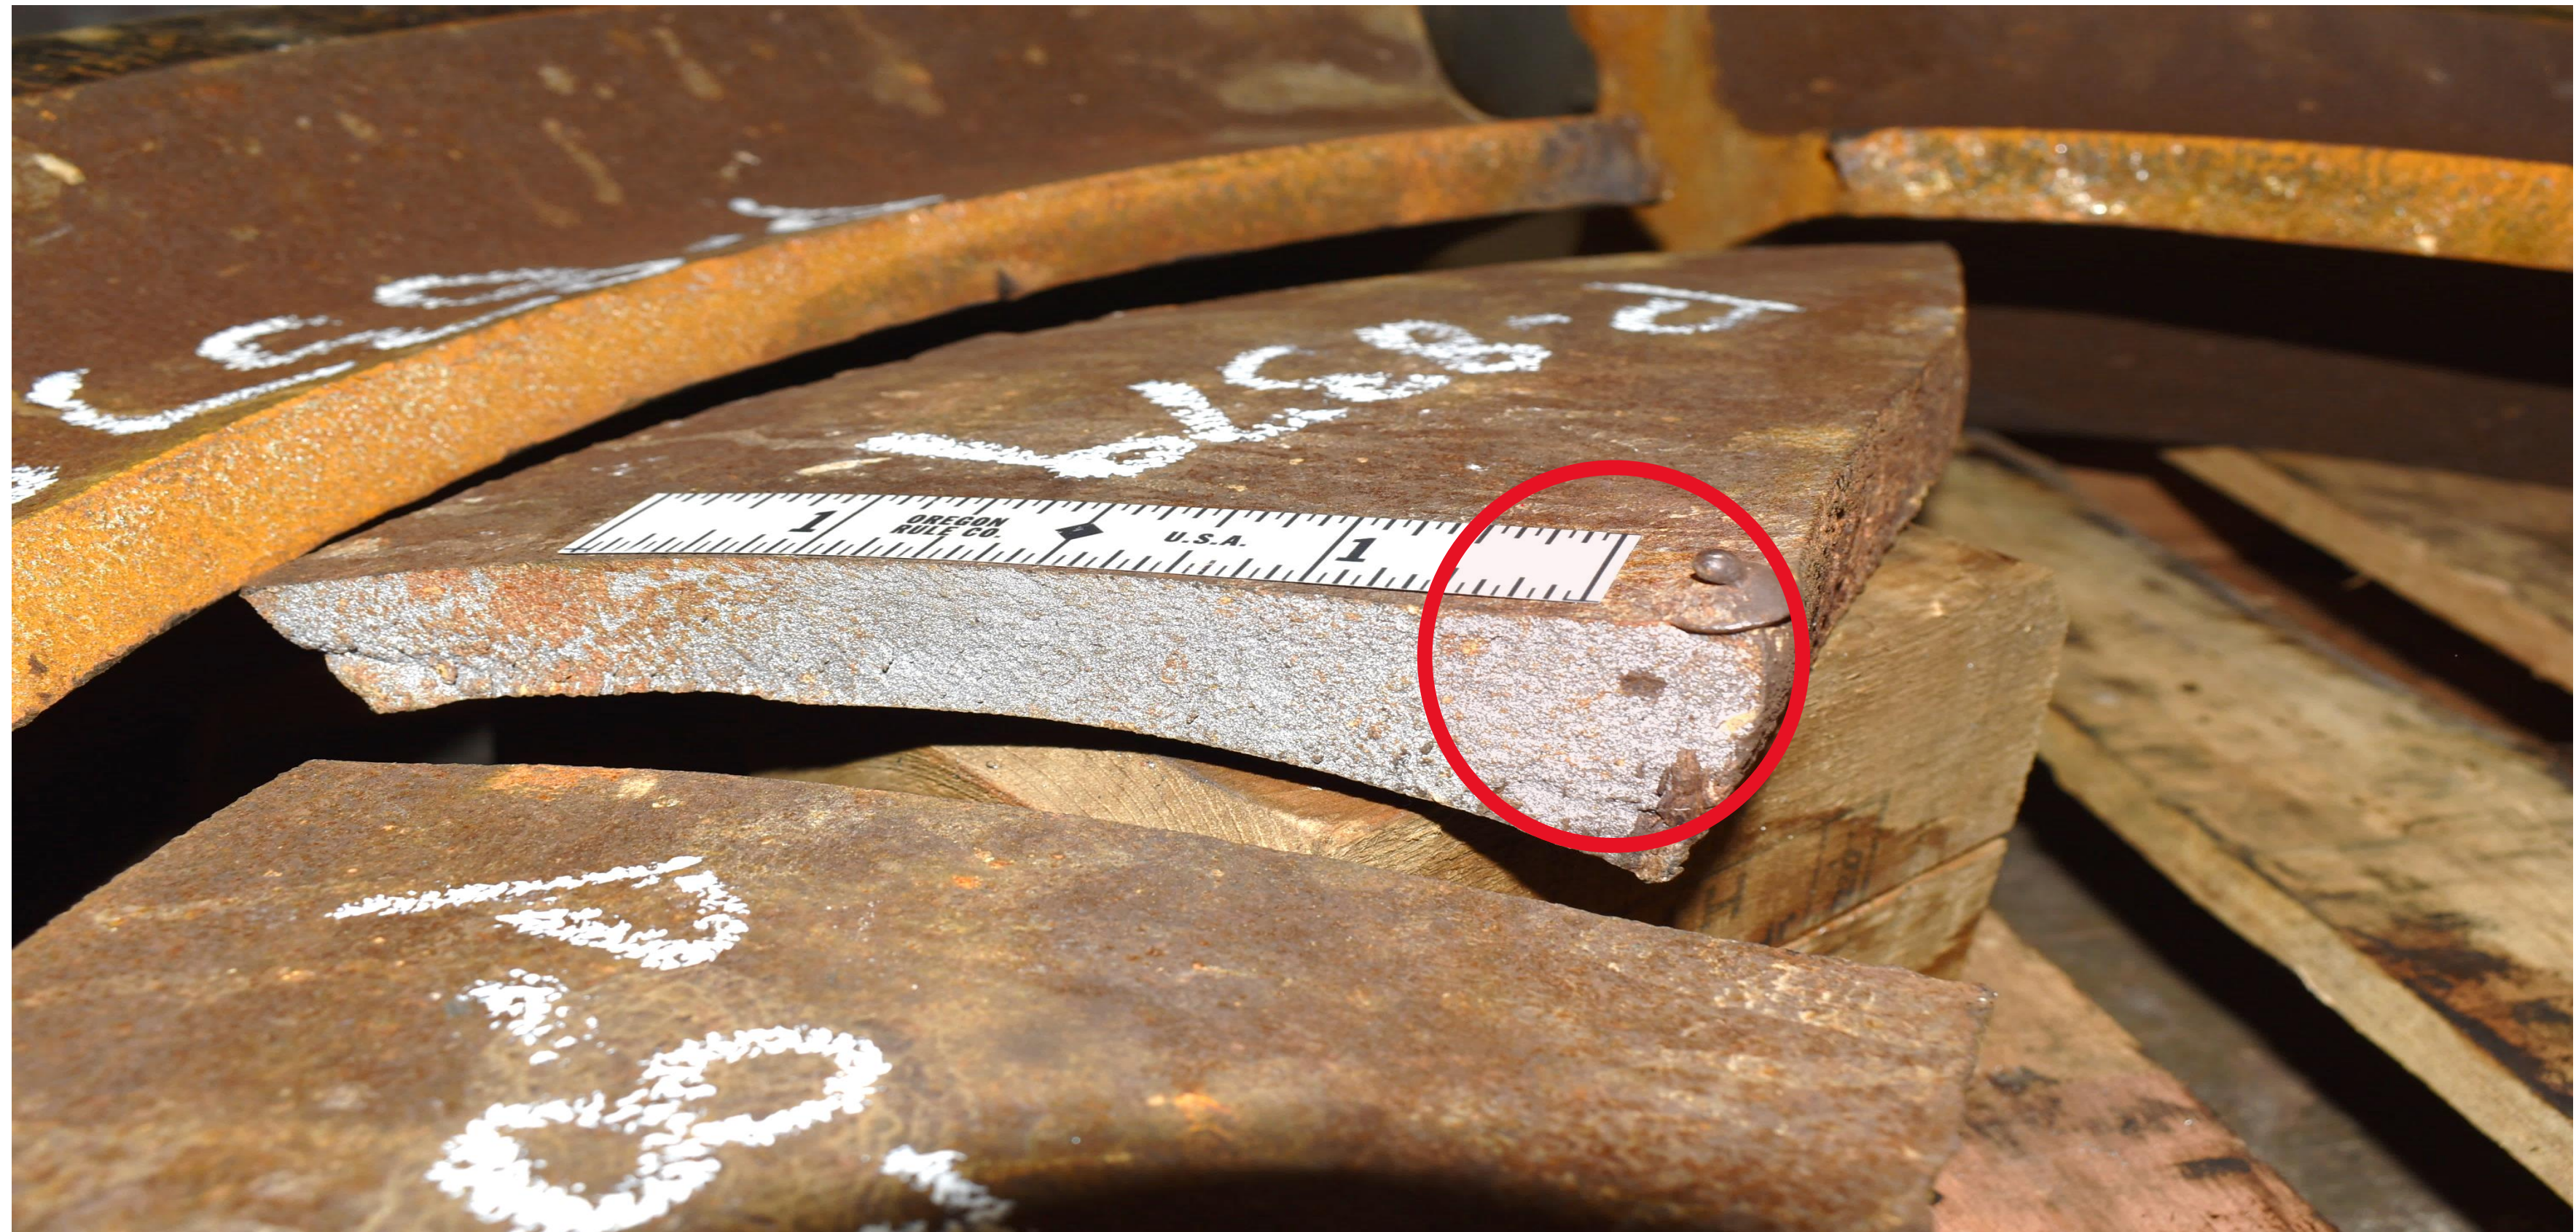
# Closer View Of Arc Strike On Plate

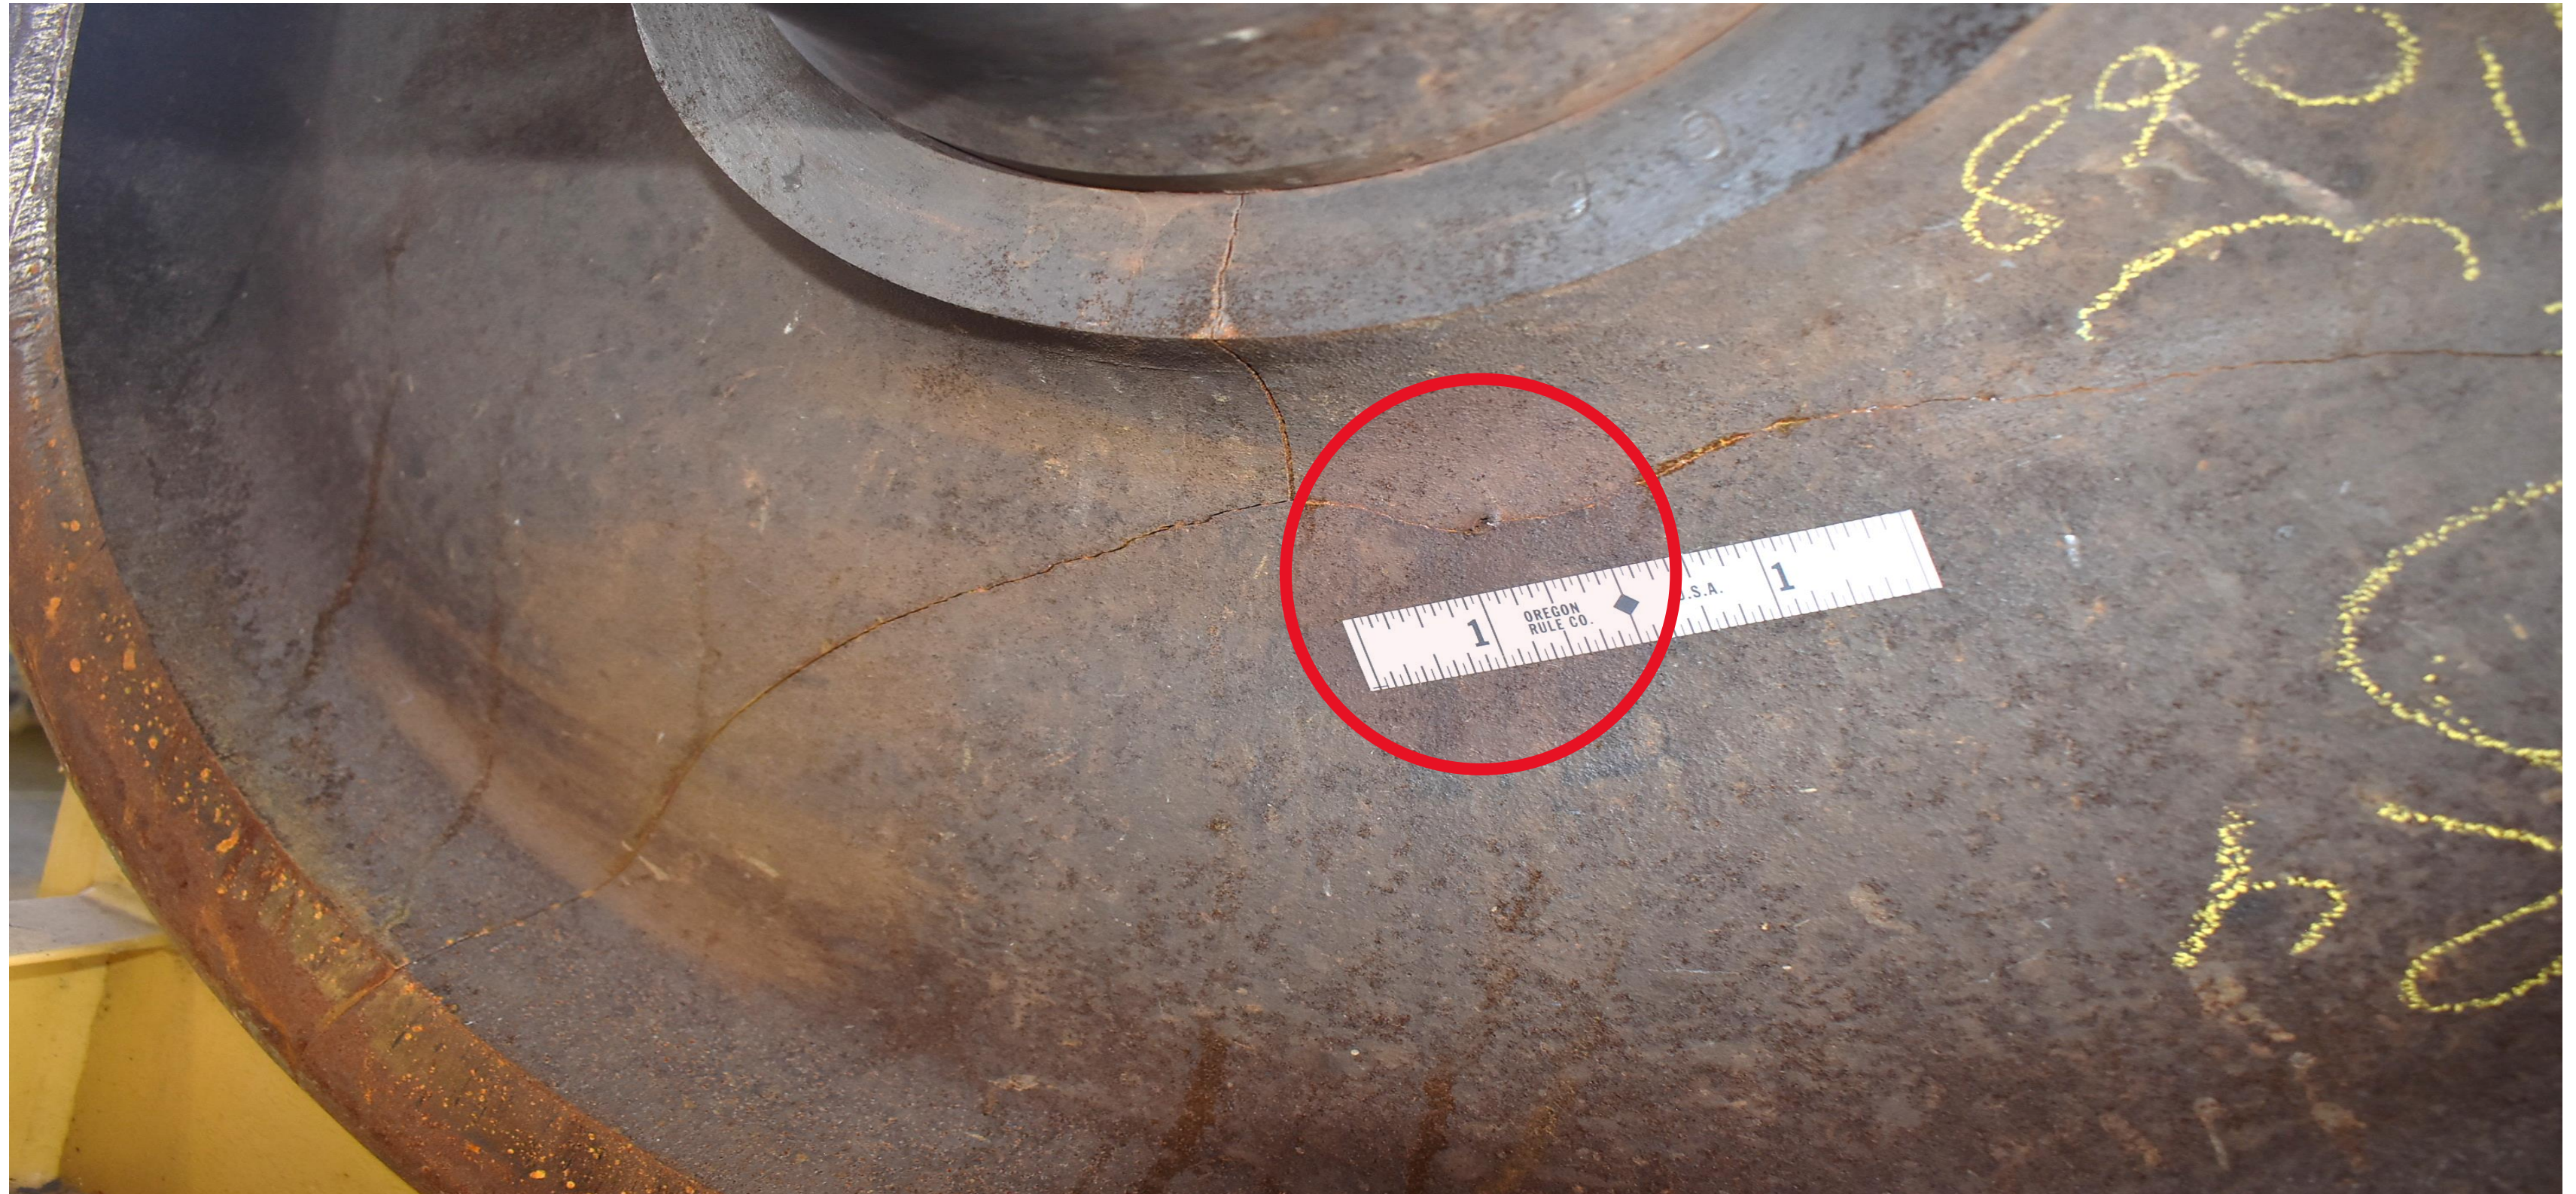
# Weld Spatter Damage On Wheel Plate

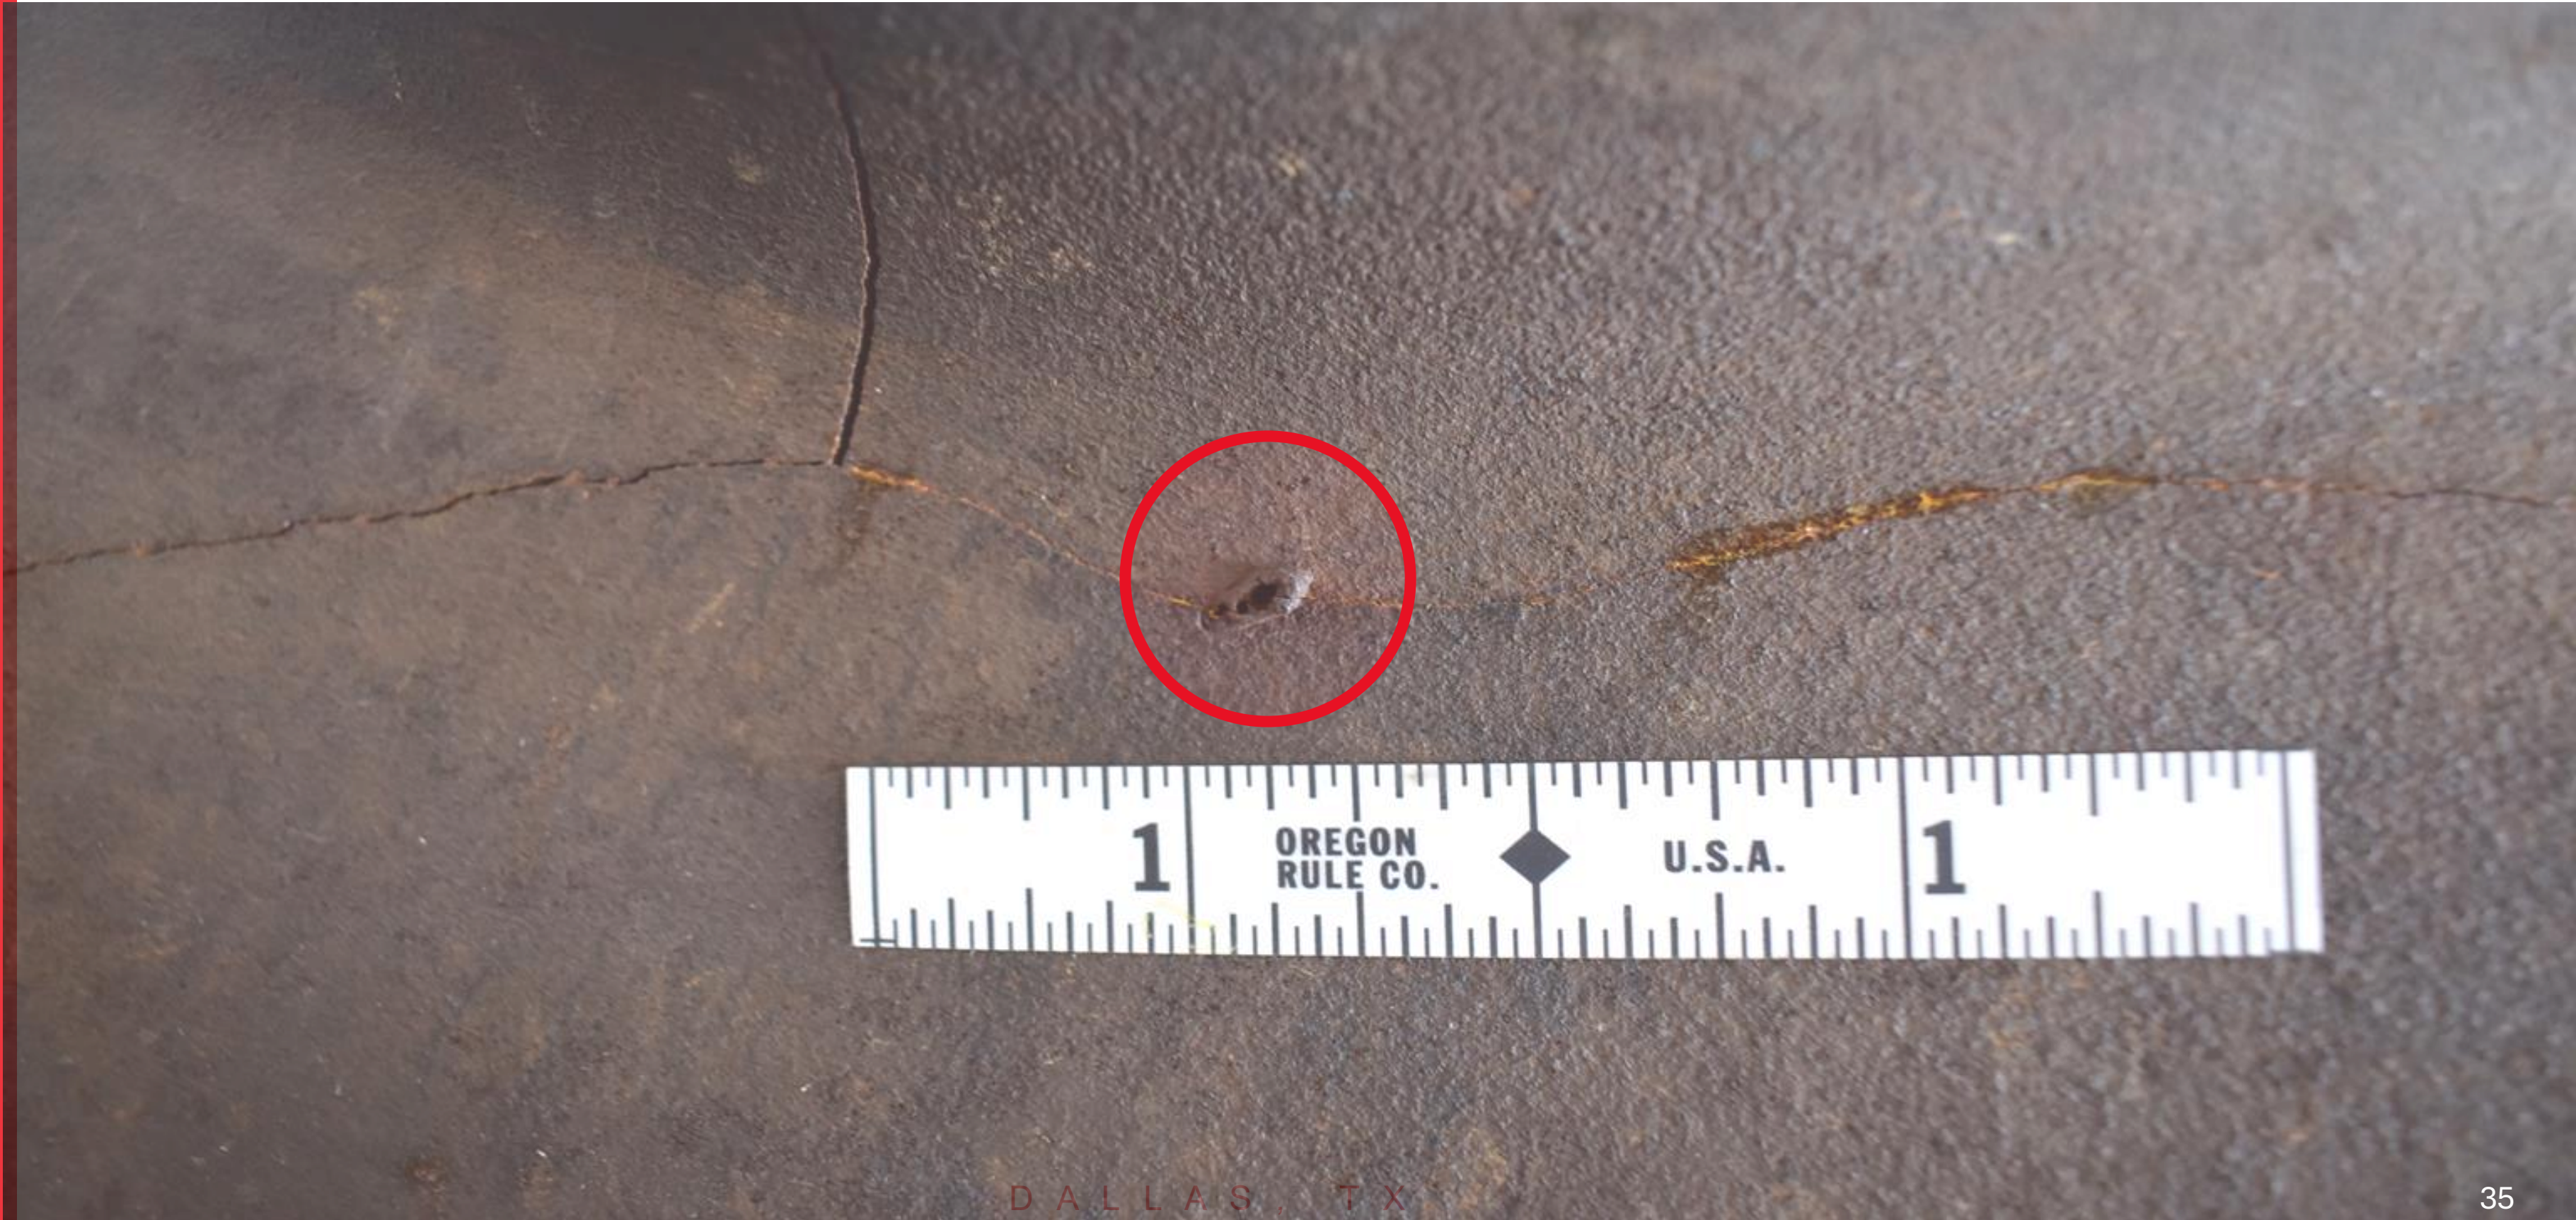
# Closer View Of Damage and Plate Cracks
