## **Data-Driven Assessment of Rail Grinding Frequency for Sustainable Track Integrity in India's Dedicated Freight Corridor**

**Mr. Praveen Kumar, Managing Director, DFCCIL**

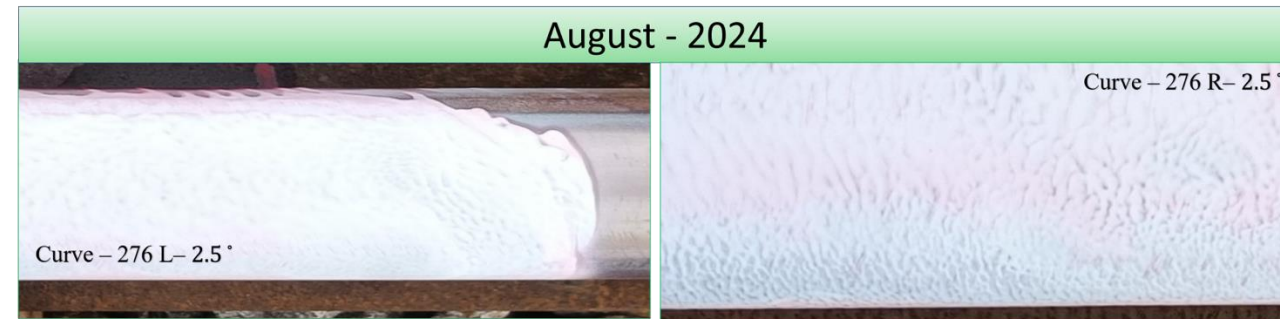
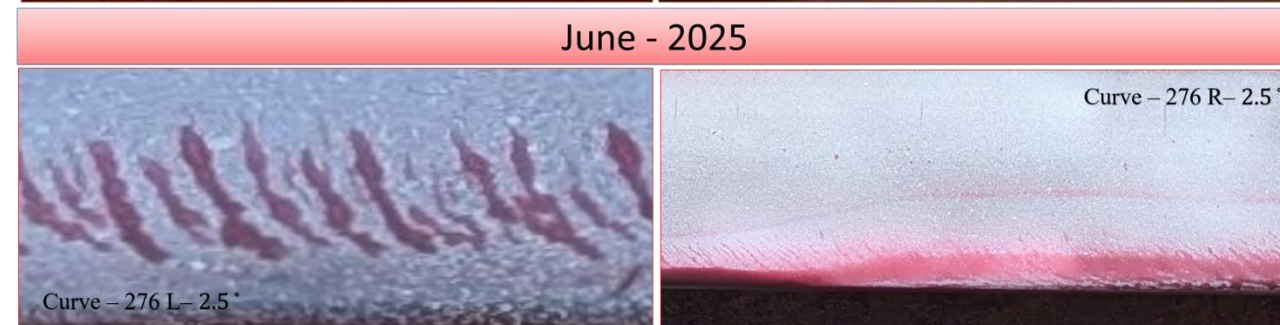
First Grind Cycle (Mar 2024)

- Immediately after grinding, the rail surfaces appear smooth with negligible damage
- By March 2025, early signs of rolling contact fatigue (RCF) emerge
- By June 2025, reflecting active propagation under cyclic loading
- By September 2025, the crack networks become deeper and more pronounced, indicating subsurface fatigue progression and an increased risk of spalling
- By January 2026, both rails exhibit significant deterioration as RCF becomes denser and visually longer
- The figure illustrates the contrasting degradation pathways under timely grinding and grinding deferral, highlighting a fundamental shift in the failure mechanism.
- This shift has significant maintenance implications, as RCF damage is more difficult to arrest once established

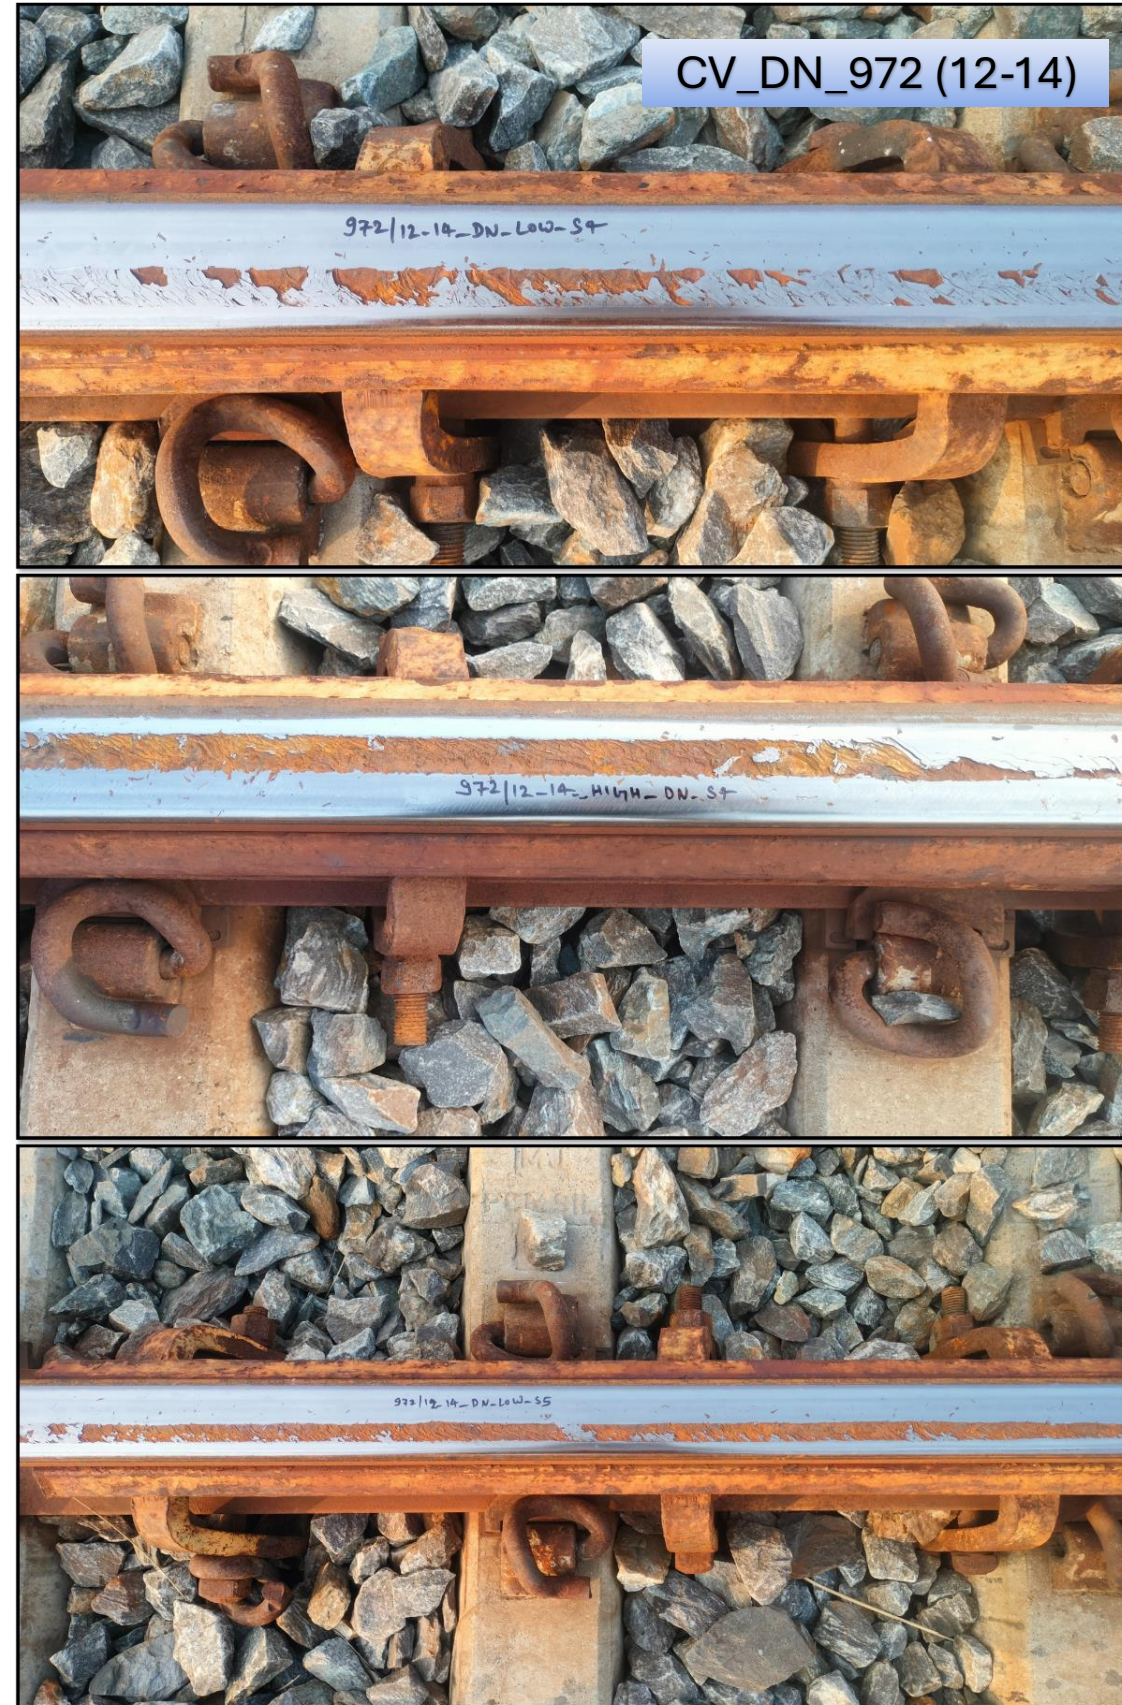
- Material flaking and continuous running band defects are observed on both high and low rails
- Rail surfaces exhibit elongated and irregular patches where the top metal layer has detached along the running band
- In several locations, these features observed over extended track lengths, forming continuous surface response patterns along the contact band
- Despite their superior wear resistance and higher hardness, 1080 head hardened (HH) rails exhibit increased sensitivity to deferred grinding. Preventive grinding seems an essential task to be carried out in a planned manner.

*Based on the study outcomes, DFCCIL has proactively strengthened its rail maintenance strategy by deploying one SRGM (20 stone) machine, with plans to induct a 96-stone grinding unit to support increasing GMT and achieve network-wide grinding in accordance with prescribed maintenance cycles.*
