Mark Reimer

Director & Co-Founder,
Sahaya Consulting

Rail Damage Mechanisms and Remediation

RAIL TRANSIT SEMINAR

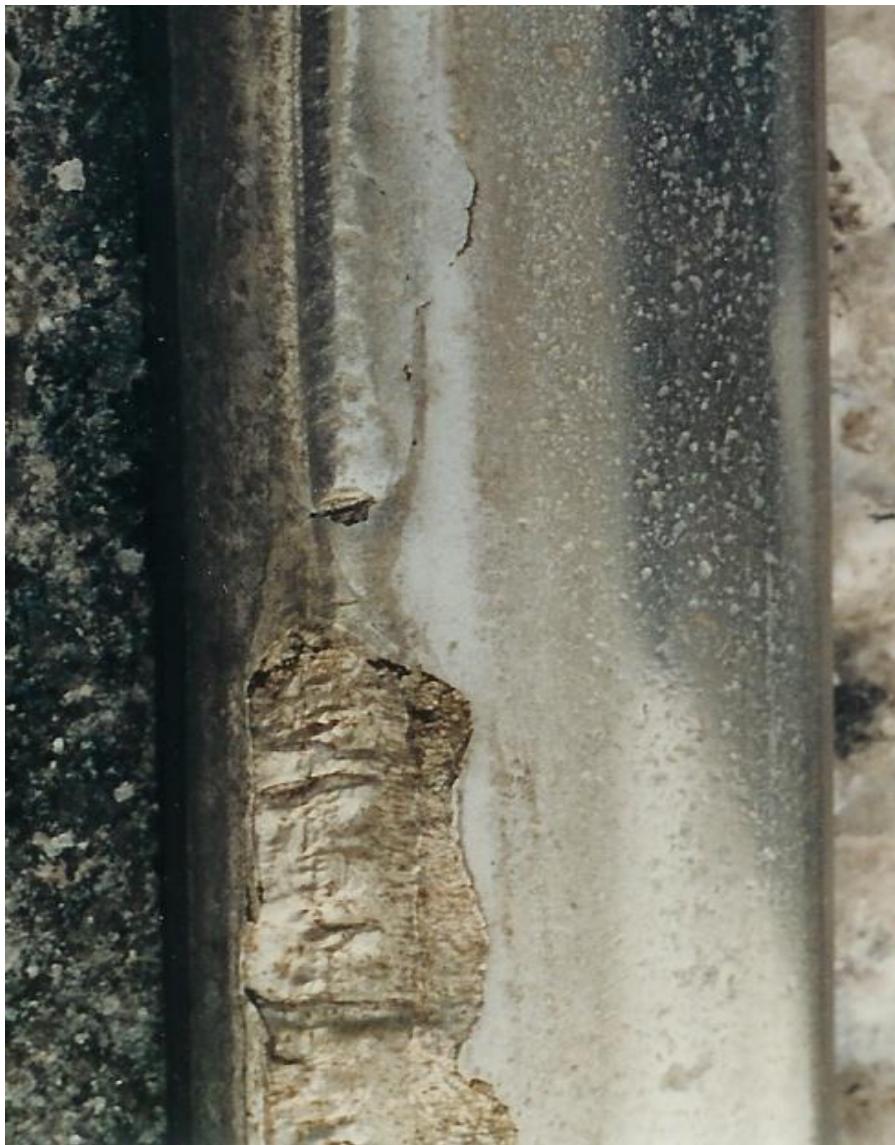
gauge-corner collapse
in a dry environment

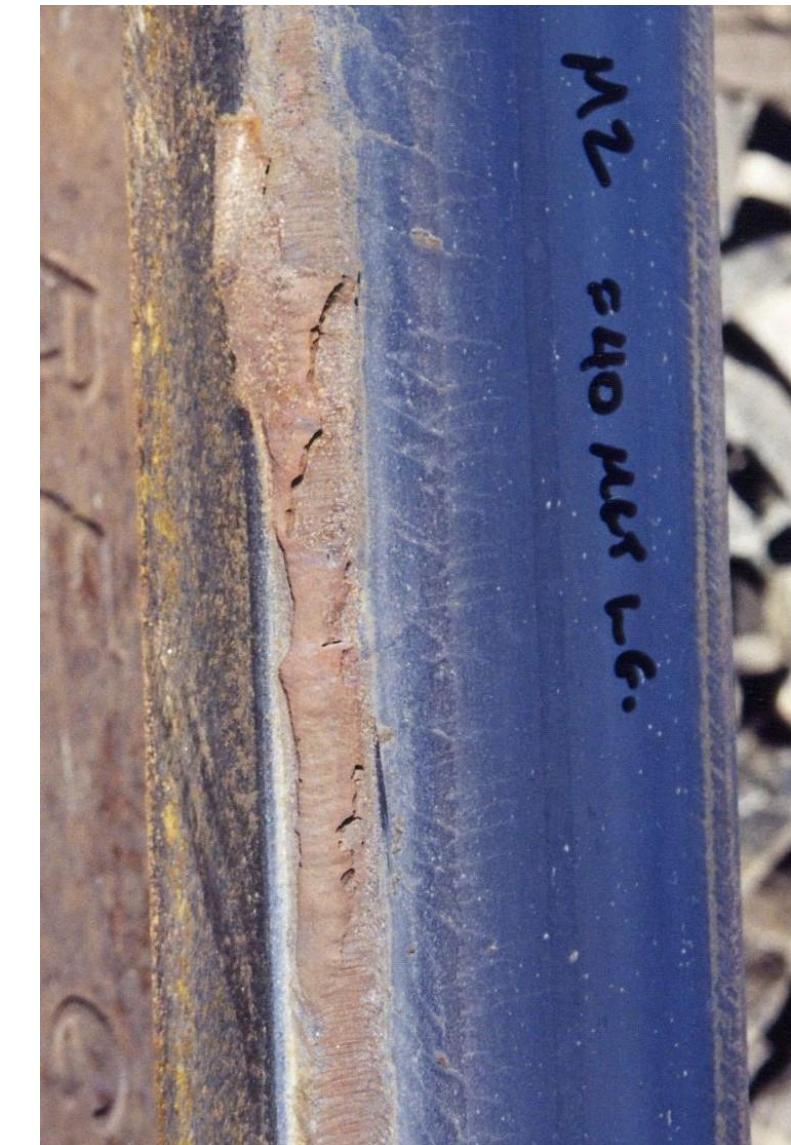
gauge-corner collapse in a
well-lubricated rail

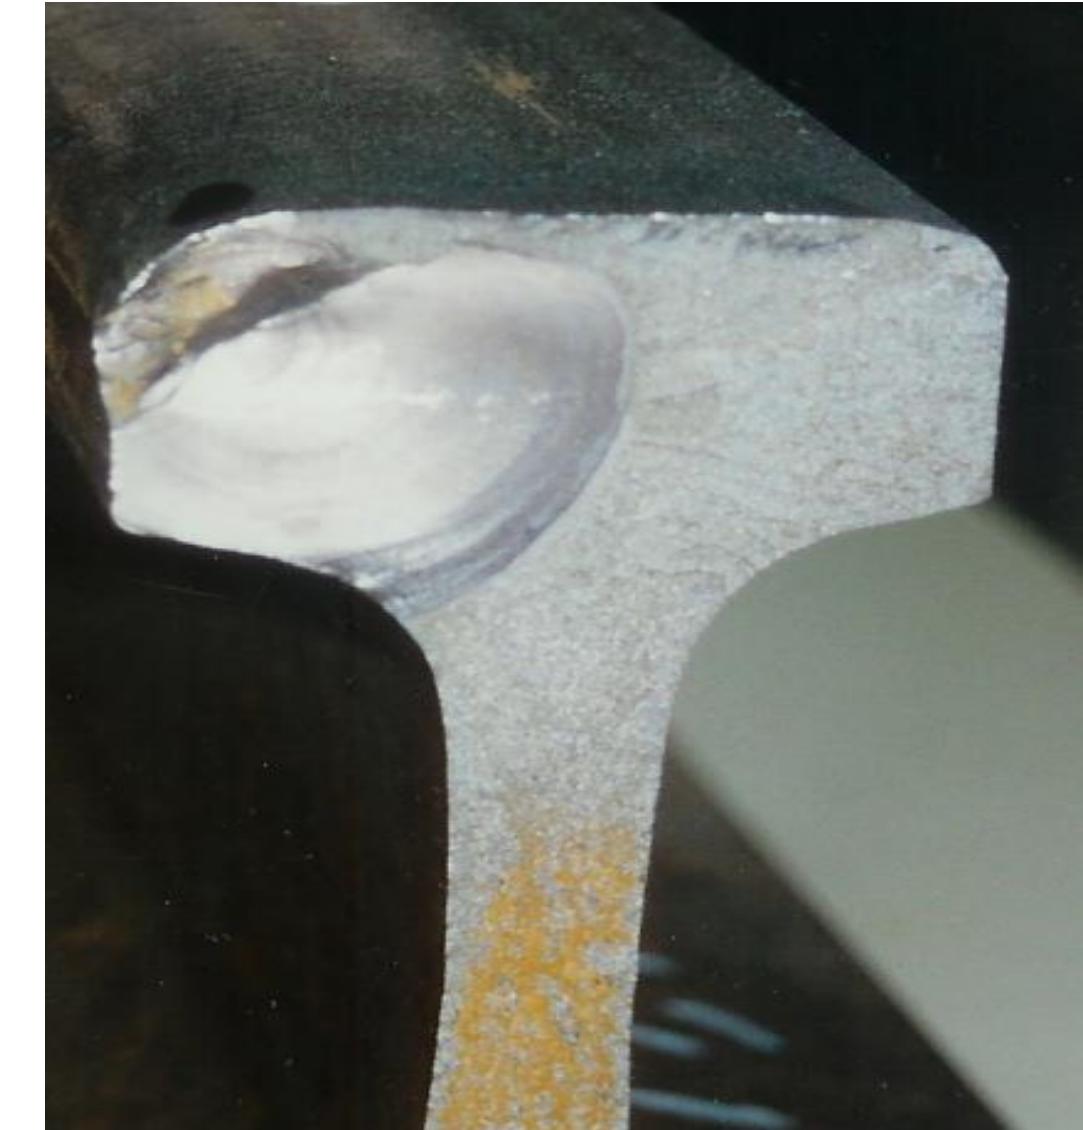
transverse defect from a shell

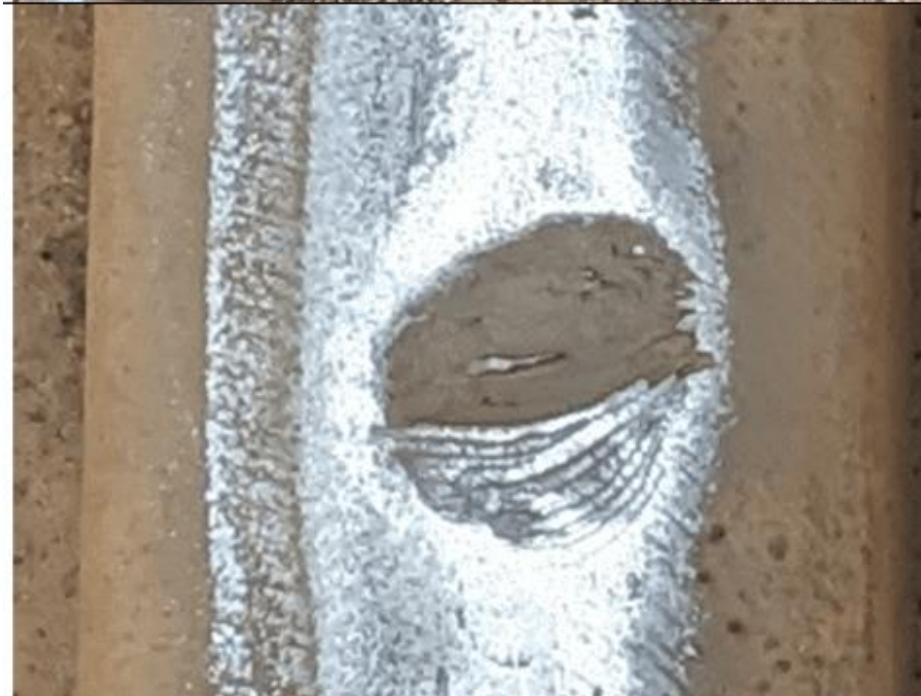
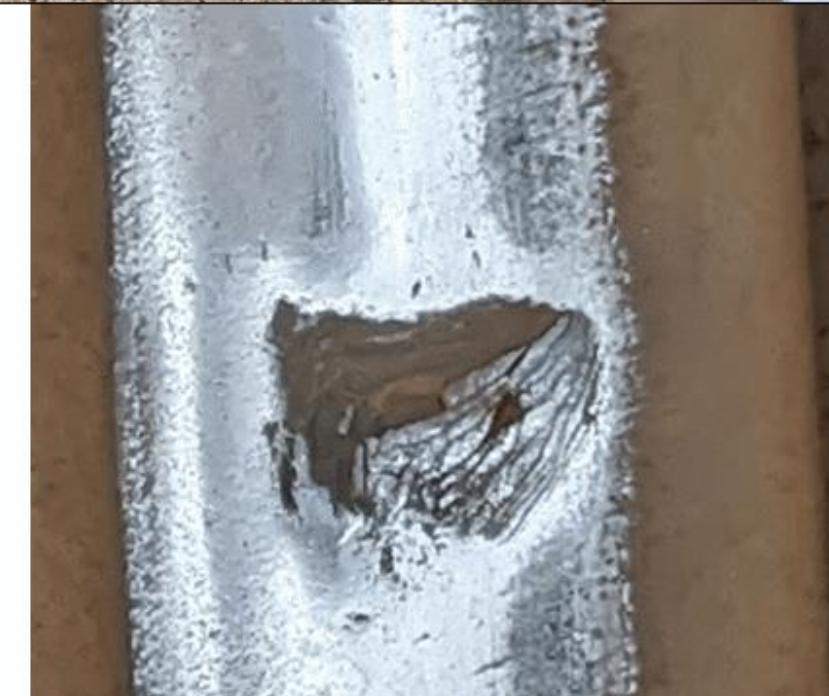
Wheel
burns

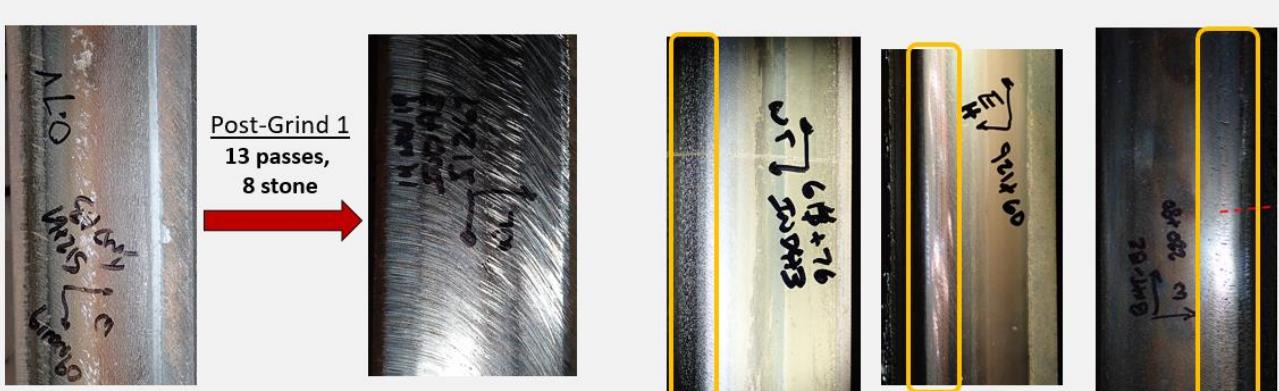
Mild Case

Rolling Contact Fatigue

RCF is a narrow band of cracks that initiate on the rail running surface and propagate into the rail subsurface, and can occur anywhere that there is wheel/rail contact.

Grind:
1 cycle

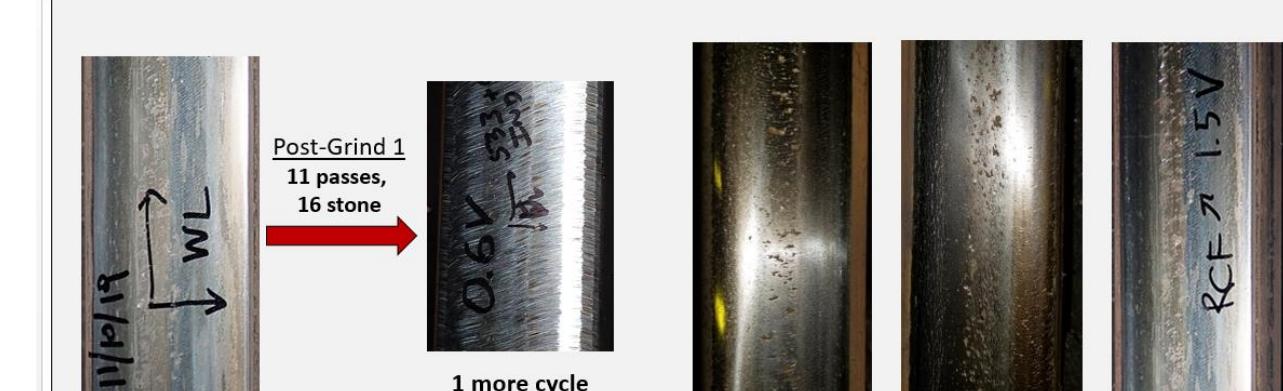
Rolling Contact Fatigue Moderate Case

RCF is a narrow band of cracks that initiate on the rail running surface and propagate into the rail subsurface, and can occur anywhere that there is wheel/rail contact.

Grind:
1-2 cycles

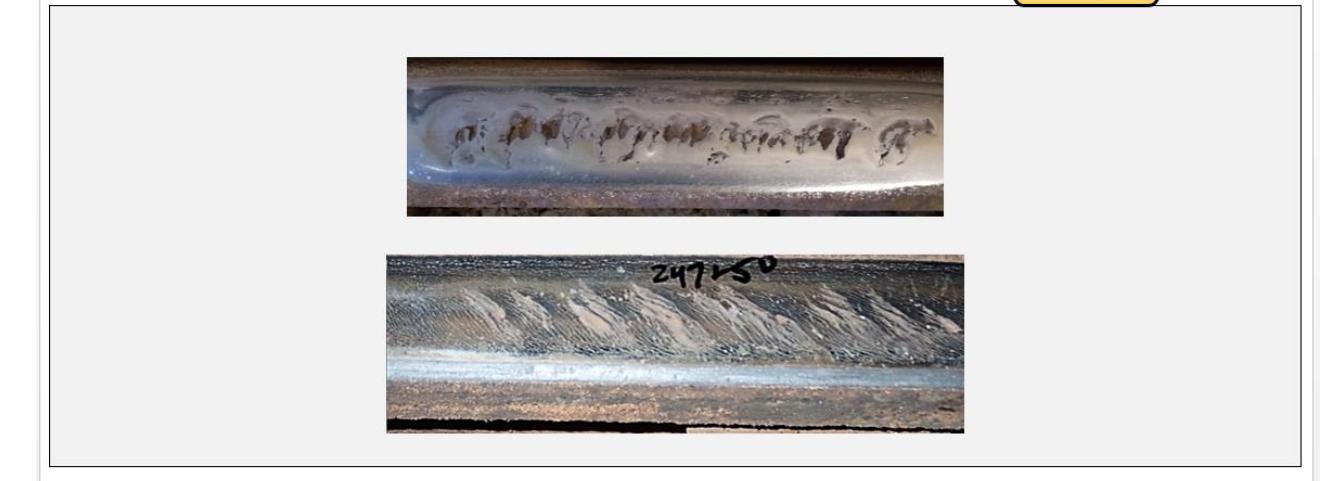
Rolling Contact Fatigue Severe Case

RCF is a narrow band of cracks that initiate on the rail running surface and propagate into the rail subsurface, and can occur anywhere that there is wheel/rail contact.

Control:
Grind to
reduce severity

Remove:
Mill to reduce
severity

**Plan for
Replacement**

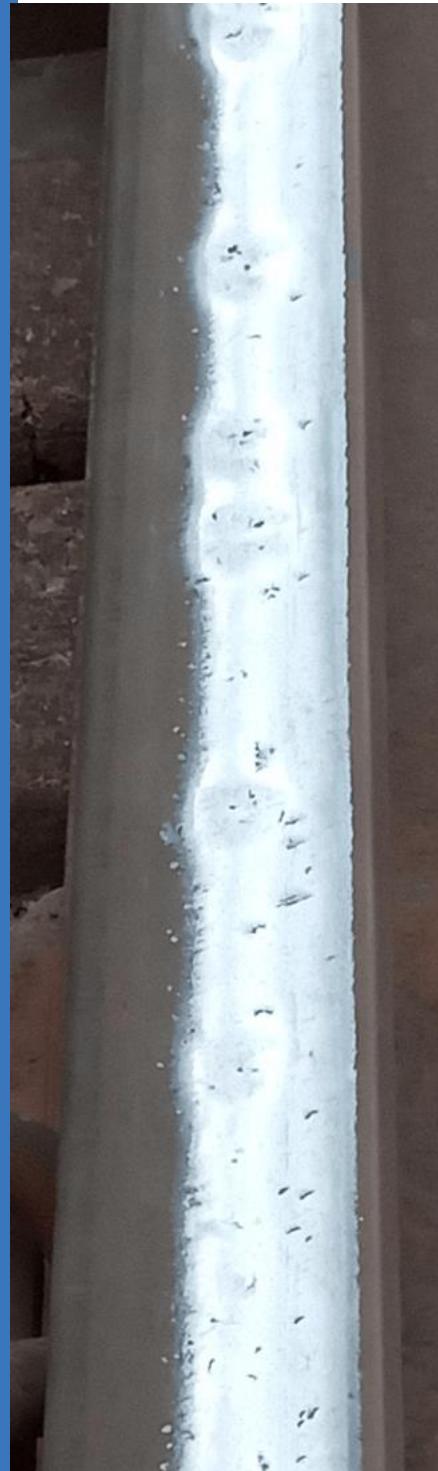
Studs – Spalls believed to be associated with wheel spin
Treatment: (possibly) traction control, preventive rail grinding, rail milling (for removal), friction management

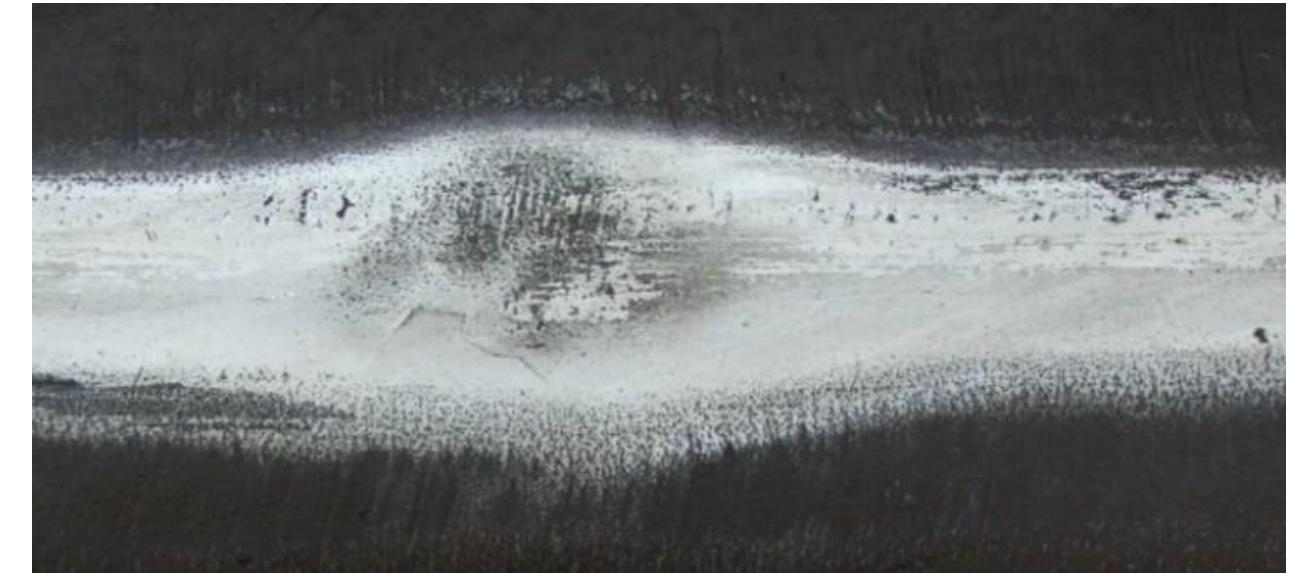
The Squat-Type Defect (stud)

- Characteristics:
 - Almost no plastic deformation
 - Formation within 10MGT or less
 - Old and new rails, tangent and curves
 - Presence of WELs
 - Not found in tunnels
- Preventive rail maintenance strategies of limited mitigation success

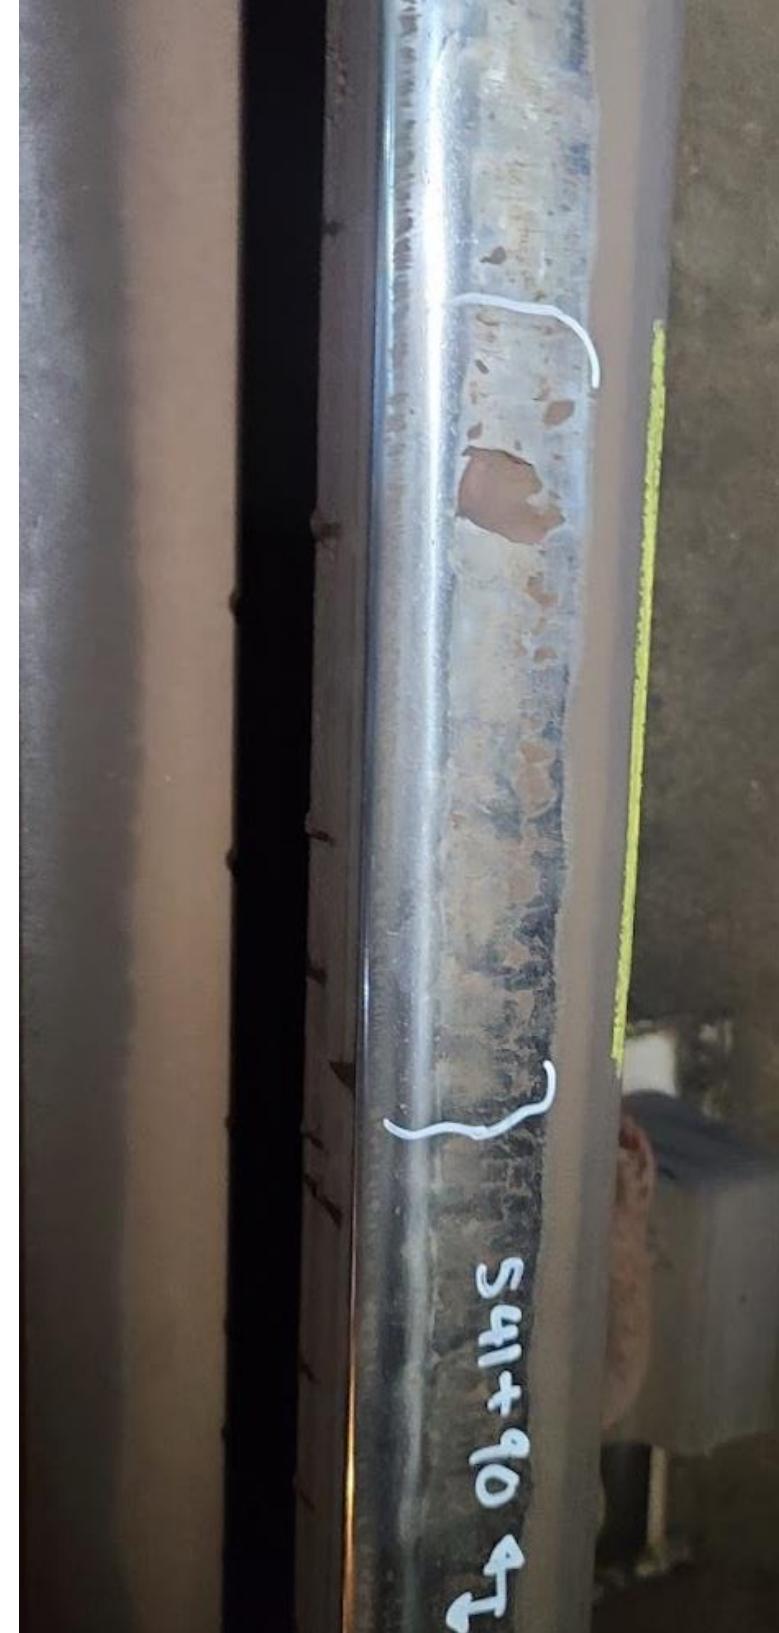
Seattle Sound Transit

- 5-mile segment of elevated track
 - Includes high speed segment (55 mph)
 - Also seen in other ballasted segments
- Occurs in tangent, curves, and grades
 - First high occurrence area was level, tangent track with corrugation
- Started in small batches and were weld head repaired, eventually ground, milled and/or replaced

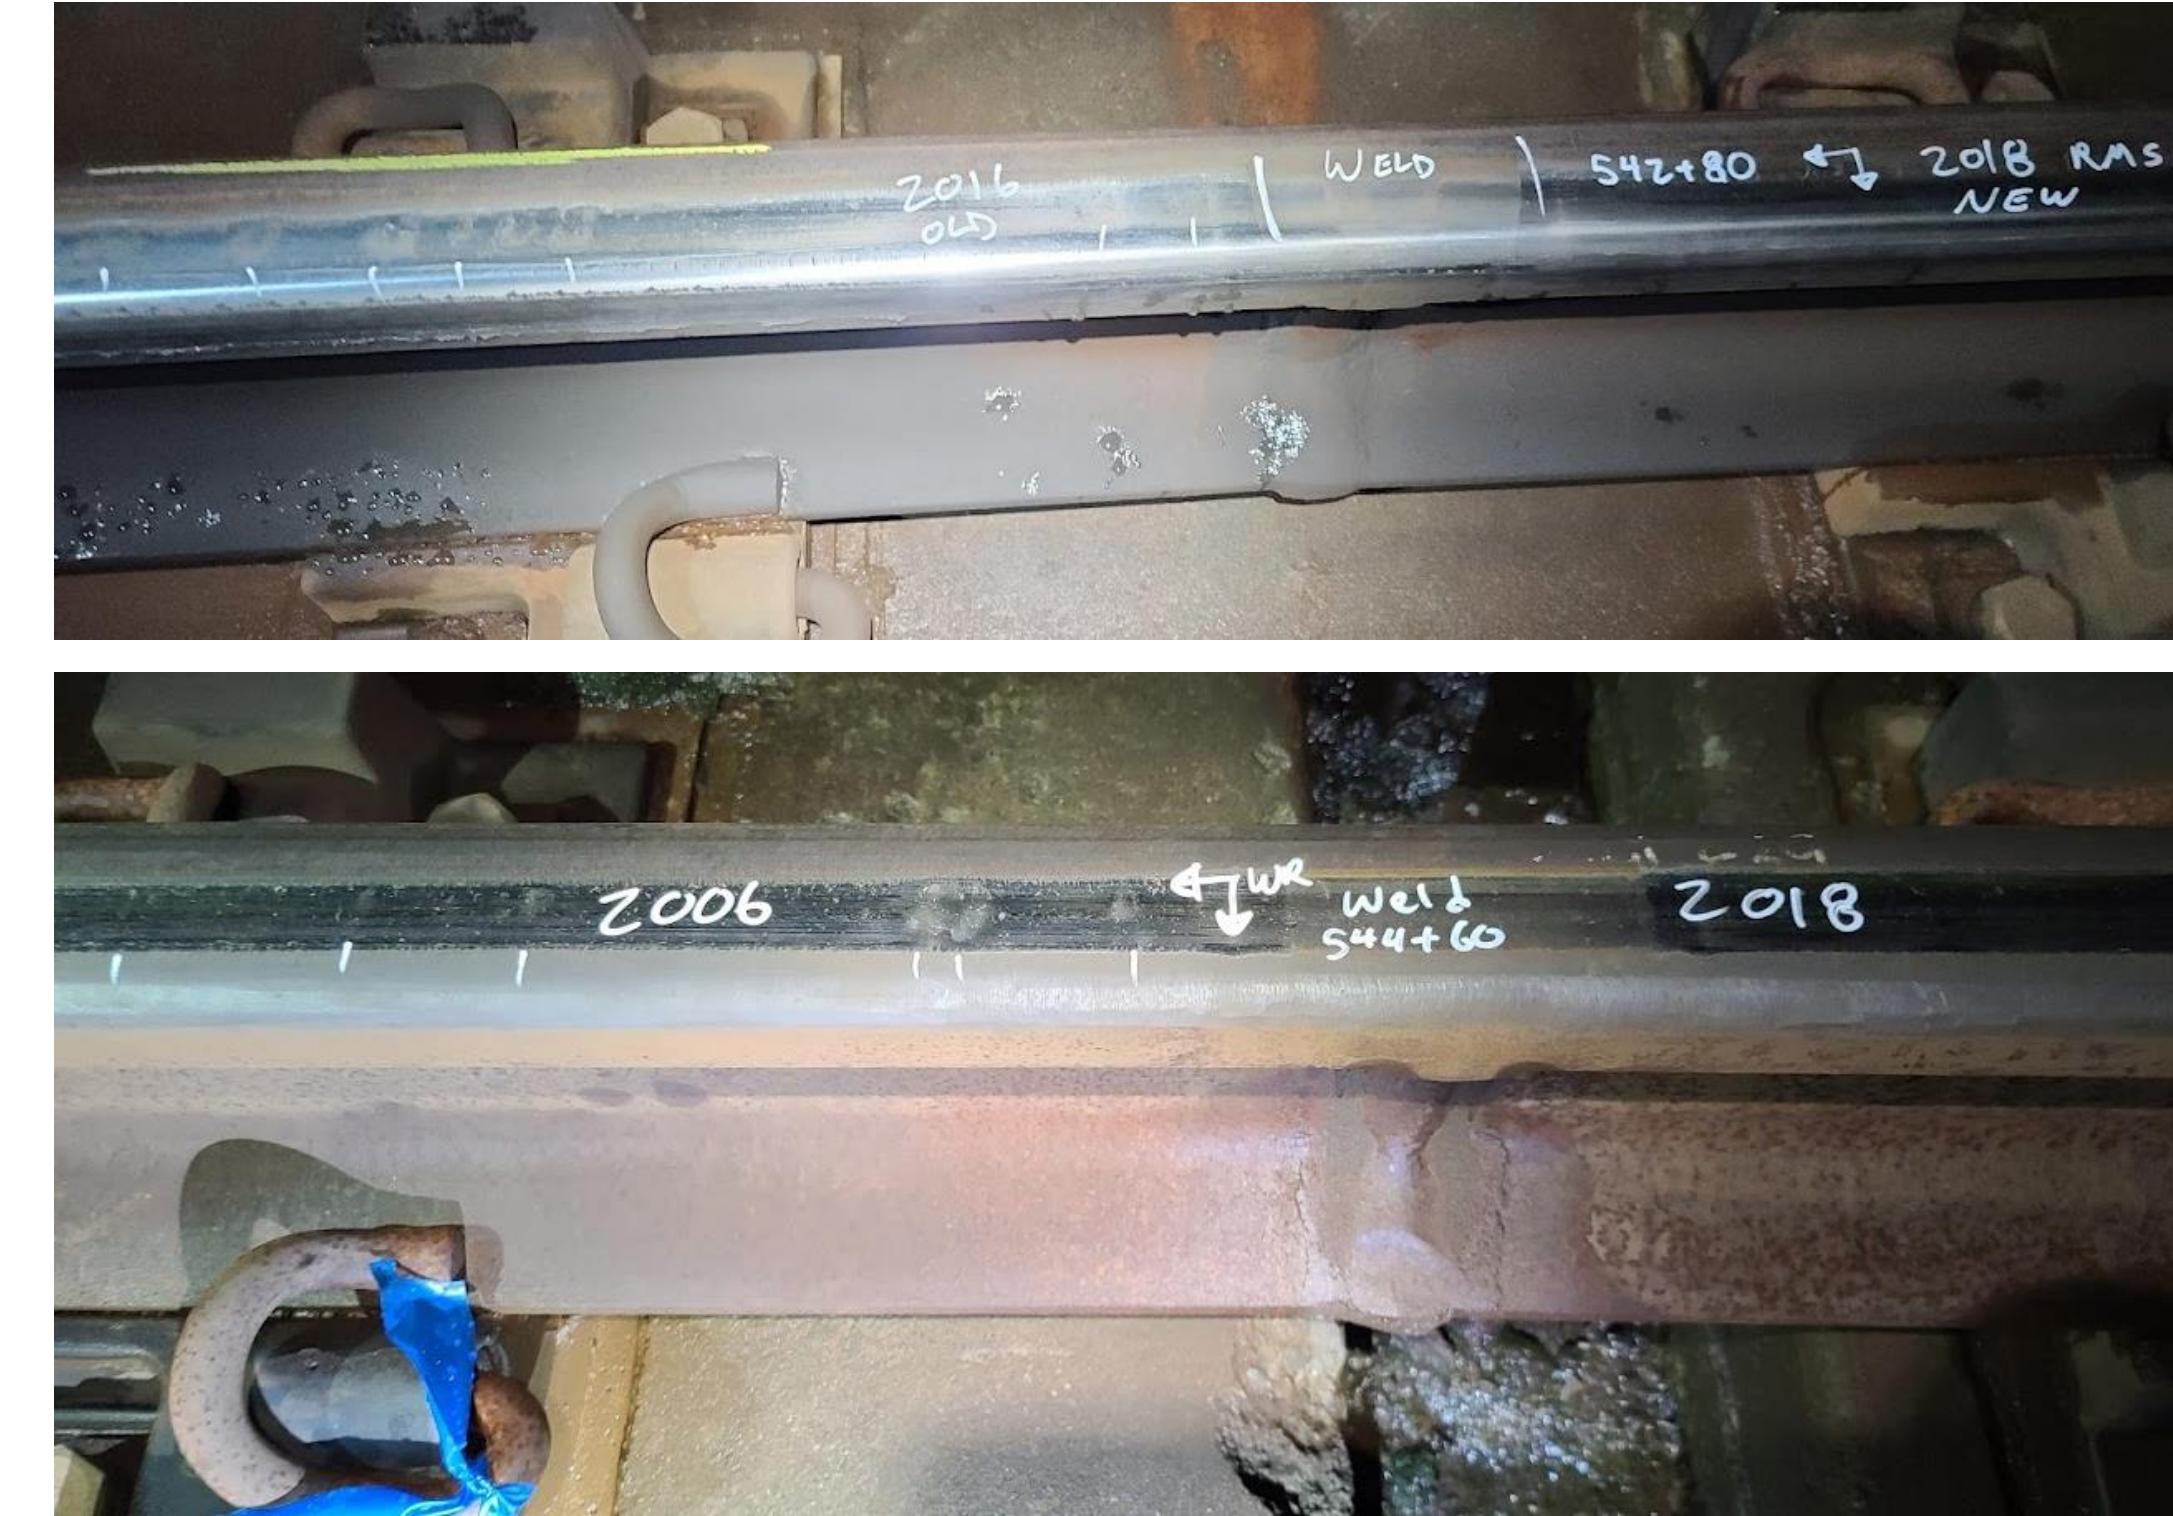
Seattle Sound Transit

- Suspected originally that defects could be associated with “bad” rail
- Defects found in almost all ages of rail but since 2018 limited recurrence

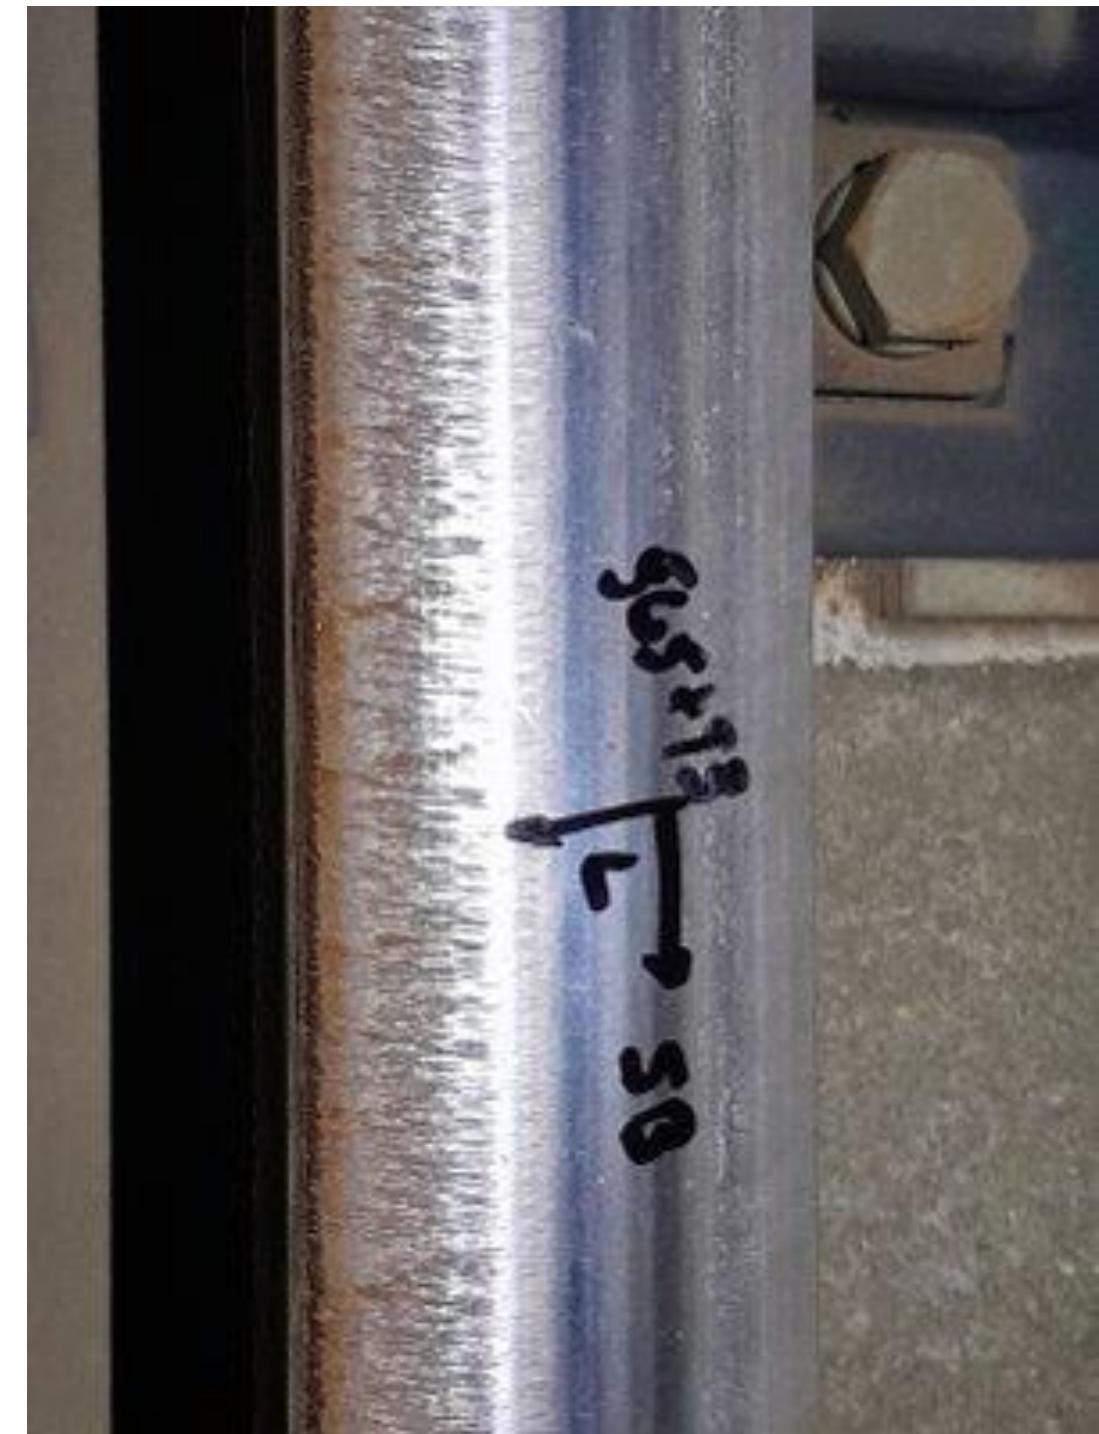
Seattle Sound Transit

- Milled rail after more than 2 years (~15 MGT) had no signs of defects returning
- Replaced rail (c. 2018 and newer) does not have the same level of studs of older rail
- Milled and replaced rail segments have been ground regularly starting in 2018
 - Area with studs had been scheduled for annual grinding

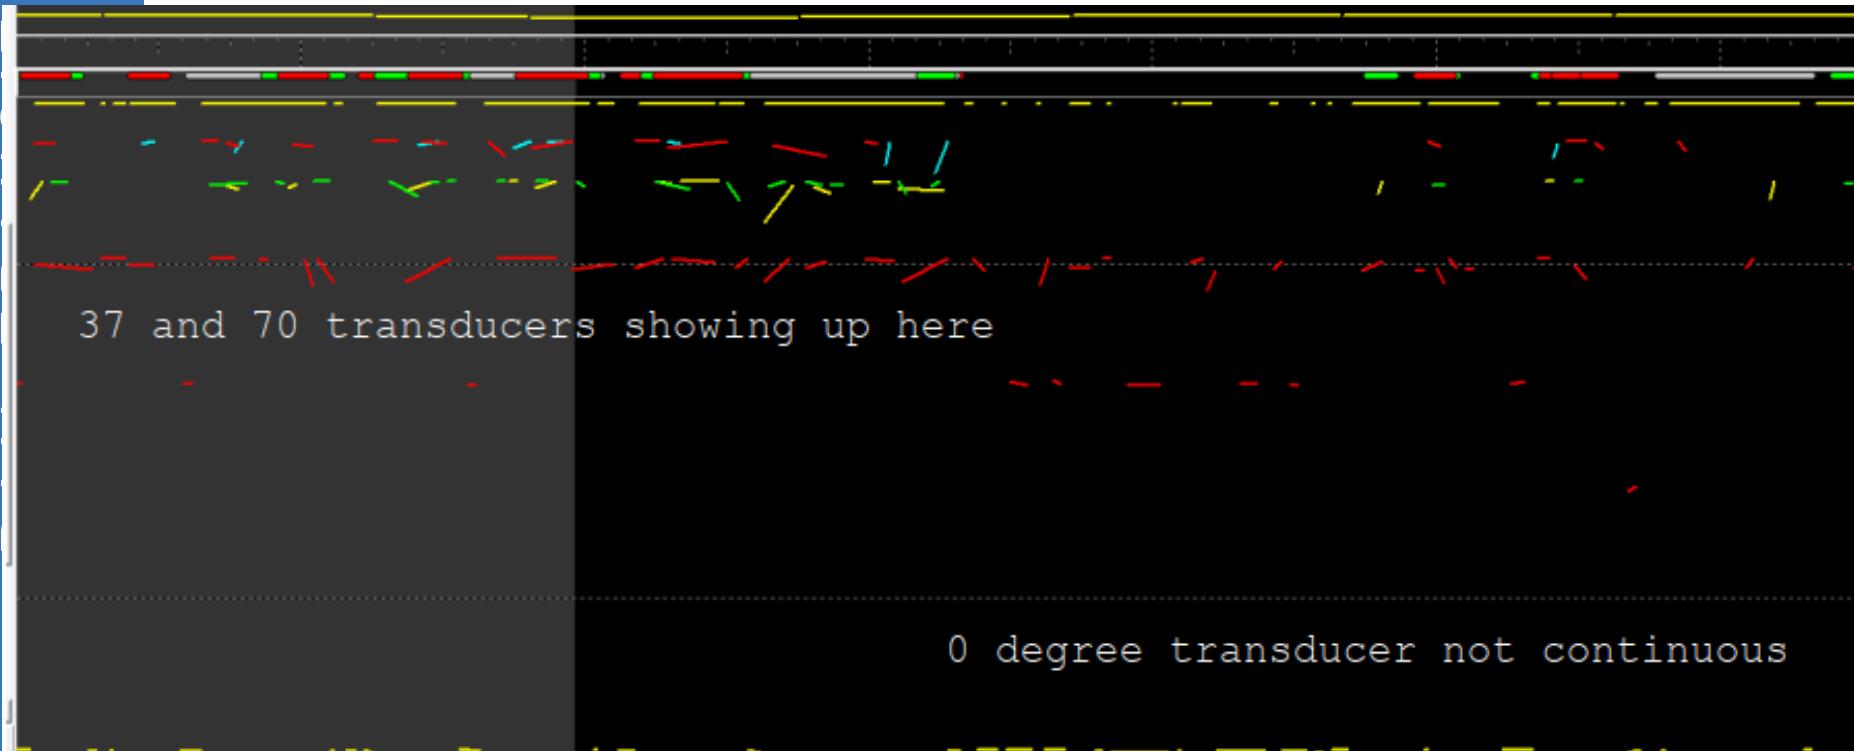
Seattle Sound Transit

- Use of eddy current and ultrasonic inspections show promise for identifying existing studs

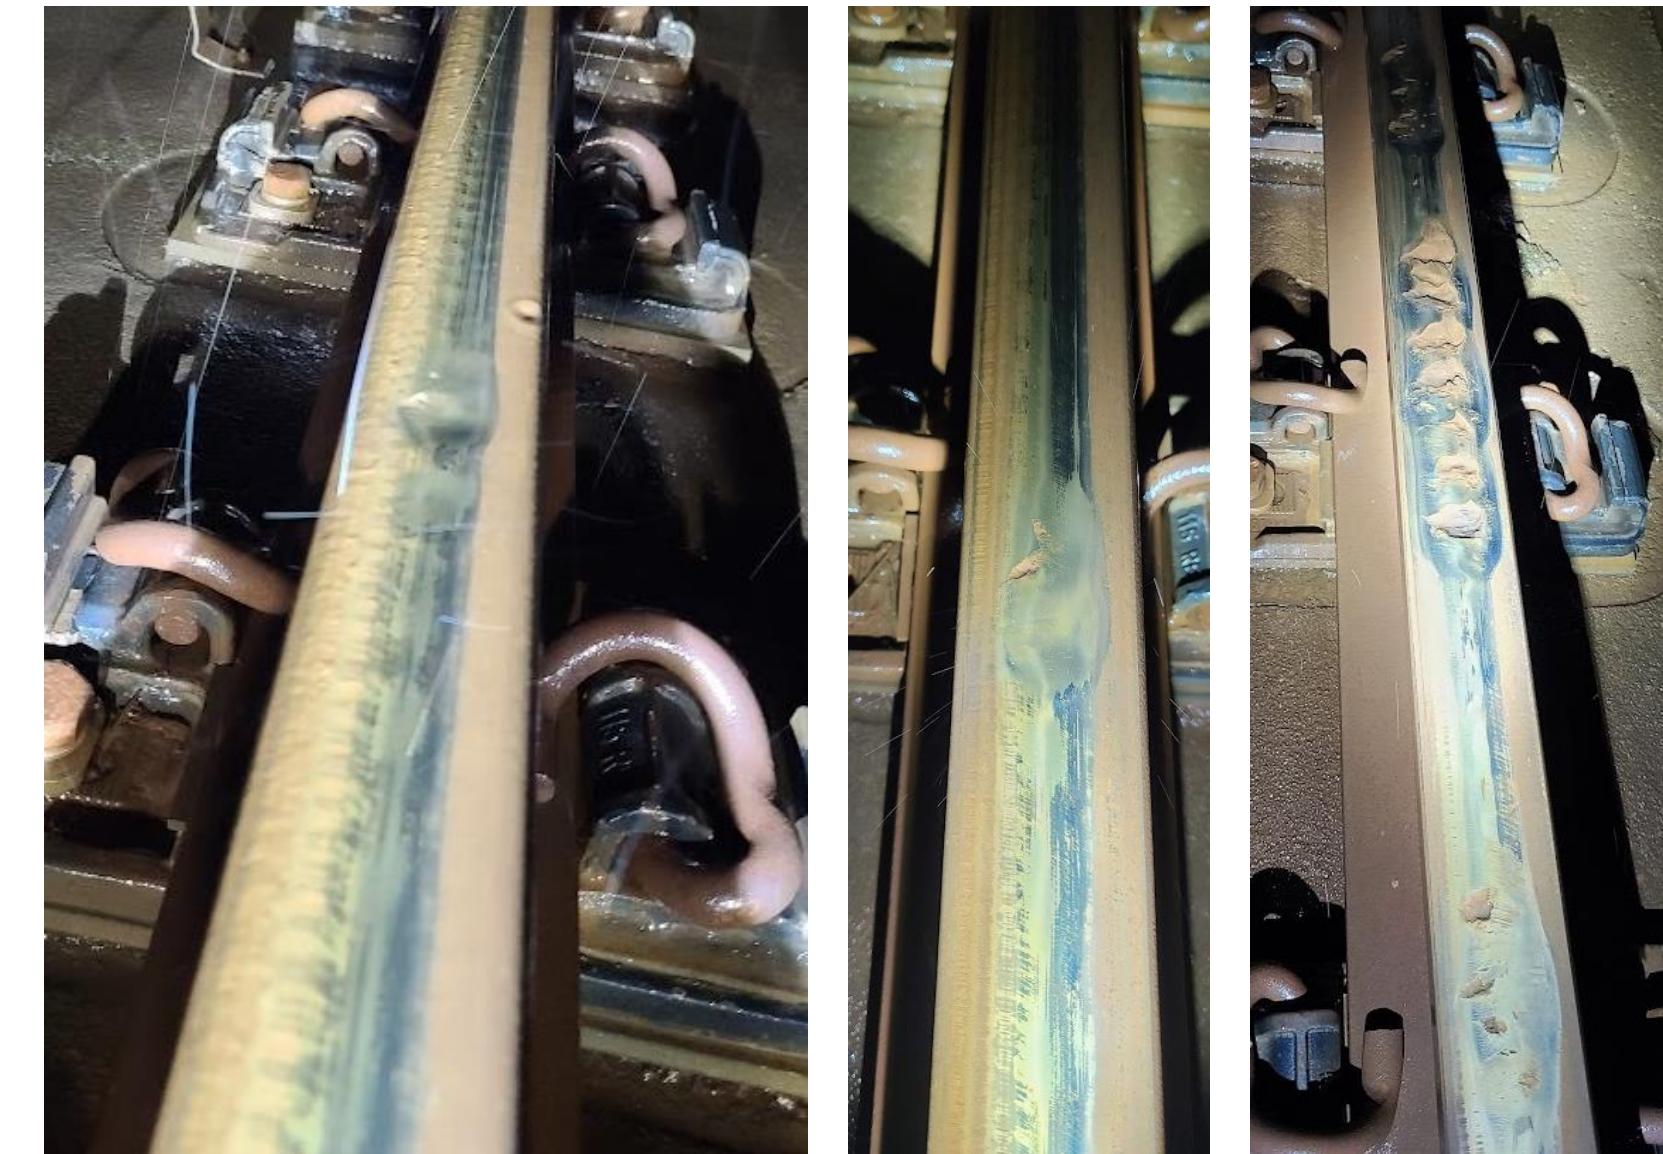
Other Metros

- Some evidence of similar type defects
 - Not as pervasive
 - No detailed study
- Annual preventive grinding
- Defects have not worsened in 5+ years
- Slowly being replaced as part of scheduled capital renewal
