## Eddy Current measuring and rail milling of defects: A case study from Finland

# Case study from rail milling by Linmag in Finland in 2025

## Case study: Rail milling in two curves

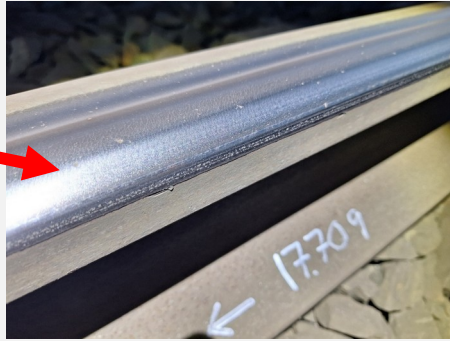
2-3 mm deep  
head checks

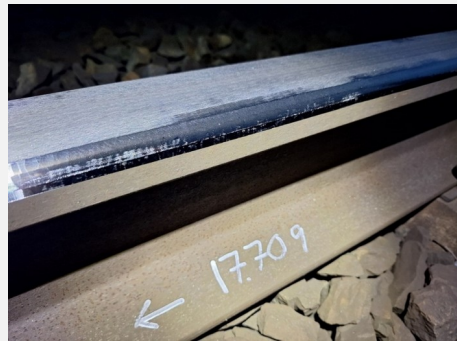
Defect free  
rails in all the  
550 m curve  
after milling  
of up to 3 mm

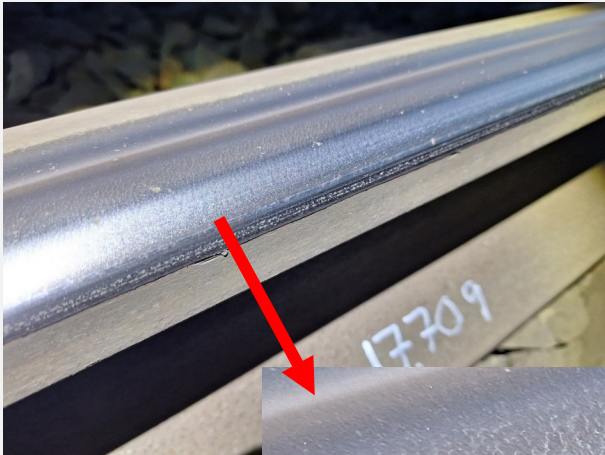
Km 17.709

Head check cracks.  
Hard to see visually!

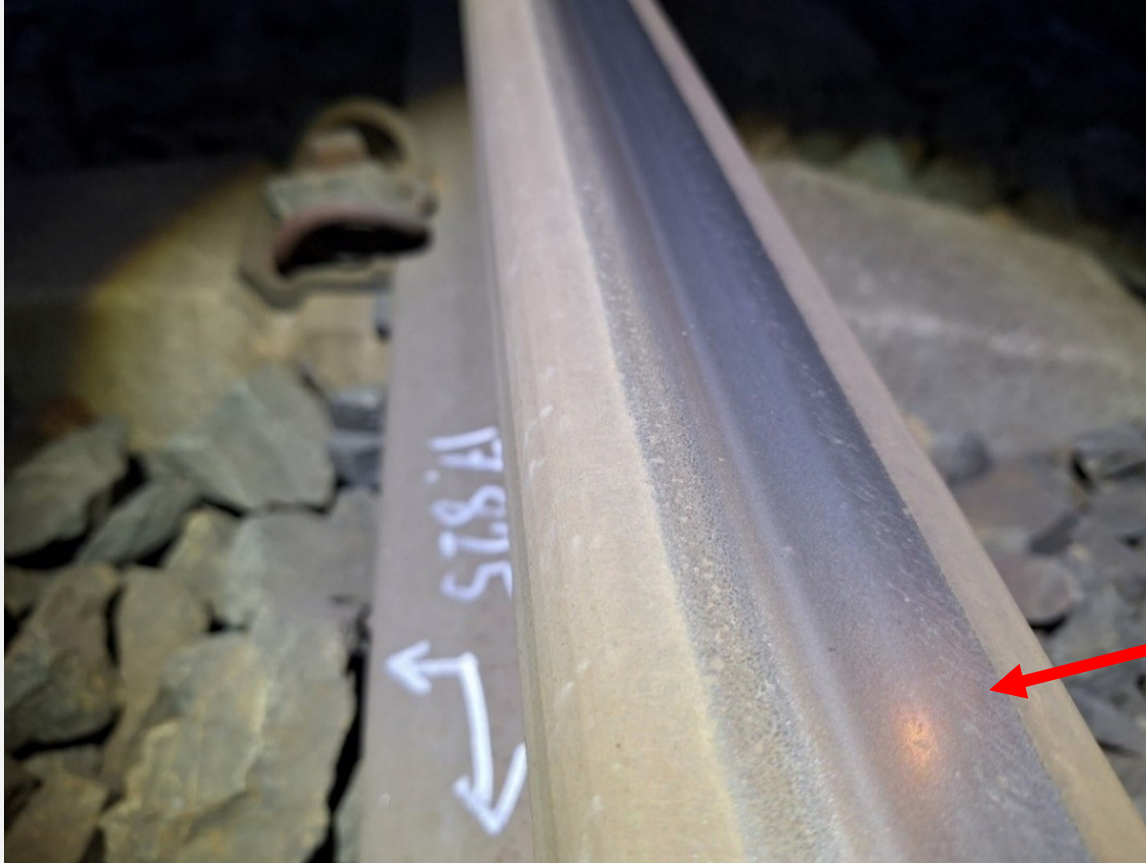
## Case 2: RCF, field side, low rail, km 17.825

(0.08 In)  
**2 mm deep  
 cracks to the  
 field site in the  
 low rail**

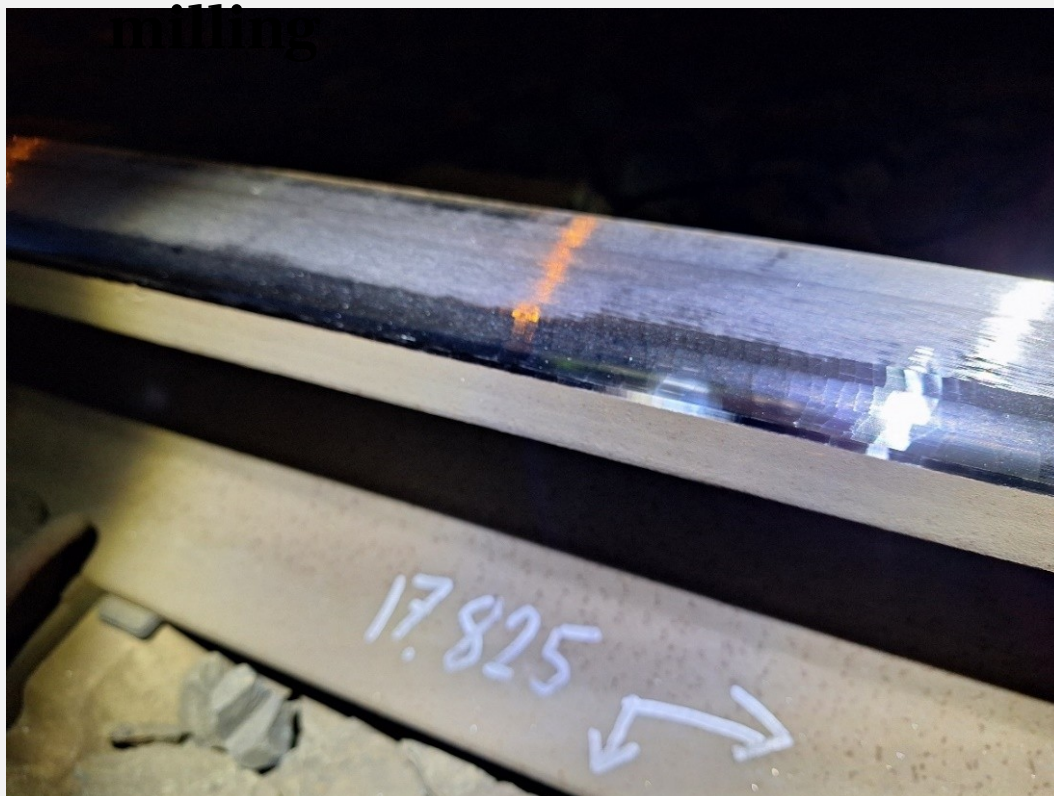
**Remaining cracks of up to approx. 1 mm in low rail to the field site.**  
(0.04 In.)

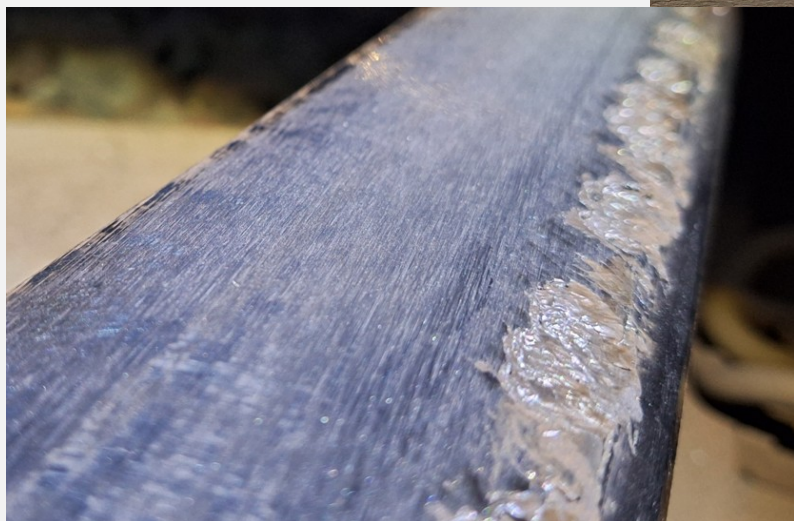
## Case 3: Head Checks in high rail km 19.415

**2 mm removed.**

**Spallation and  
damages  
reduced**

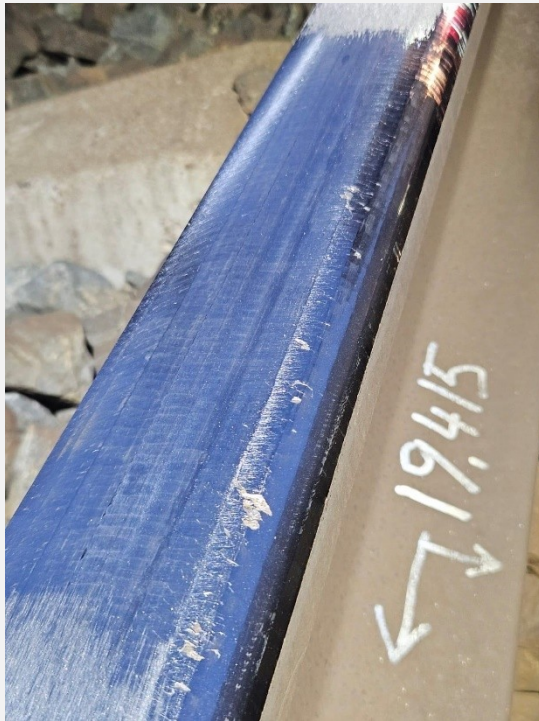
**Looks better**

**3 mm removed**

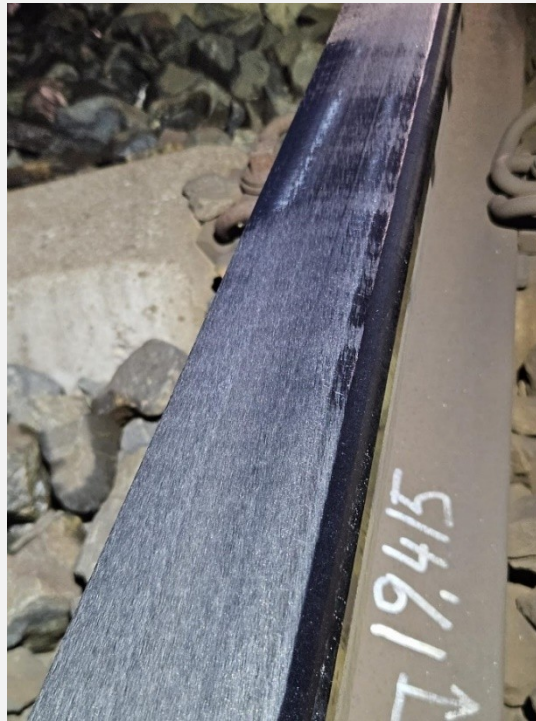
**Looks defect free**

**4 mm removed**

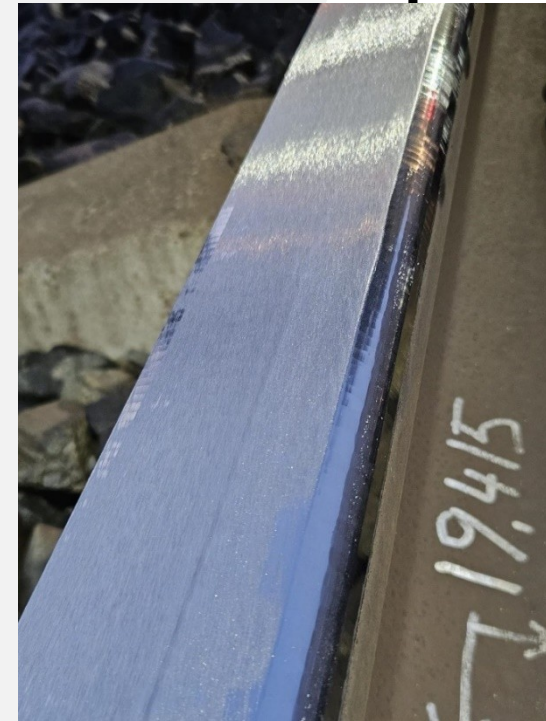
**All defects**

**5 mm removed**

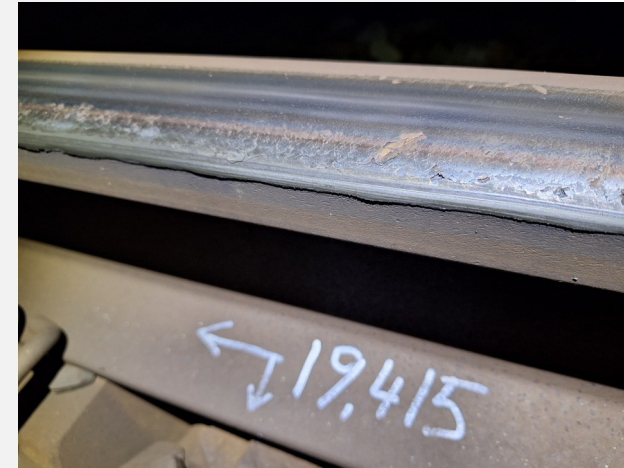
4-5 mm deep  
Head Checks  
after 10 years  
and 70 MGT

- Natural rail wear only 1.5 mm
- Removal up to 5.0 mm
- 6,5 mm and wear limit 14 mm

**The milling has at least  
doubled the rails  
lifetime**
