## Overview of Modern Component Failures in Rail Transit Environment

Joel D. Hassebrock – Sr. Consultant  
Anna J. Banks – Staff Consultant  
Engineering Systems Inc.

# Case Study 1: Failure Analysis of Passenger Wheel Tires

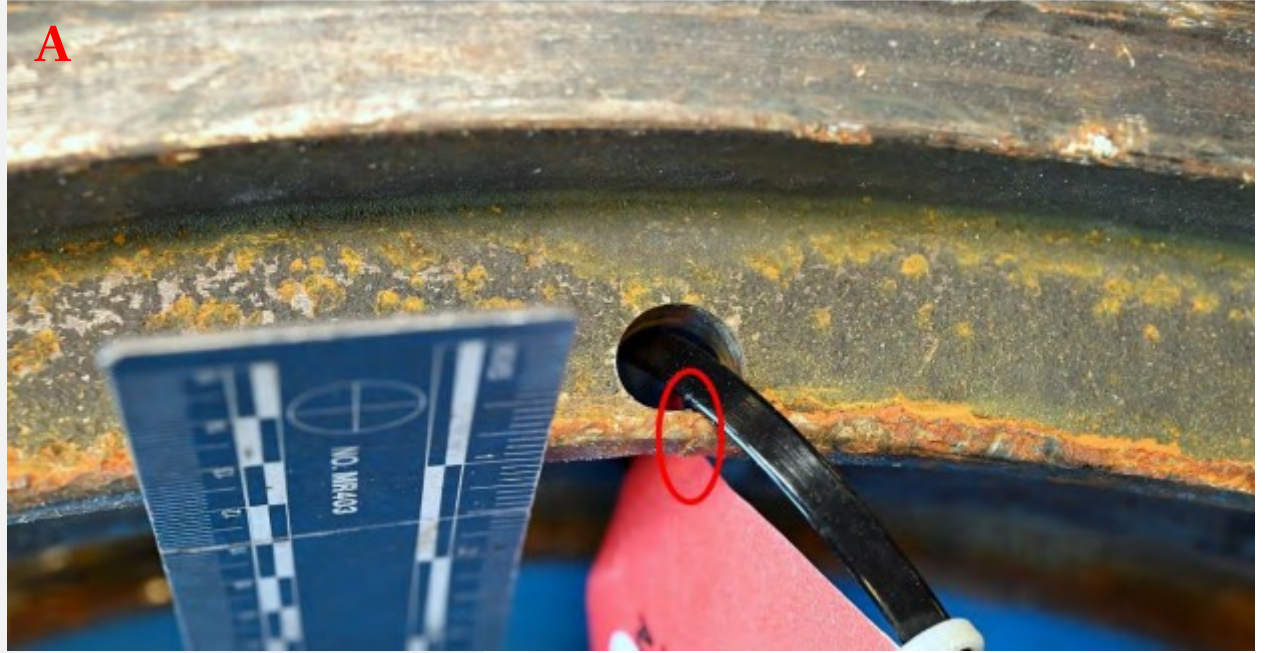
# Fractography of Fracture Surfaces

1. The flange side shunt screw hole initiation location
2. Tool marks were present from cutting of the slot
3. A stress riser from the tool marks resulted in fatigue cracking
4. The fatigue crack size was minor compared to wheel cross section

- Inspection of fleet for cracking
- Magnetic Particle testing
- Inspect incoming stock wheels for machine marks

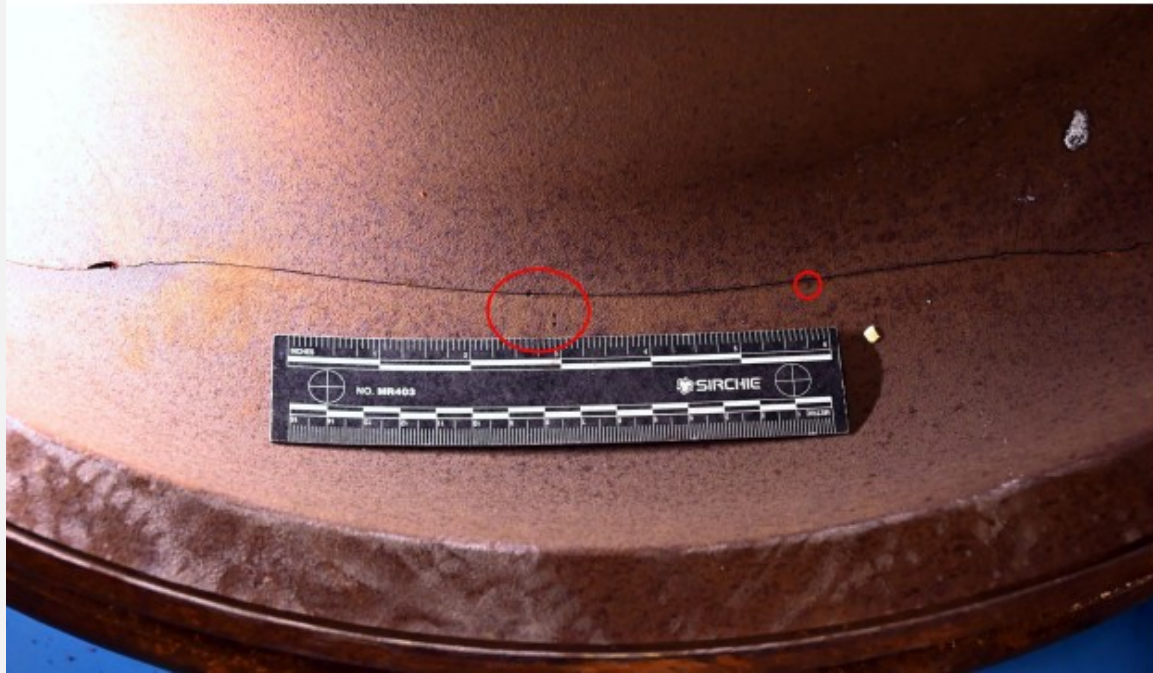
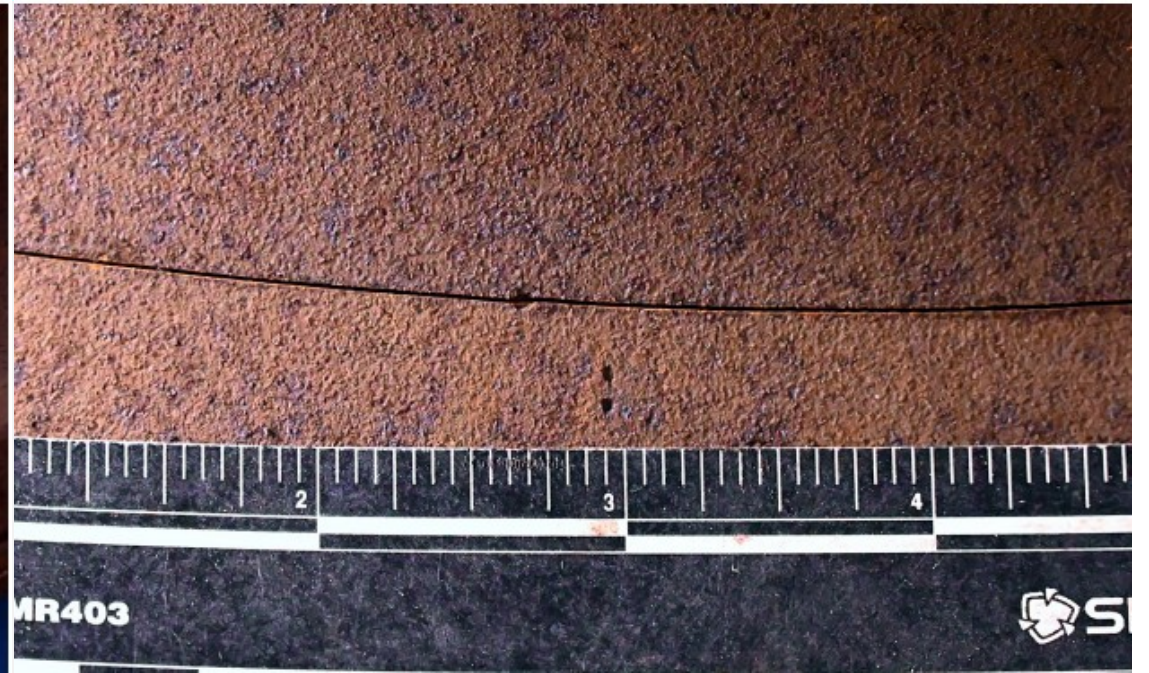
# Fractography of Fracture Surfaces

1. The wheel cracked due to fatigue cracking that initiated on the front plate of the wheel.
2. The initiation location of the fatigue crack was a corrosion pit that was 0.022 inches deep and 0.064 inches wide
3. The pitting was not widespread

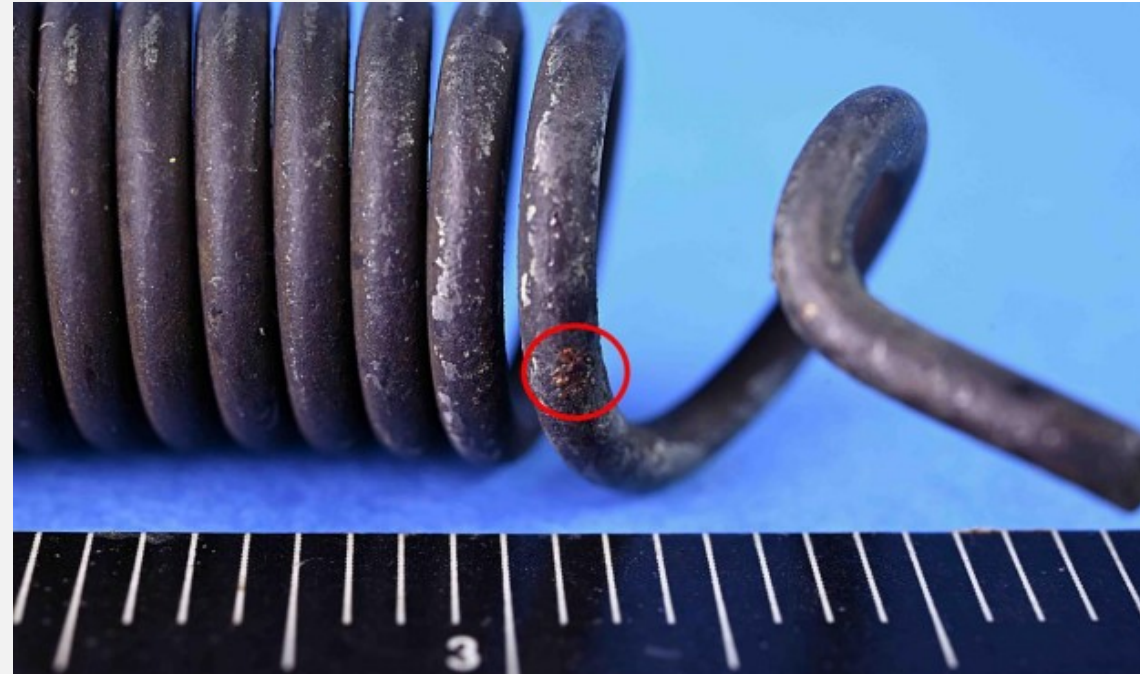
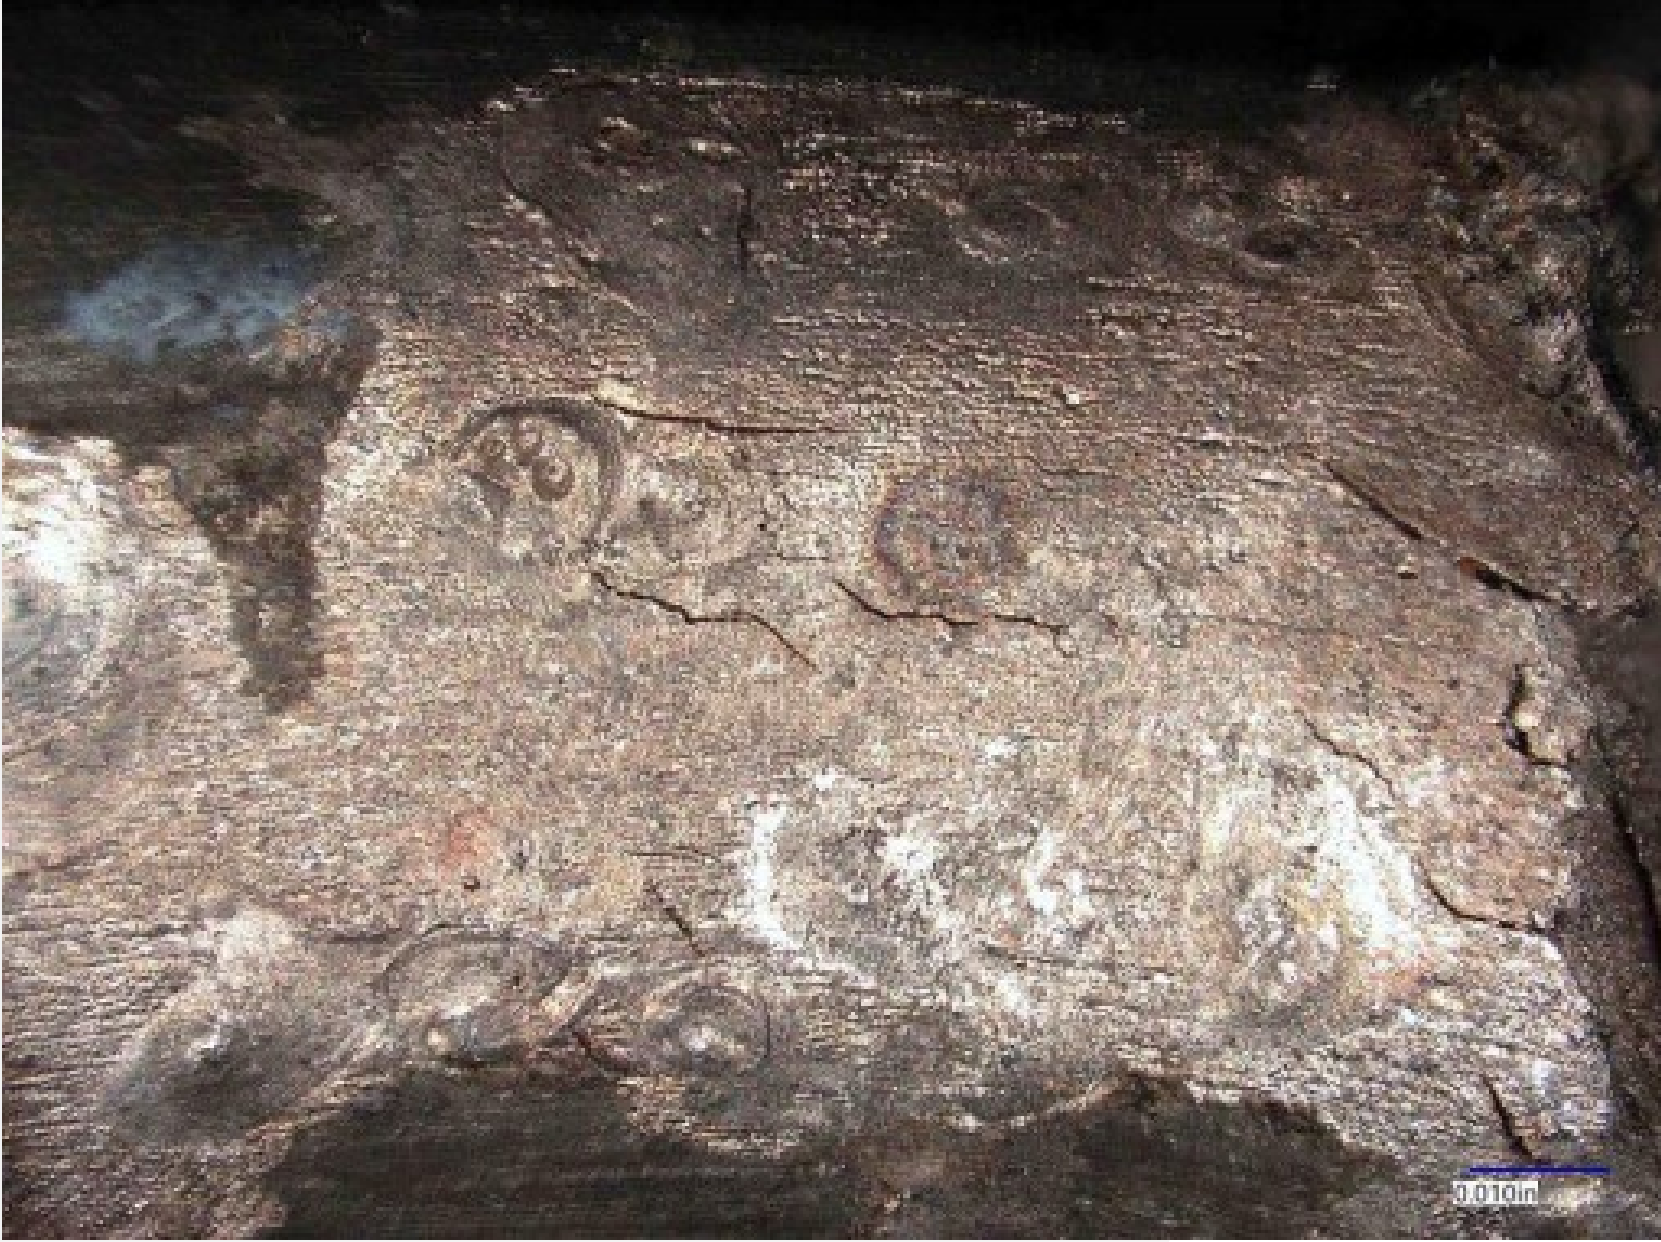
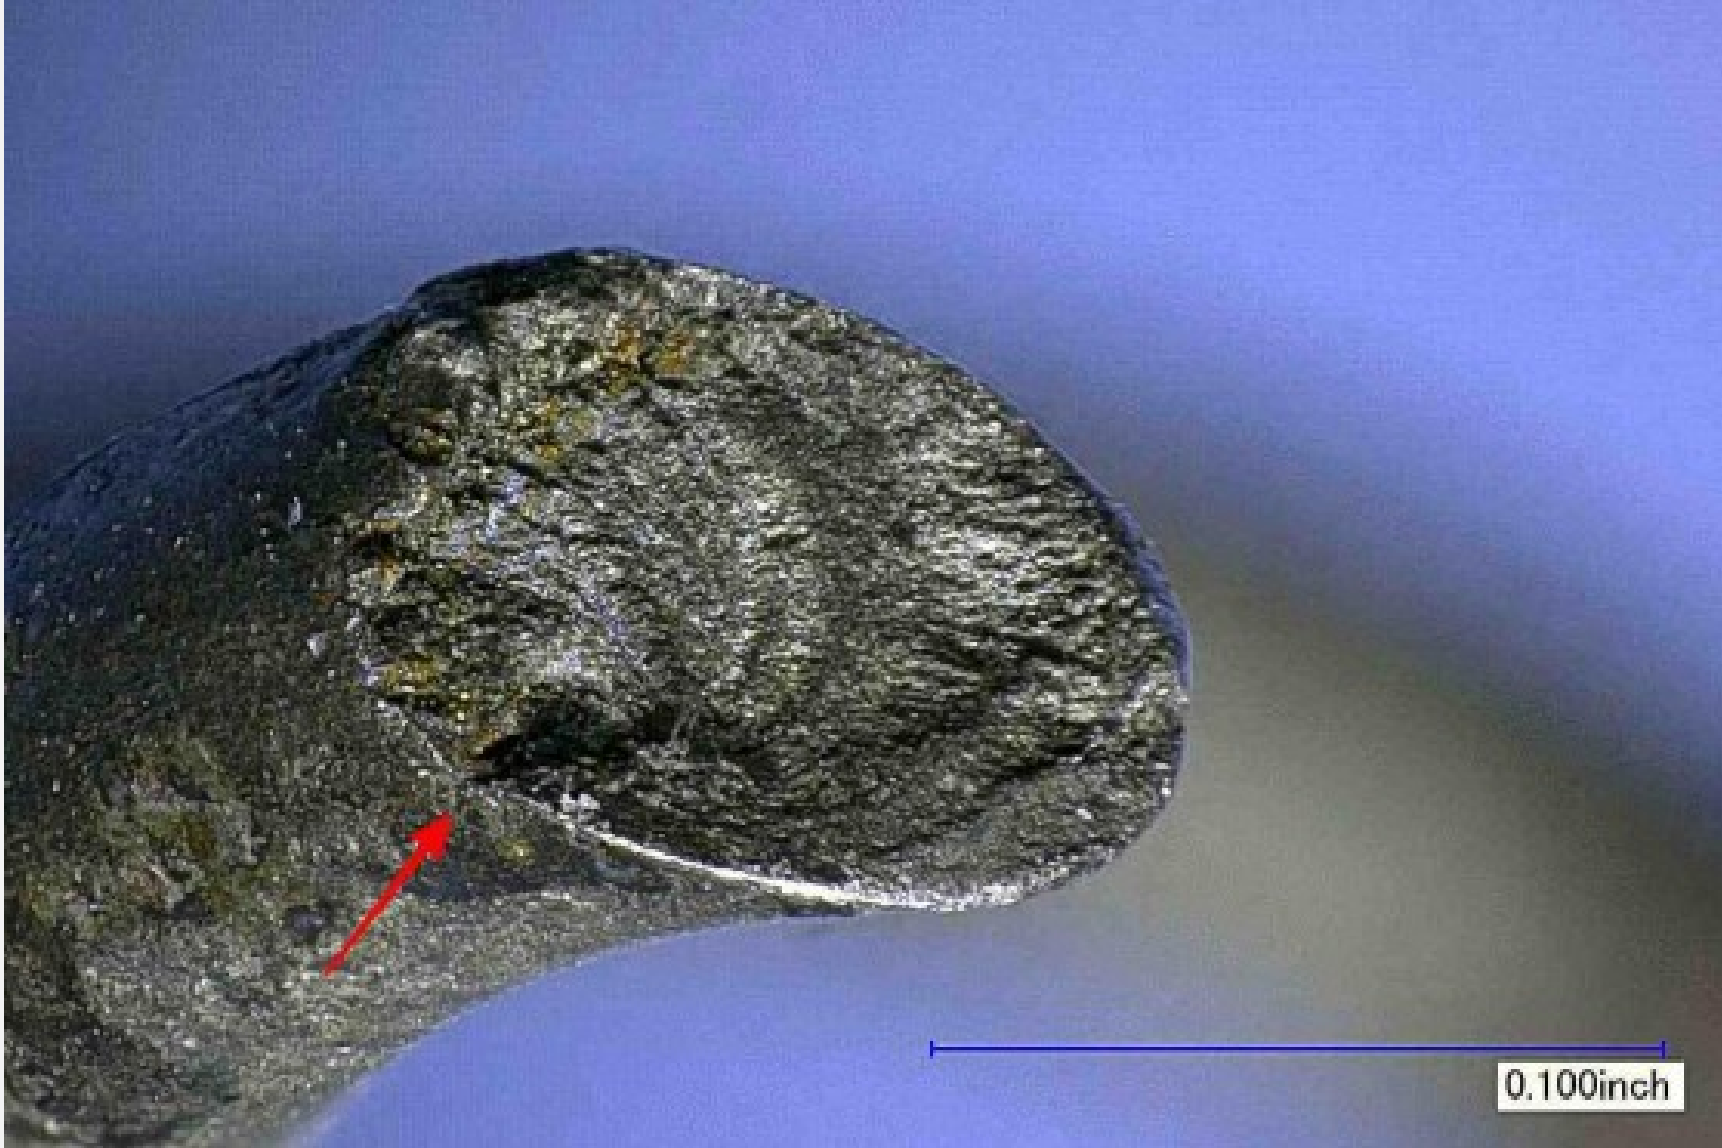
# Fractography of Fracture Surfaces

1. Failure was caused by fatigue cracking initiated from a location of electrical arcing.
2. Un-tempered martensite was present at arc locations
3. Source of arcing not identified, but copper was present at arc locations.
4. The spring ultimately failed due to heat related damage which accumulated from the multiple electrical arcing incidences.
5. The spring had been permanently deformed from its as supplied state.
