FAILURE ANALYSIS OF AN ALLOY 718

BARREL NUT FROM AN ARMY ATTACK HELICOPTER

V. K. Champagne, G. Wechsler, and M. S. Pepi

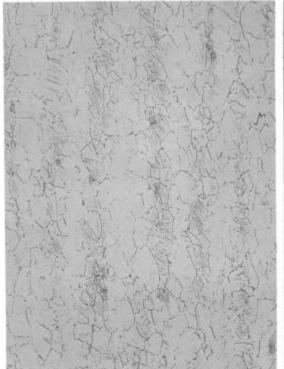
A transverse section (parallel to the fracture plane) was taken from each of the three failed barrel nuts. Figure 2 reveals the extrusion direction of barrel nut R2 which extends parallel to the direction of crack propagation. A transverse section of a Contractor B barrel nut was also examined for comparative purposes and the resultant flow pattern was perpendicular to that of the Contractor A counterpart and would be more desirable under the loading conditions encountered during service. Banding was also observed in both the Contractor A and Contractor B barrel nuts running in the same direction as their respective flow patterns. The Contractor A material displayed heavy banding which consisted primarily of MC carbides and delta phase in the form of a Widmanstätten structure. An acicular delta phase was also observed surrounding much of the grain boundaries, as shown in Figure 3. The Contractor B material contained only slight evidence of banding which was comprised primarily of MC carbides as shown in Figure 4. The Contractor A sample contained a large concentration of delta phase in the form of a Widmanstätten structure while the Contractor B material did not. The MC carbides which were aligned preferentially in the extrusion direction seemed to be found in clusters more often in the Contractor A material. The grain boundary delta phase was in the form of an acicular structure in the Contractor A material while the Contractor B material contained a more spherodized structure. Figure 5 is an optical micrograph representative of the Contractor A material at high magnification. The grains are almost completely surrounded by an acicular delta phase whereas the Contractor B microstructure contained a more spherodized grain boundary delta phase which surrounded a significantly smaller percentage of the grains, as depicted in Figure 6. The etchant used during this examination consisted of 100 ml of ethyl alcohol added to 100 ml of hydrochloric acid and 5 grams of cupric chloride.

Figure 2. Extrusion direction of nut "R2", parallel to crack. Mag. 20x.

- 6. The extrusion direction should be aligned parallel to the principal stress.

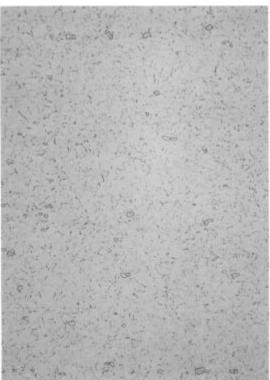
Figure 3. Nut "H" microstructure showing banding and Widmanstätten delta phase in the extrusion direction. Mag. 200x.
