MICROSTRUCTURE COMPARISON OF HIGH STRENGTH INCONEL 718 NUTS

Daniel P. Dennies, Ph.D.

The Boeing Company

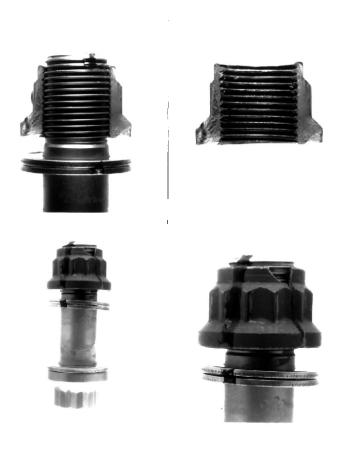
Figure 1: Split Inconel 718 Nut

One of the most difficult failure investigations to perform concerns delayed failure. In the spring of 2000, a 220-ksi strength Inconel 718 nut was found to have failed sometime after installation. The fractured nut was discovered when part of an expendable launch vehicle static fire test structure was requested from a Boeing storage facility, approximately 4 months after nut installation. Upon removal of the assembly from storage, one of the 16 installed nuts was discovered to have split in half.

This failure was interesting for two reasons. One, in fastener systems, it is more common for the bolt to fail than the nut. And two, the nut was split completely in half, not just fractured on one side. The exact clocking of the nut position on the bolt could be determined by the torque stripe markings, which were applied when the nut was installed (Figure 1).

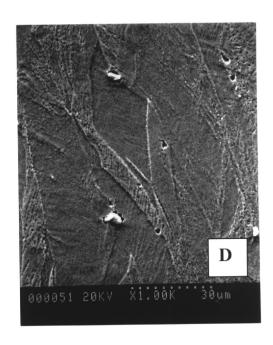
Figure 6: Vendor B Lot 1 TMP Grains

Note: 1) "Warm-Worked" Grain Structure
2) No Grain Boundary Precipitates
