**project spotlight**

# THE CHERRY FACTORY

**BROOKLYN, NY**

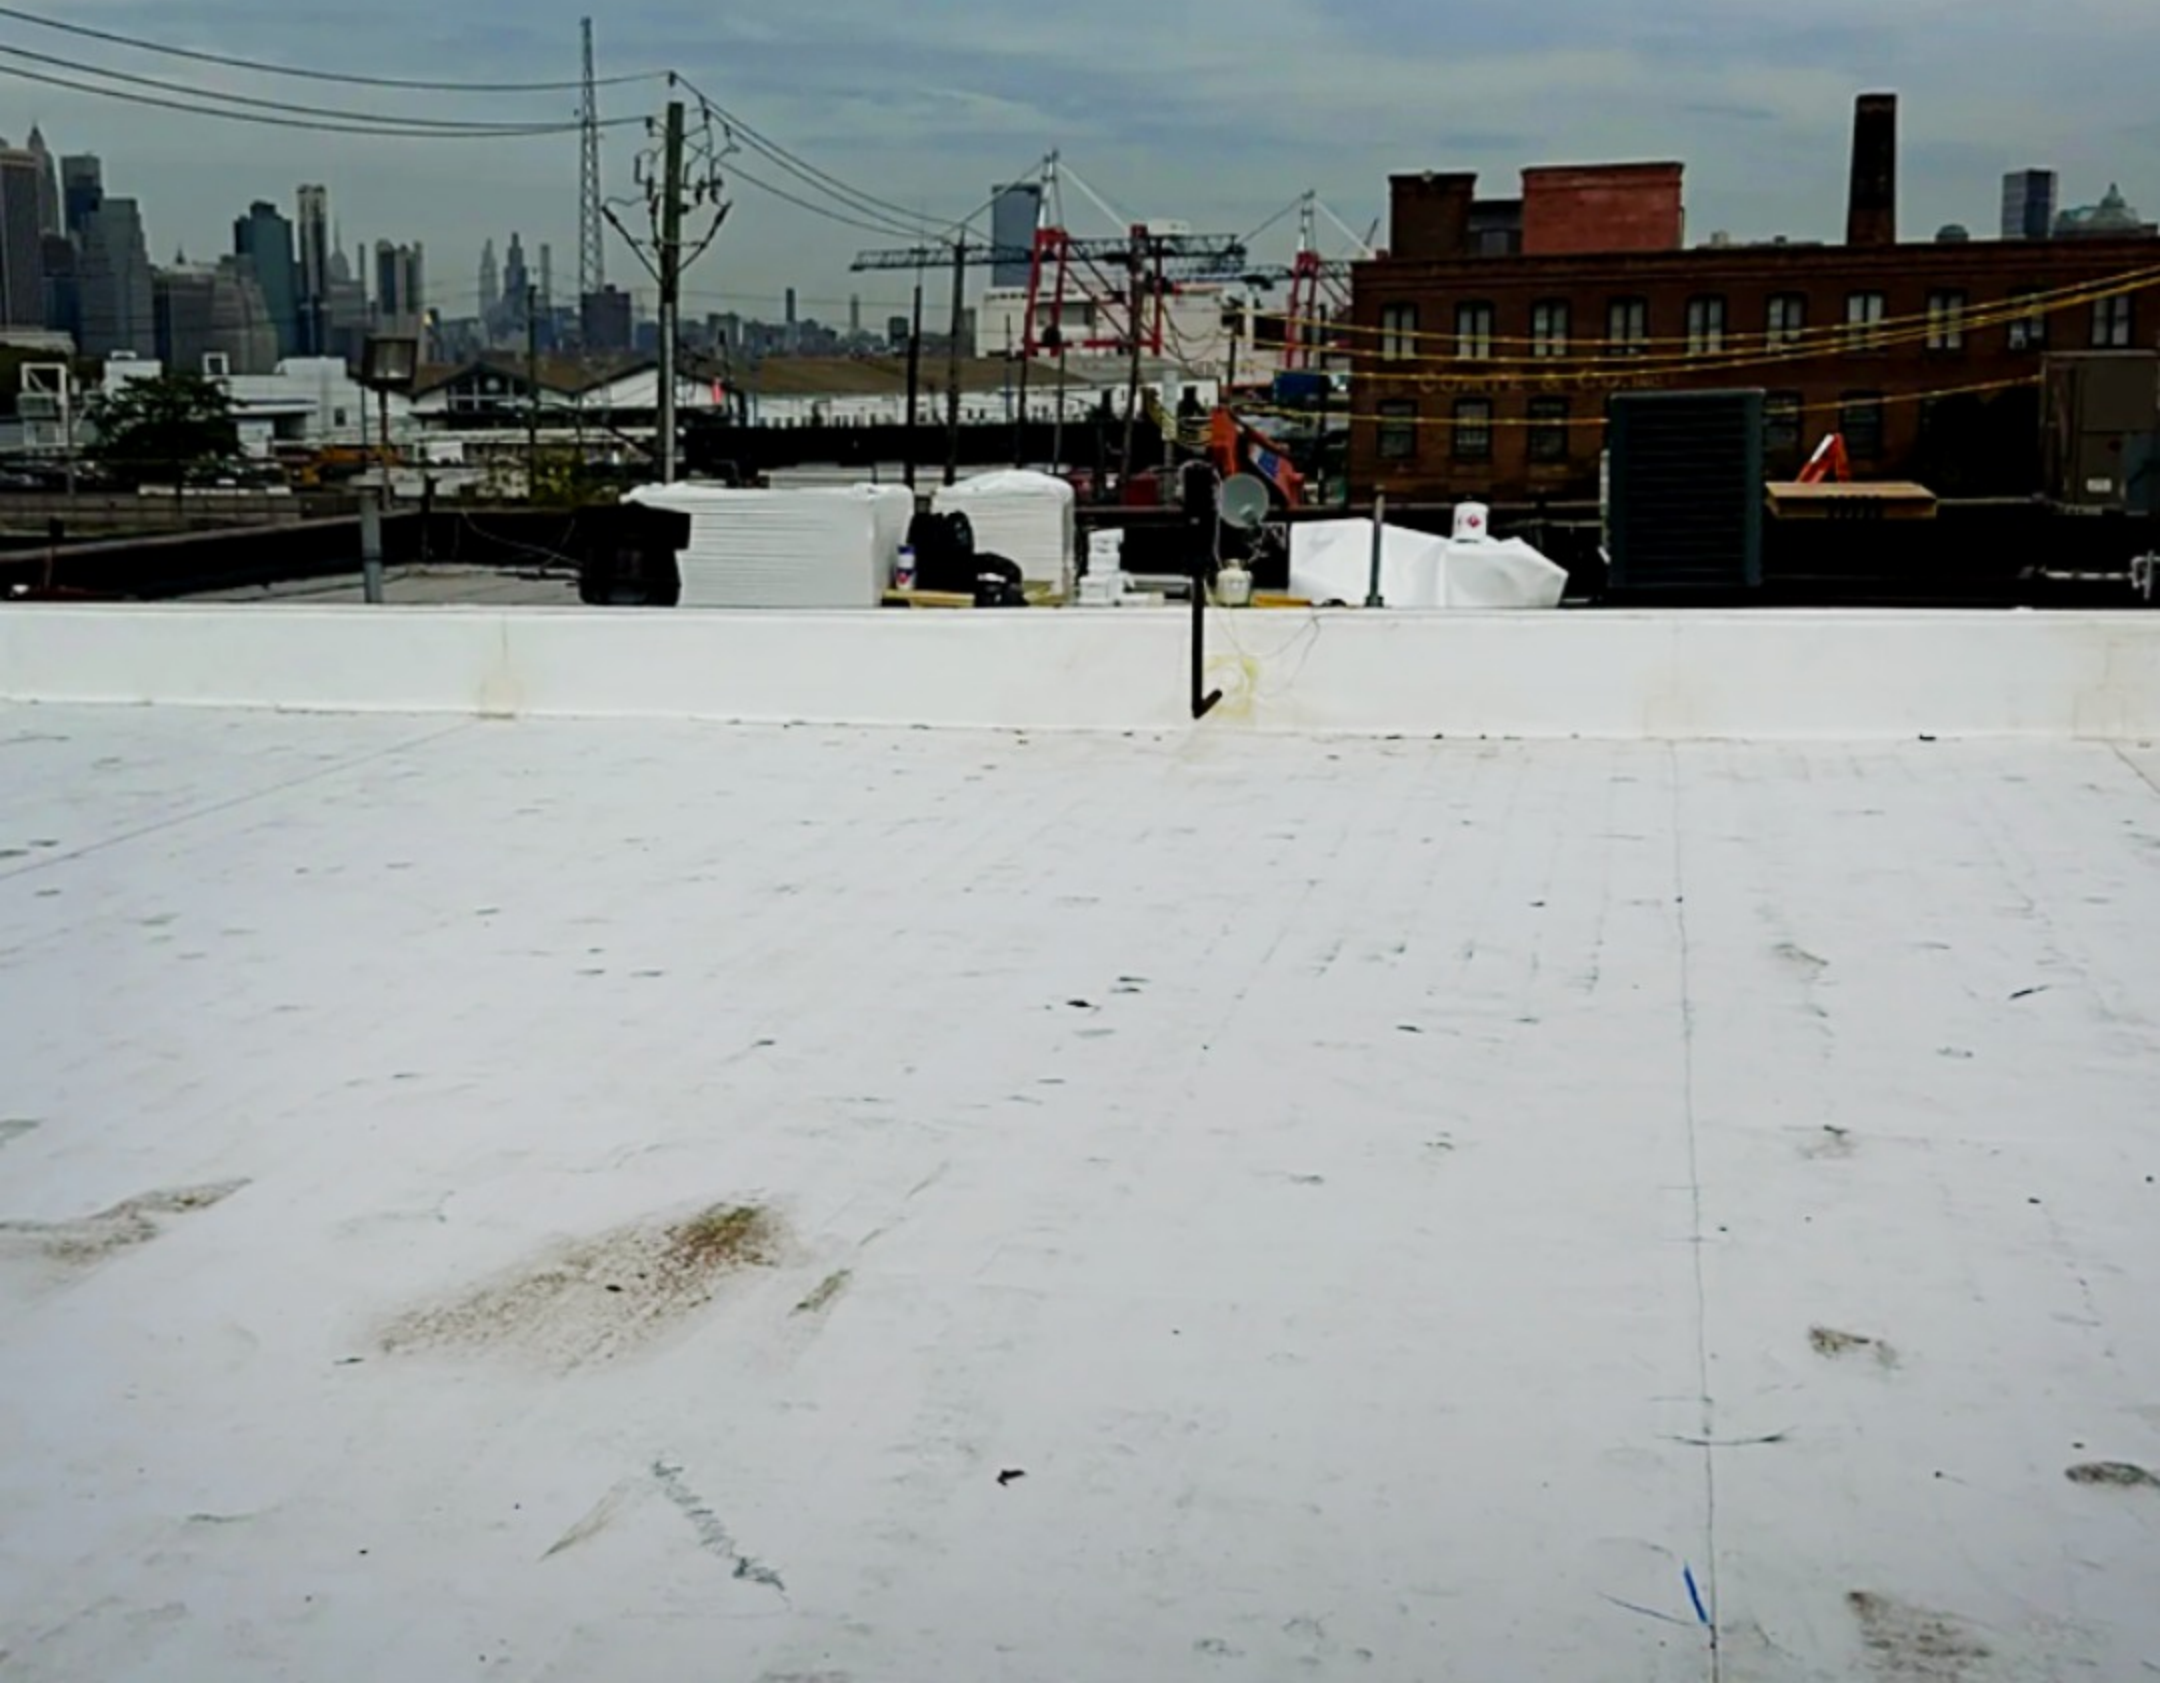
part of the old roof

# BLEW OFF

so the rest of it came off too

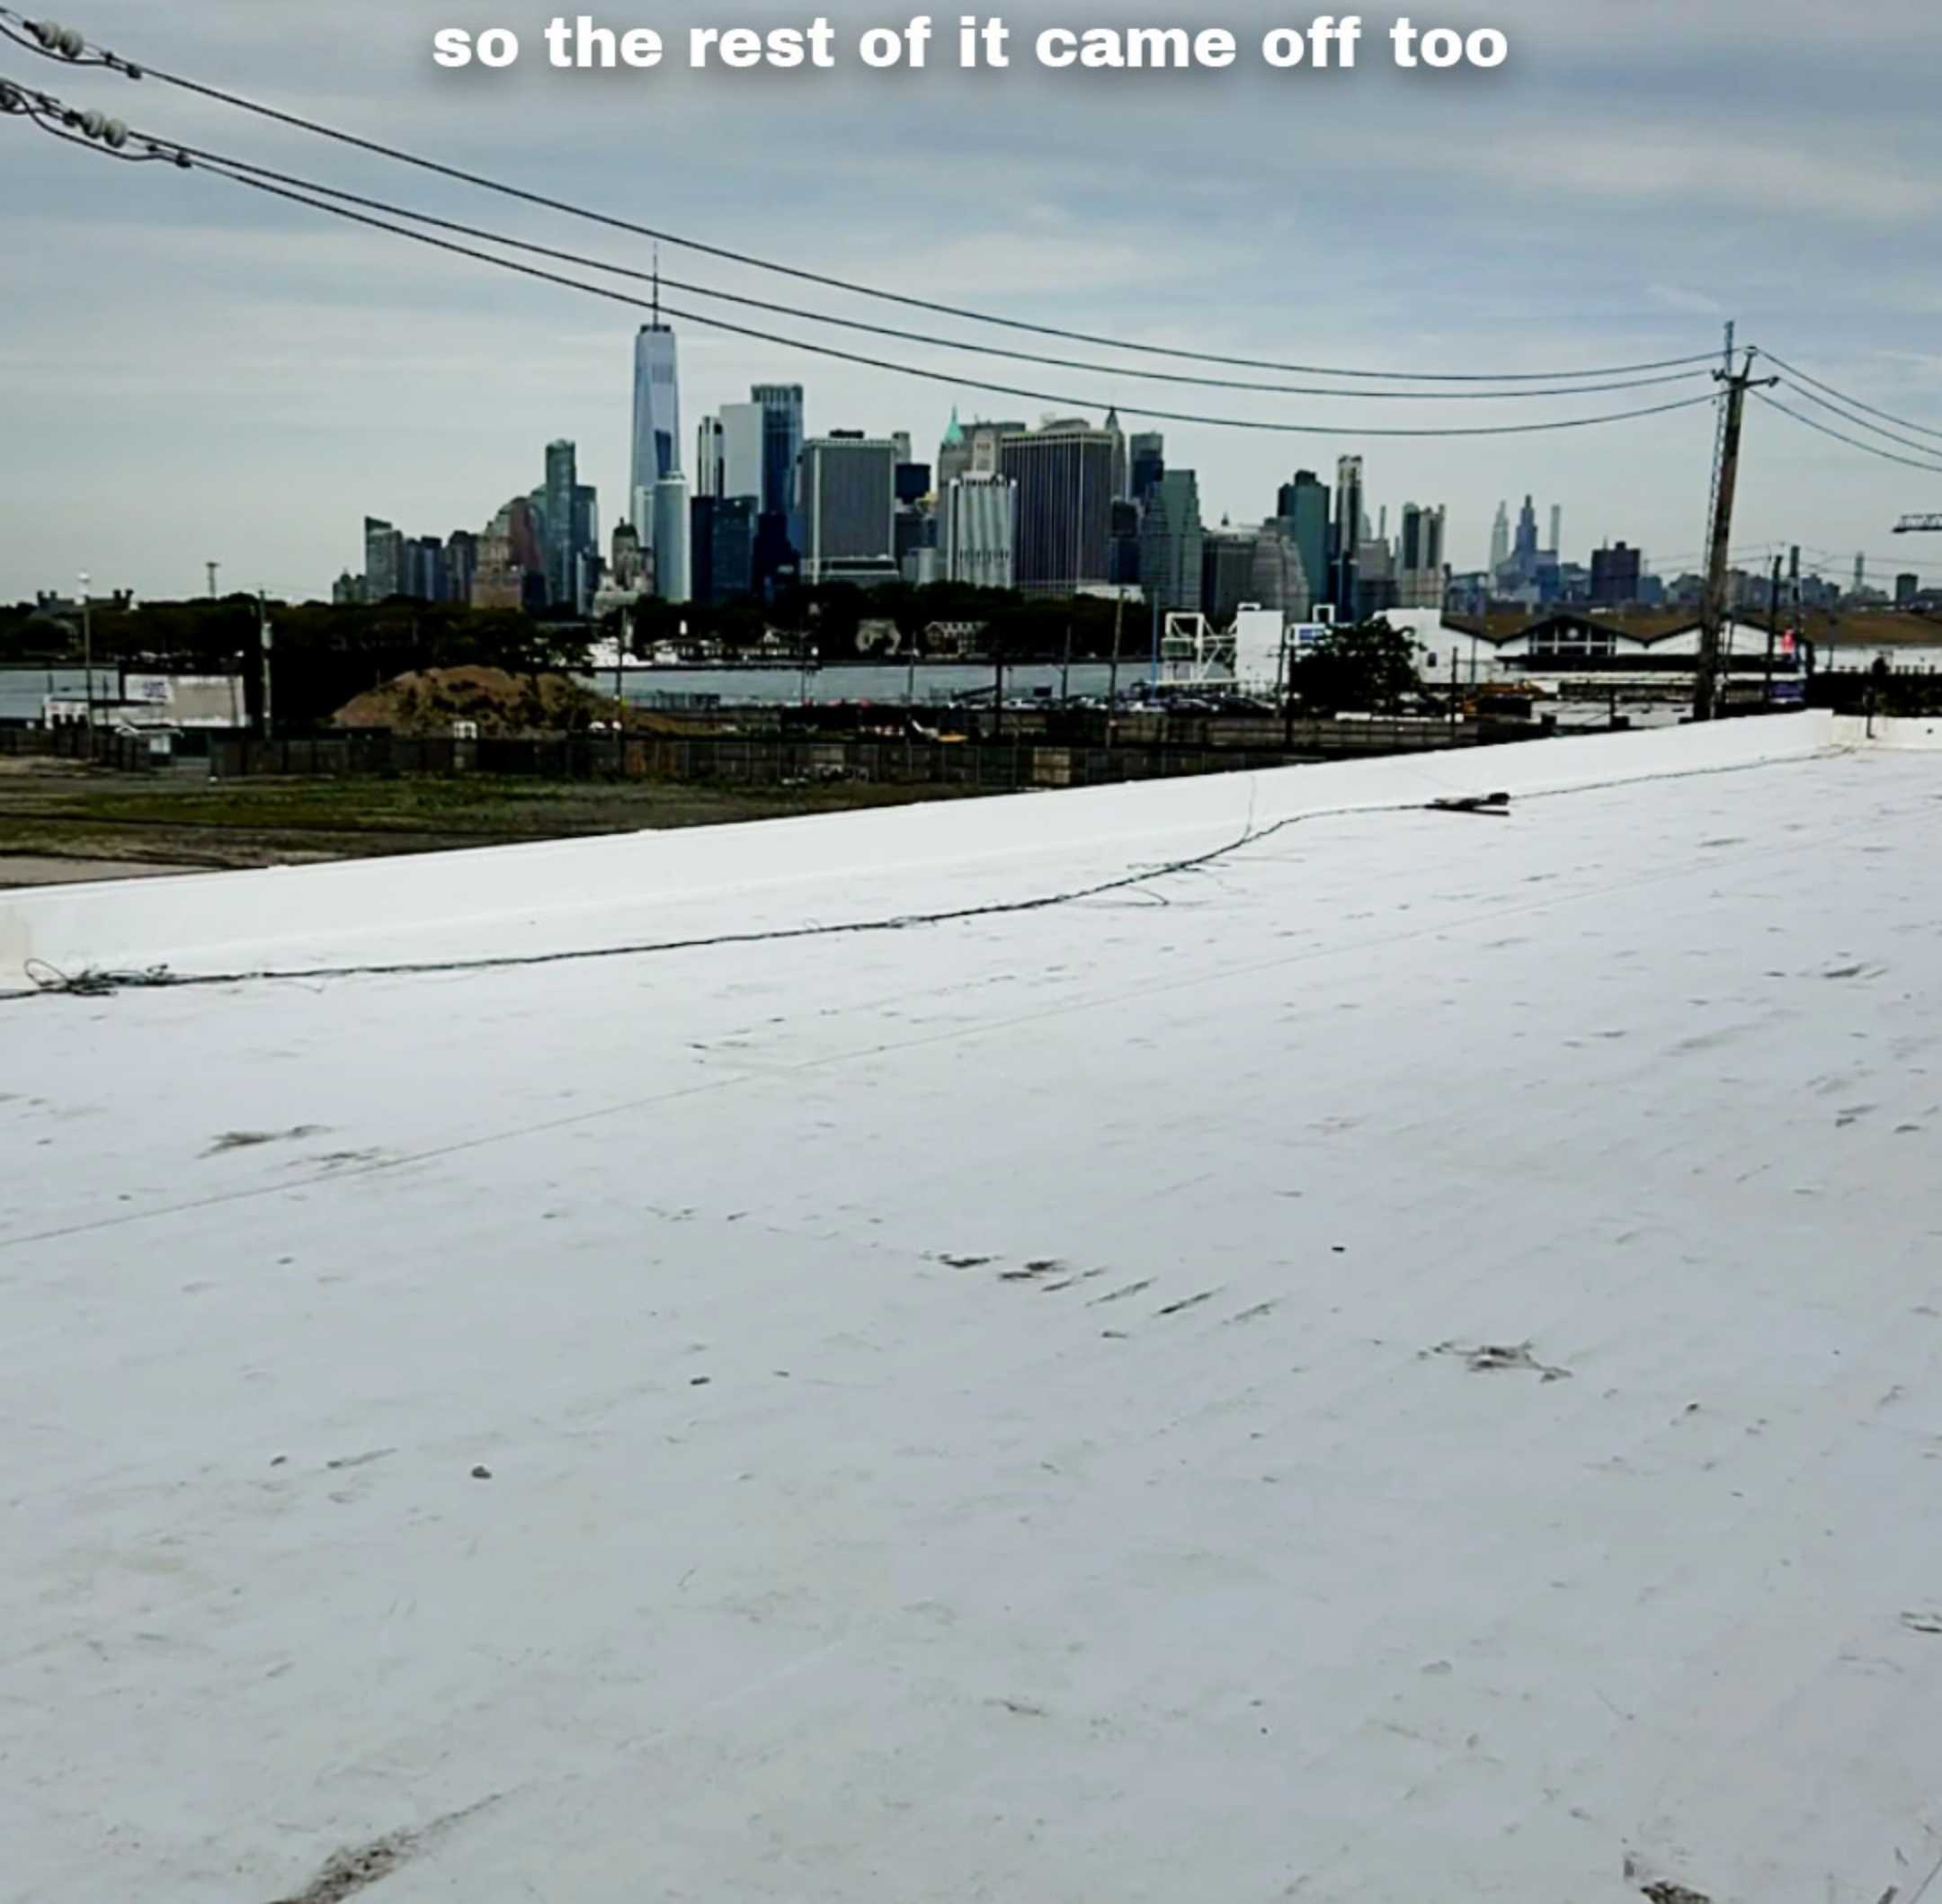
AND UNDERNEATH

**ABOUT  
1,000 SQ FT  
OF ROTTED  
STEEL DECK.**

**Steel. Not wood.**

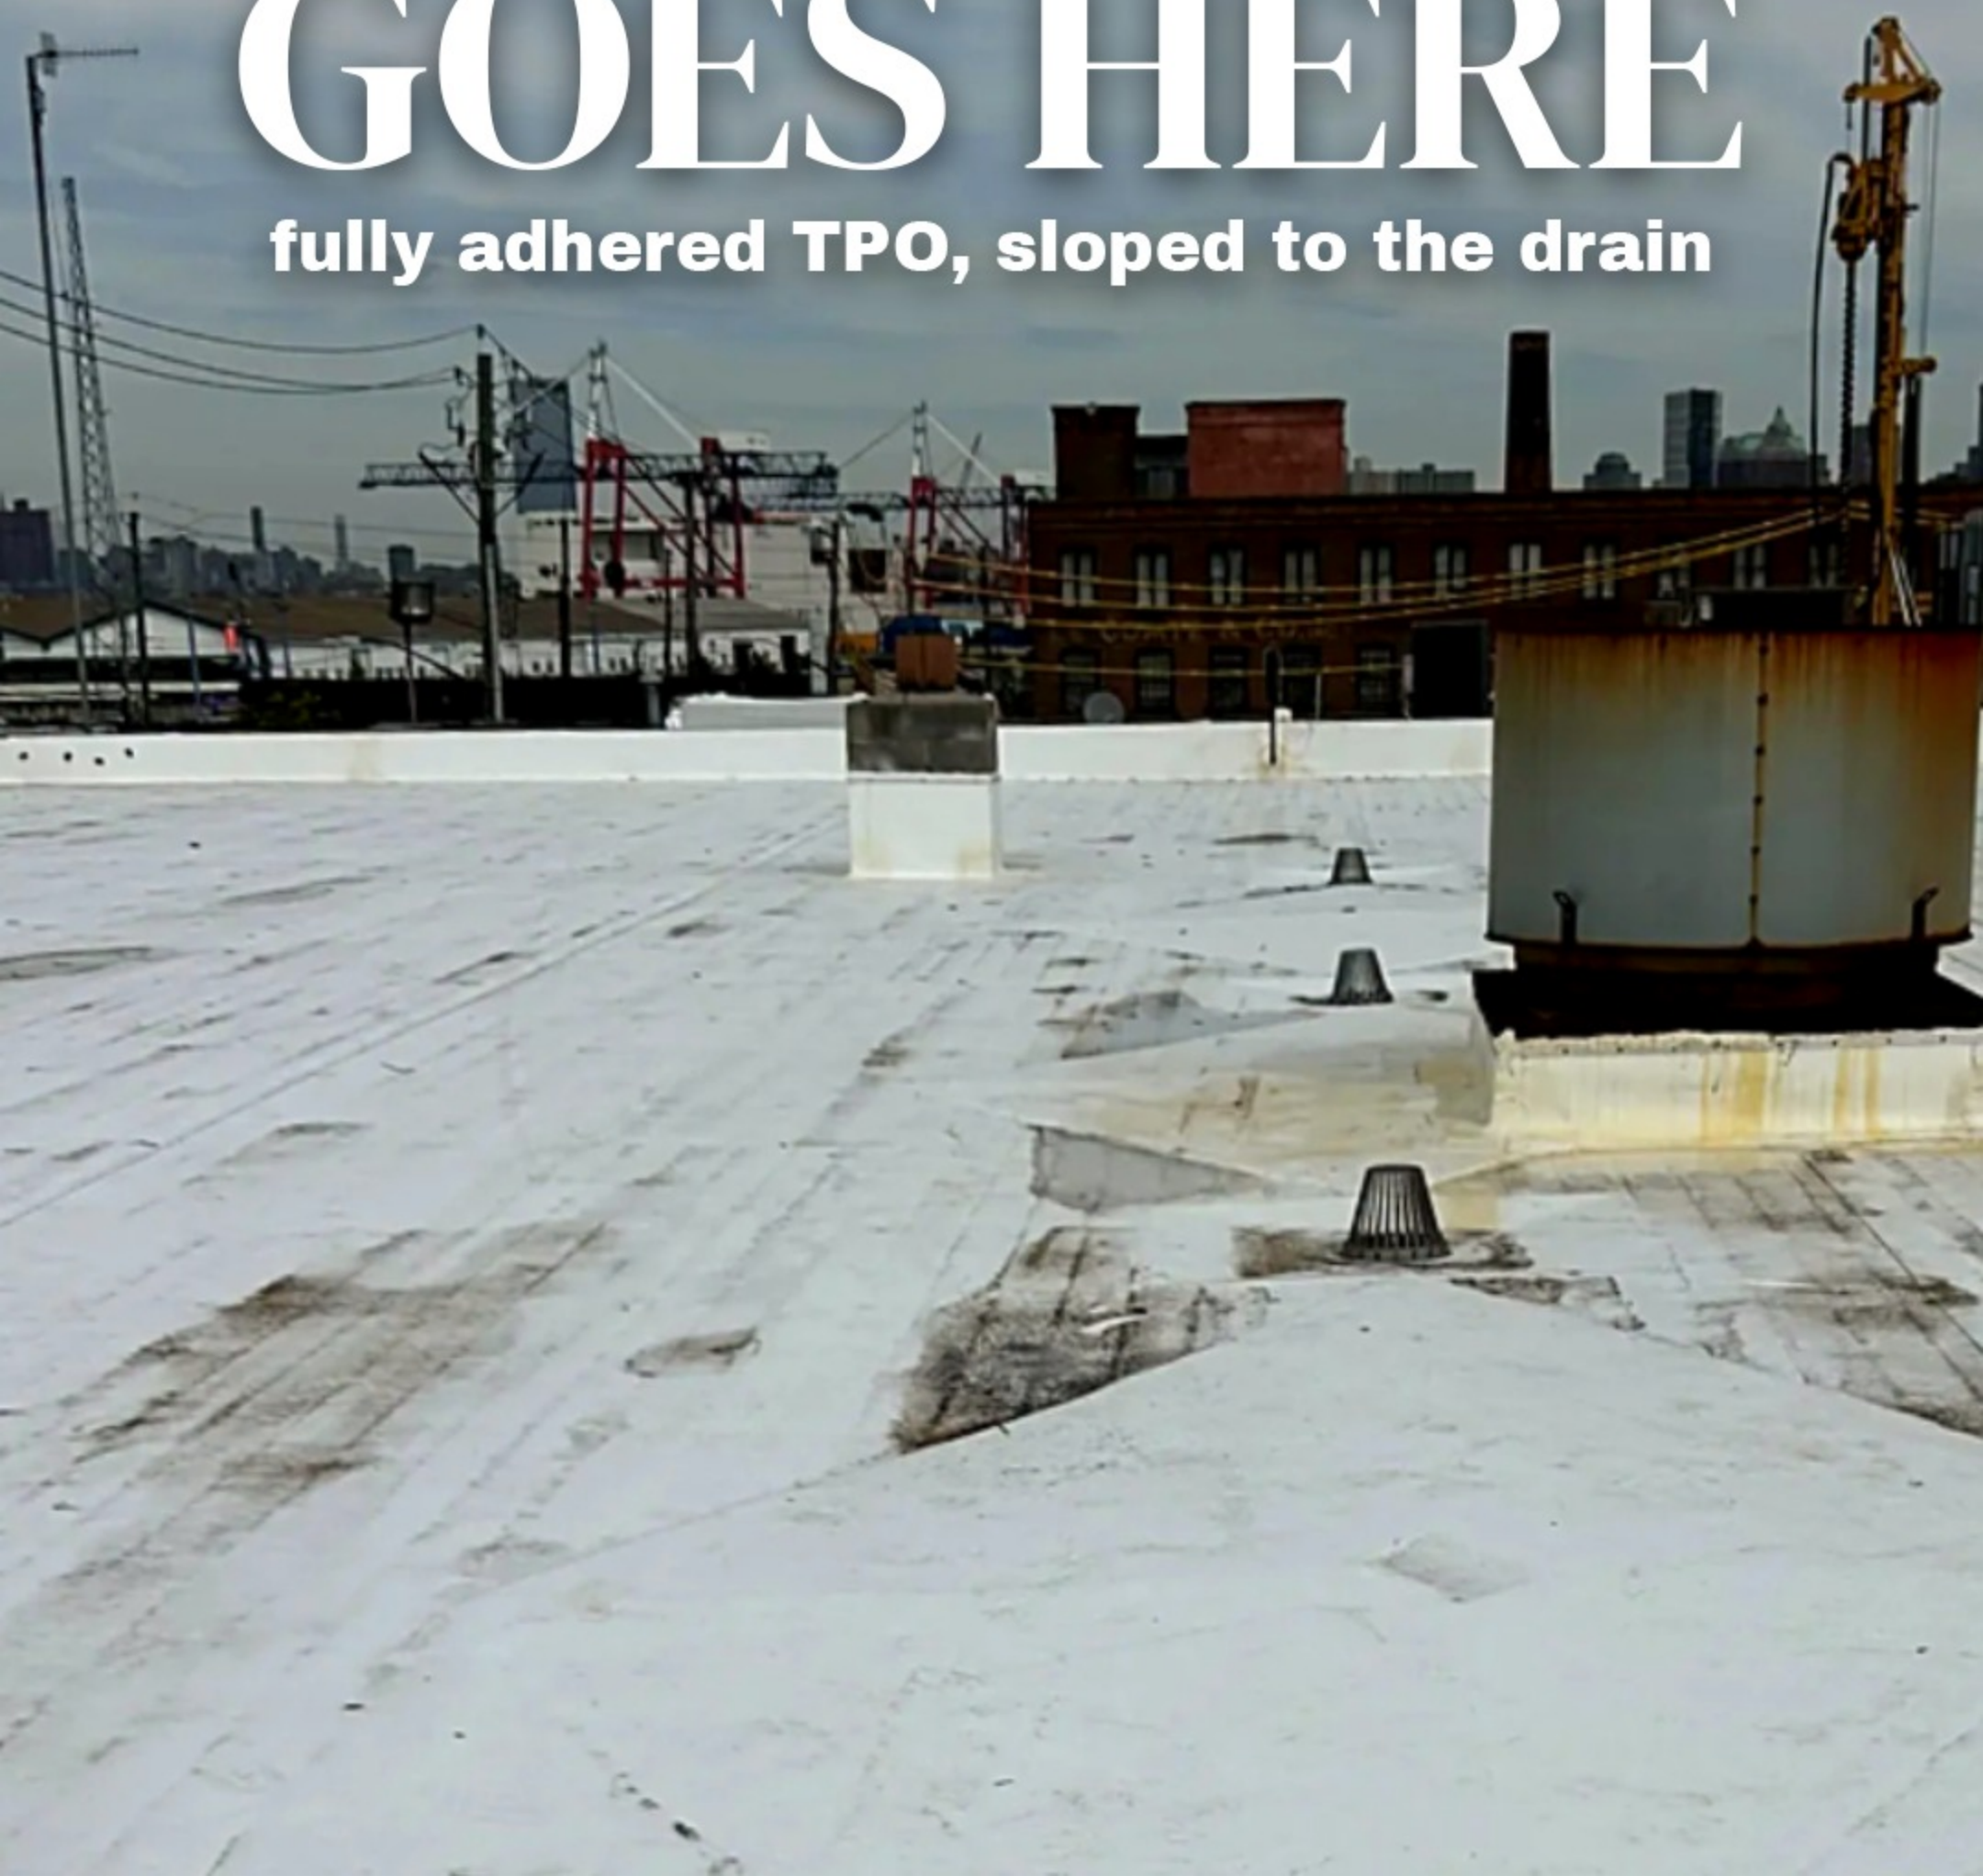
new deck, new roof, and

# THE WATER GOES HERE

fully adhered TPO, sloped to the drain
