City of Marion

# Coastal Climate Change Adaptation Study

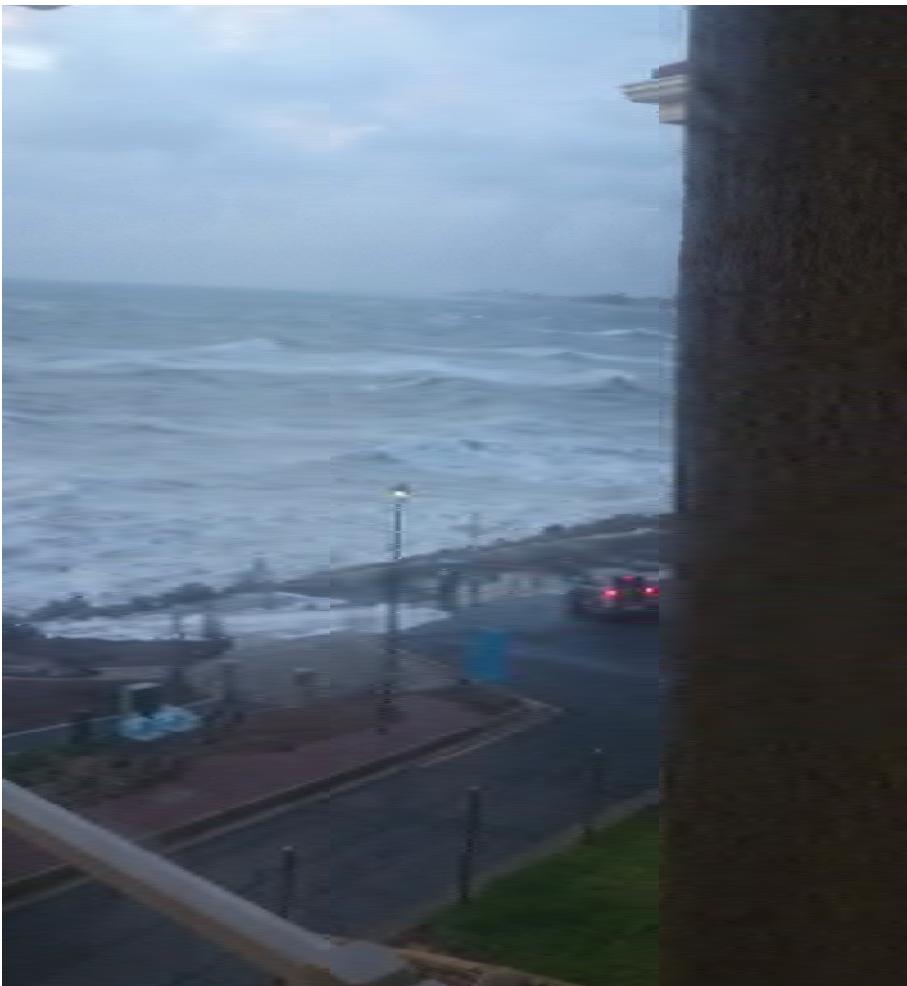
**Figure 9: Storm surge impact at The Esplanade, Marion (17:20, 9<sup>th</sup> May 2016)**

Photograph: Bill and Glenys Summersides of 4 Esplanade at 17.20

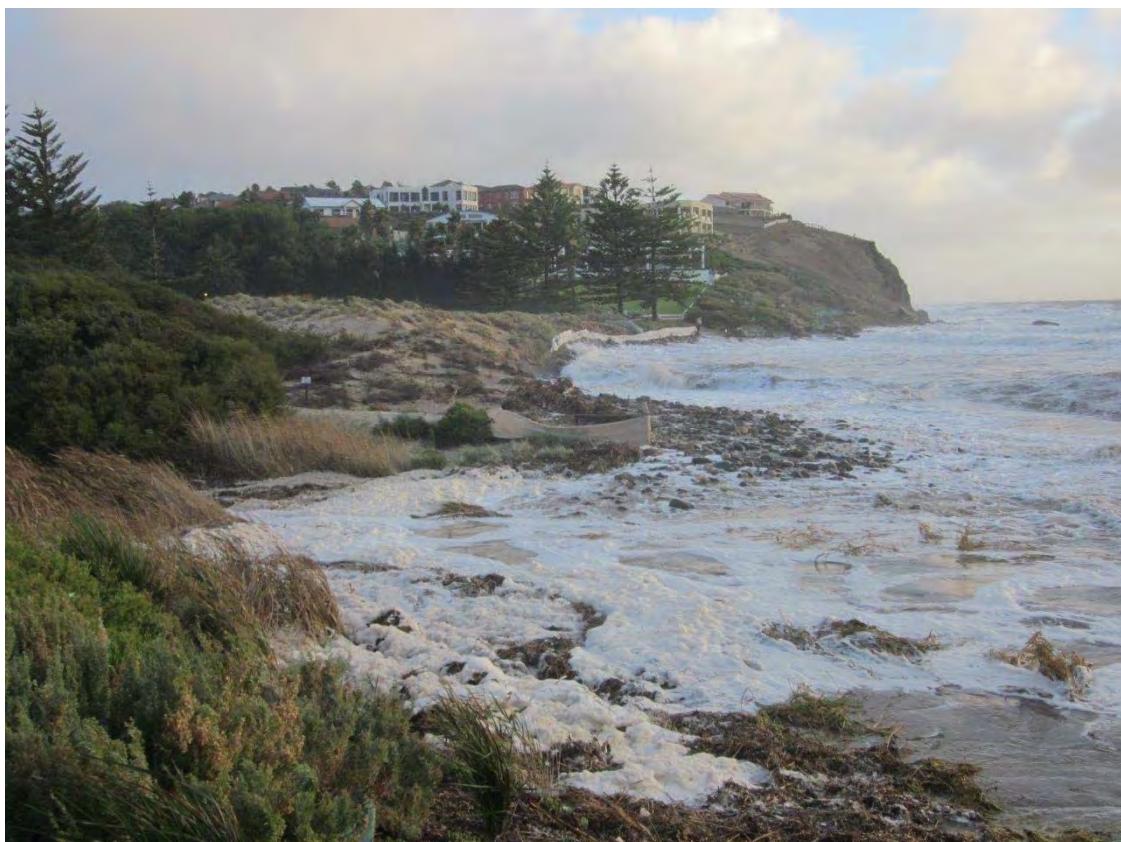
**Figure 10: Storm surge in Field River region (9<sup>th</sup> May 2016)**

Photograph: Bill and Glenys Summersides of 4 Esplanade at 17.50 (but the sky suggests it was earlier)

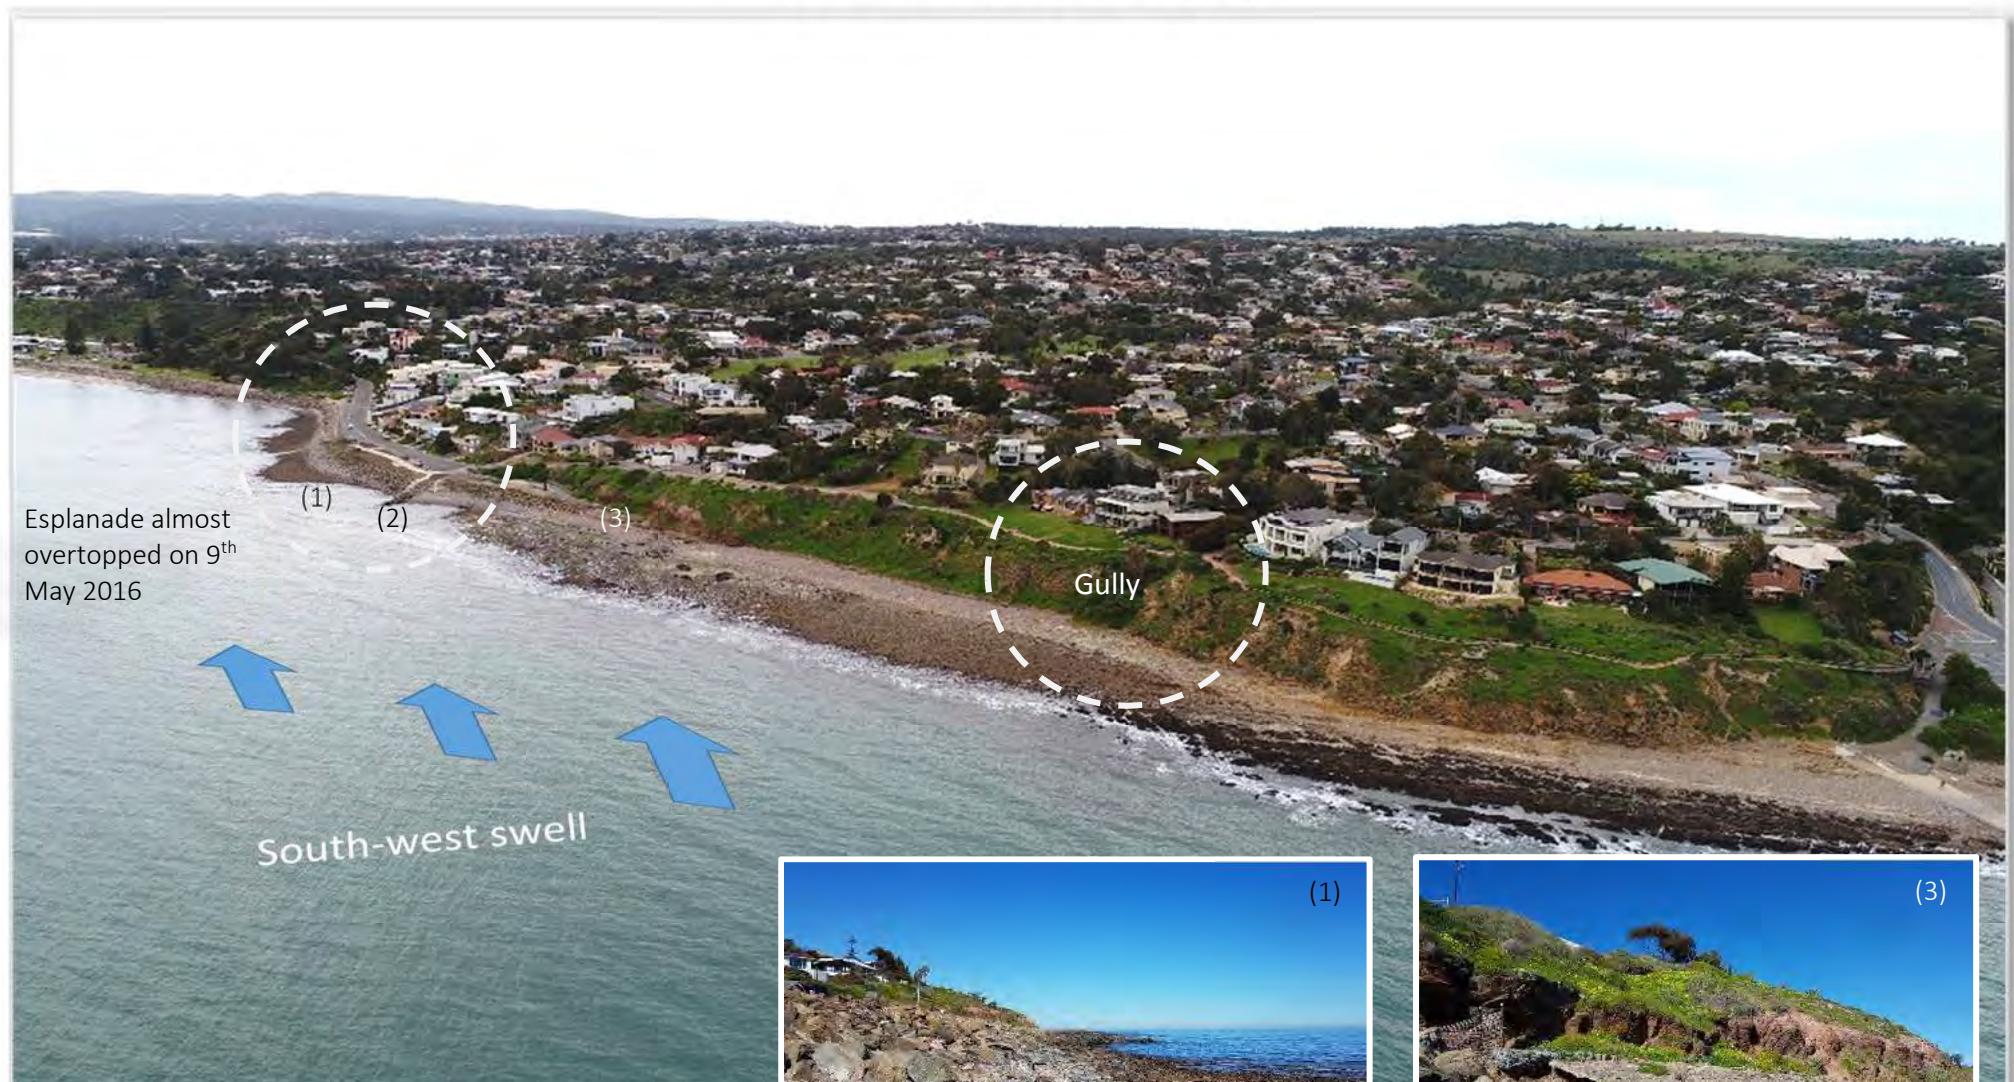
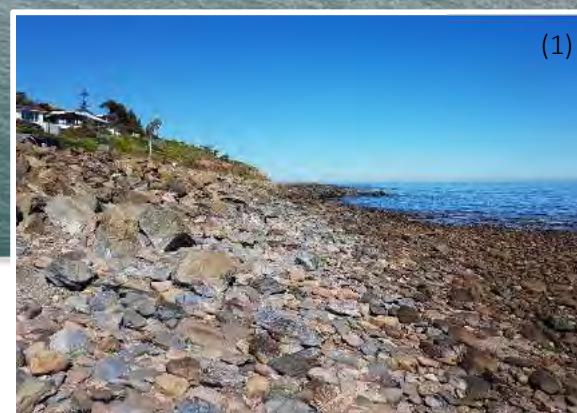
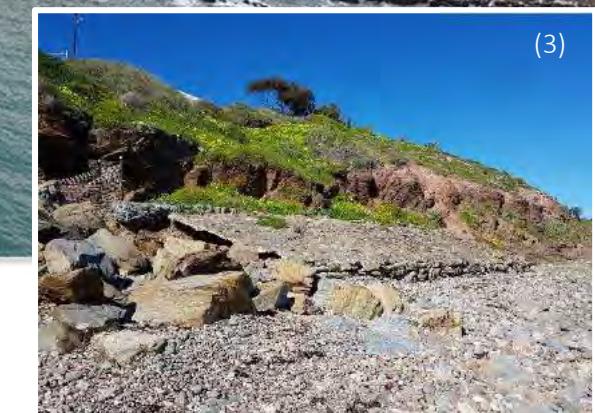
## Cell 1: Marino Cliffs (1:1)

Rock revetment protecting The Esplanade is degrading (1). Small groyne exists (see above) perhaps to act as protection for small boat launching in the past (2). Protection structure (3) is likely to have protected former building, now undermined with erosion.

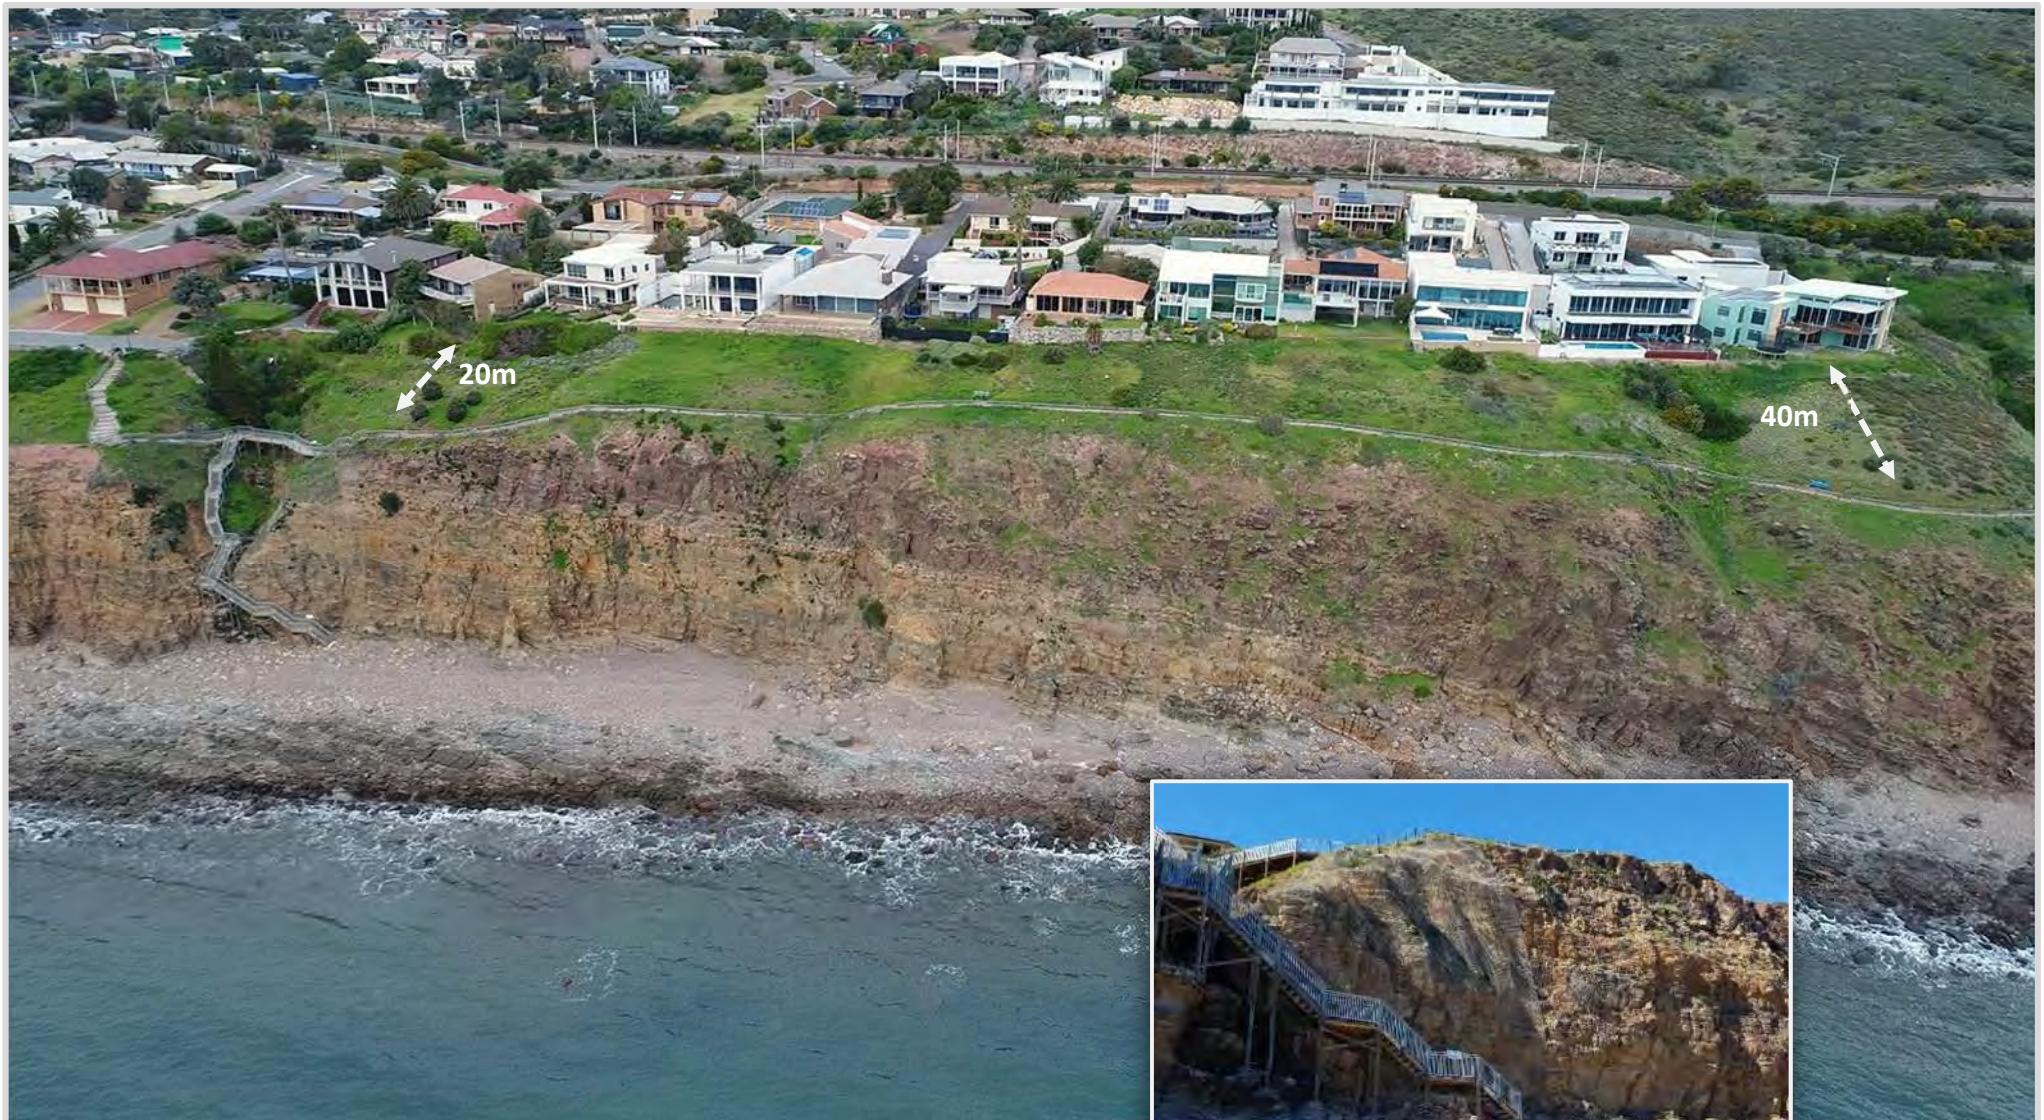
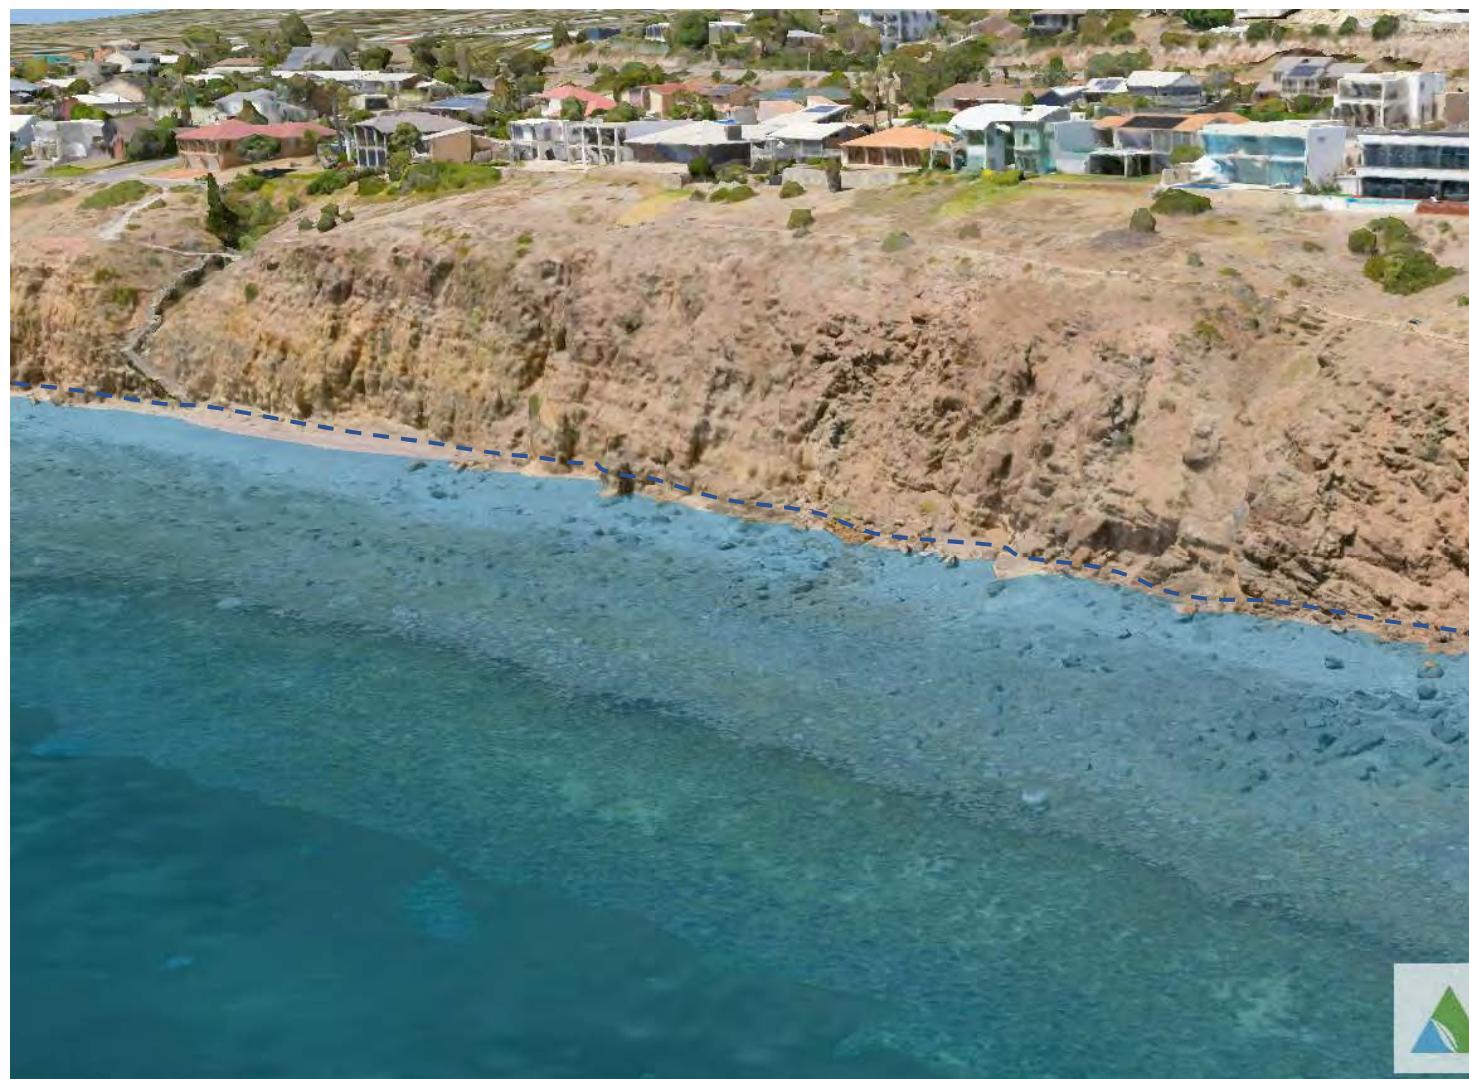
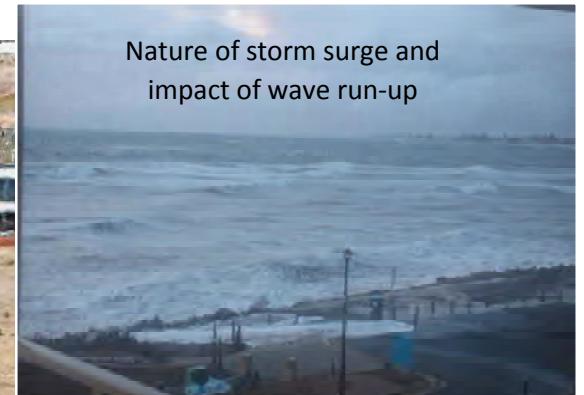
## Cell 1: Marino Cliffs (4)

Falling rocks hazard contained with wire netting. Beach access stairs may come under increasing impact from sea processes but improved design can cater for impacts when stairs are upgraded.

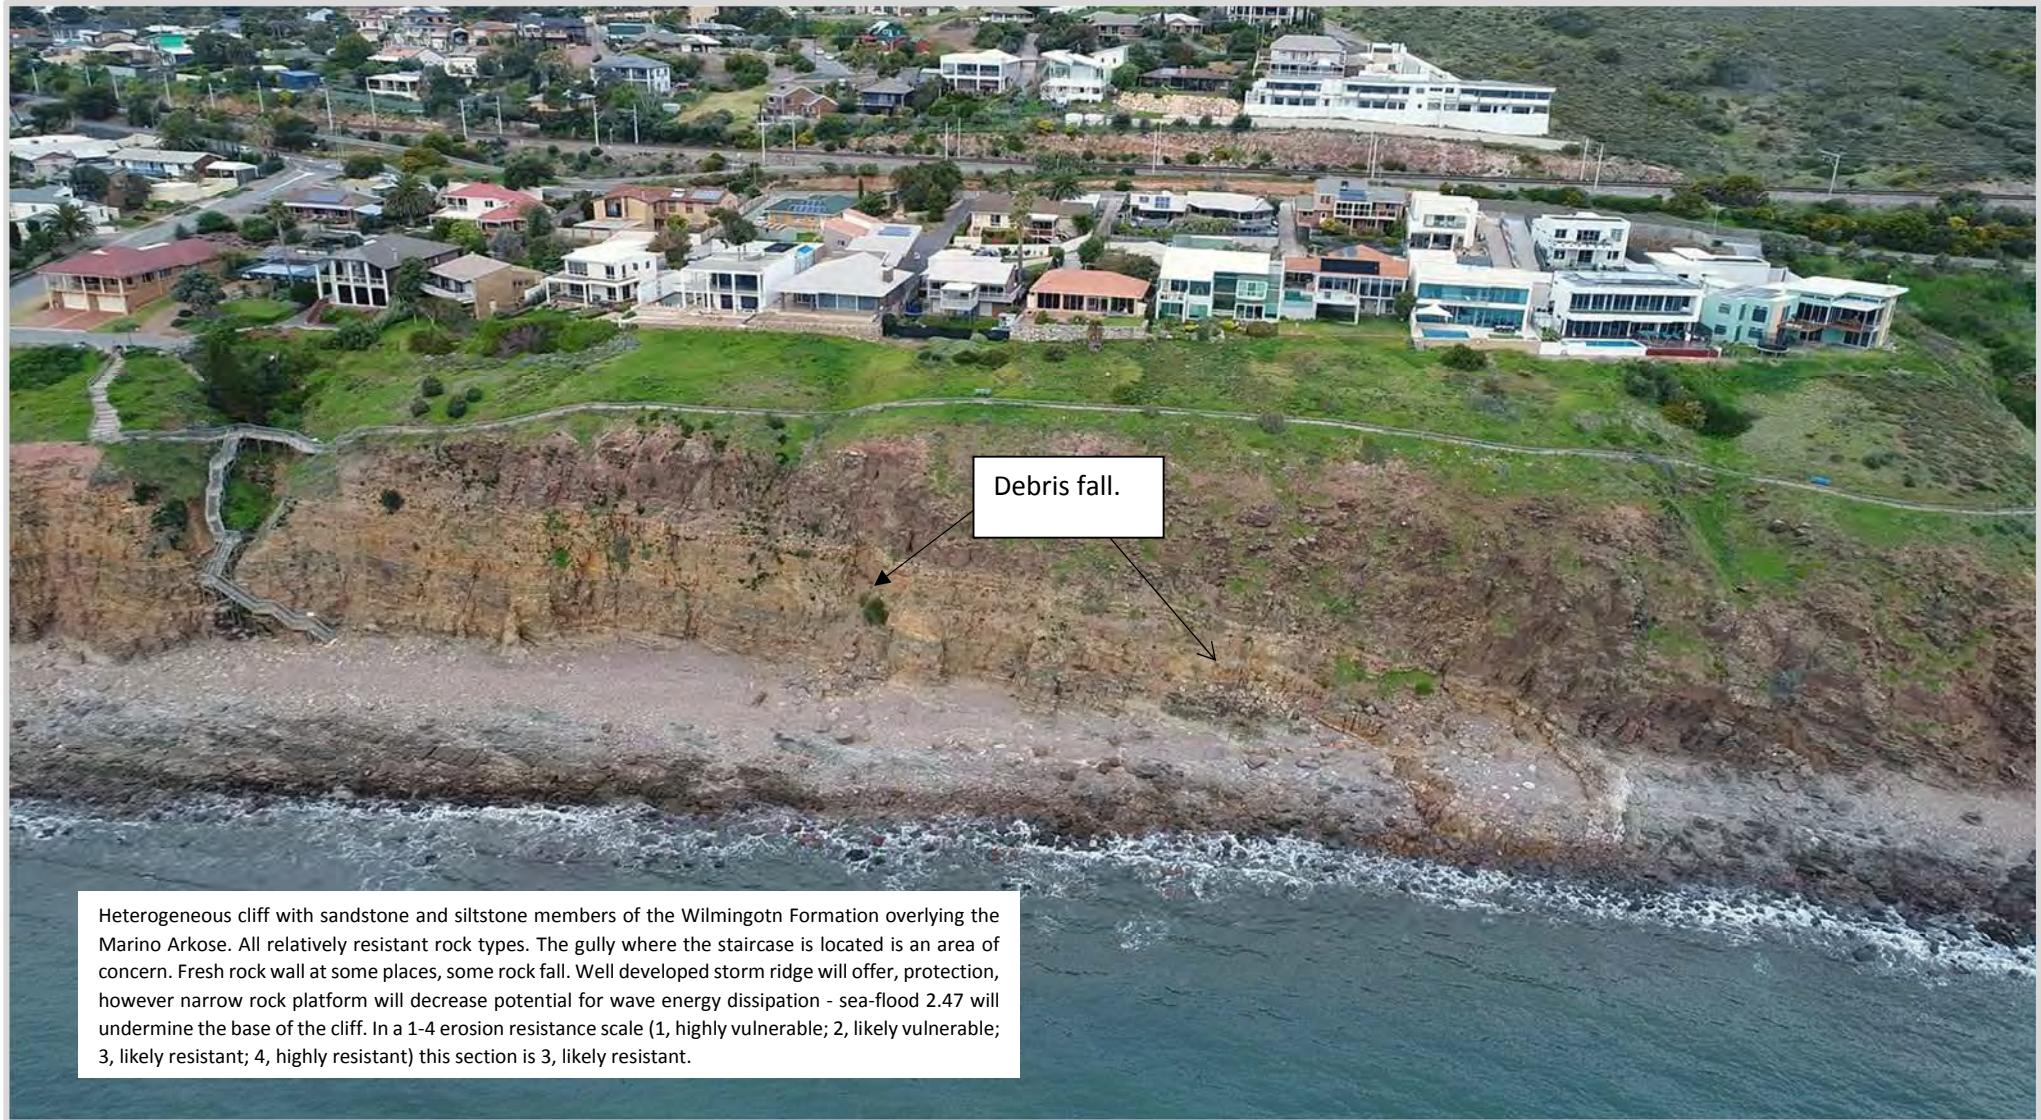
SW1.11 – Old pipe is situated under house on no 20. Water flows into well vegetated gully (small catchment...but is this coming from the other side of the trainline as well?)  
SW1.12

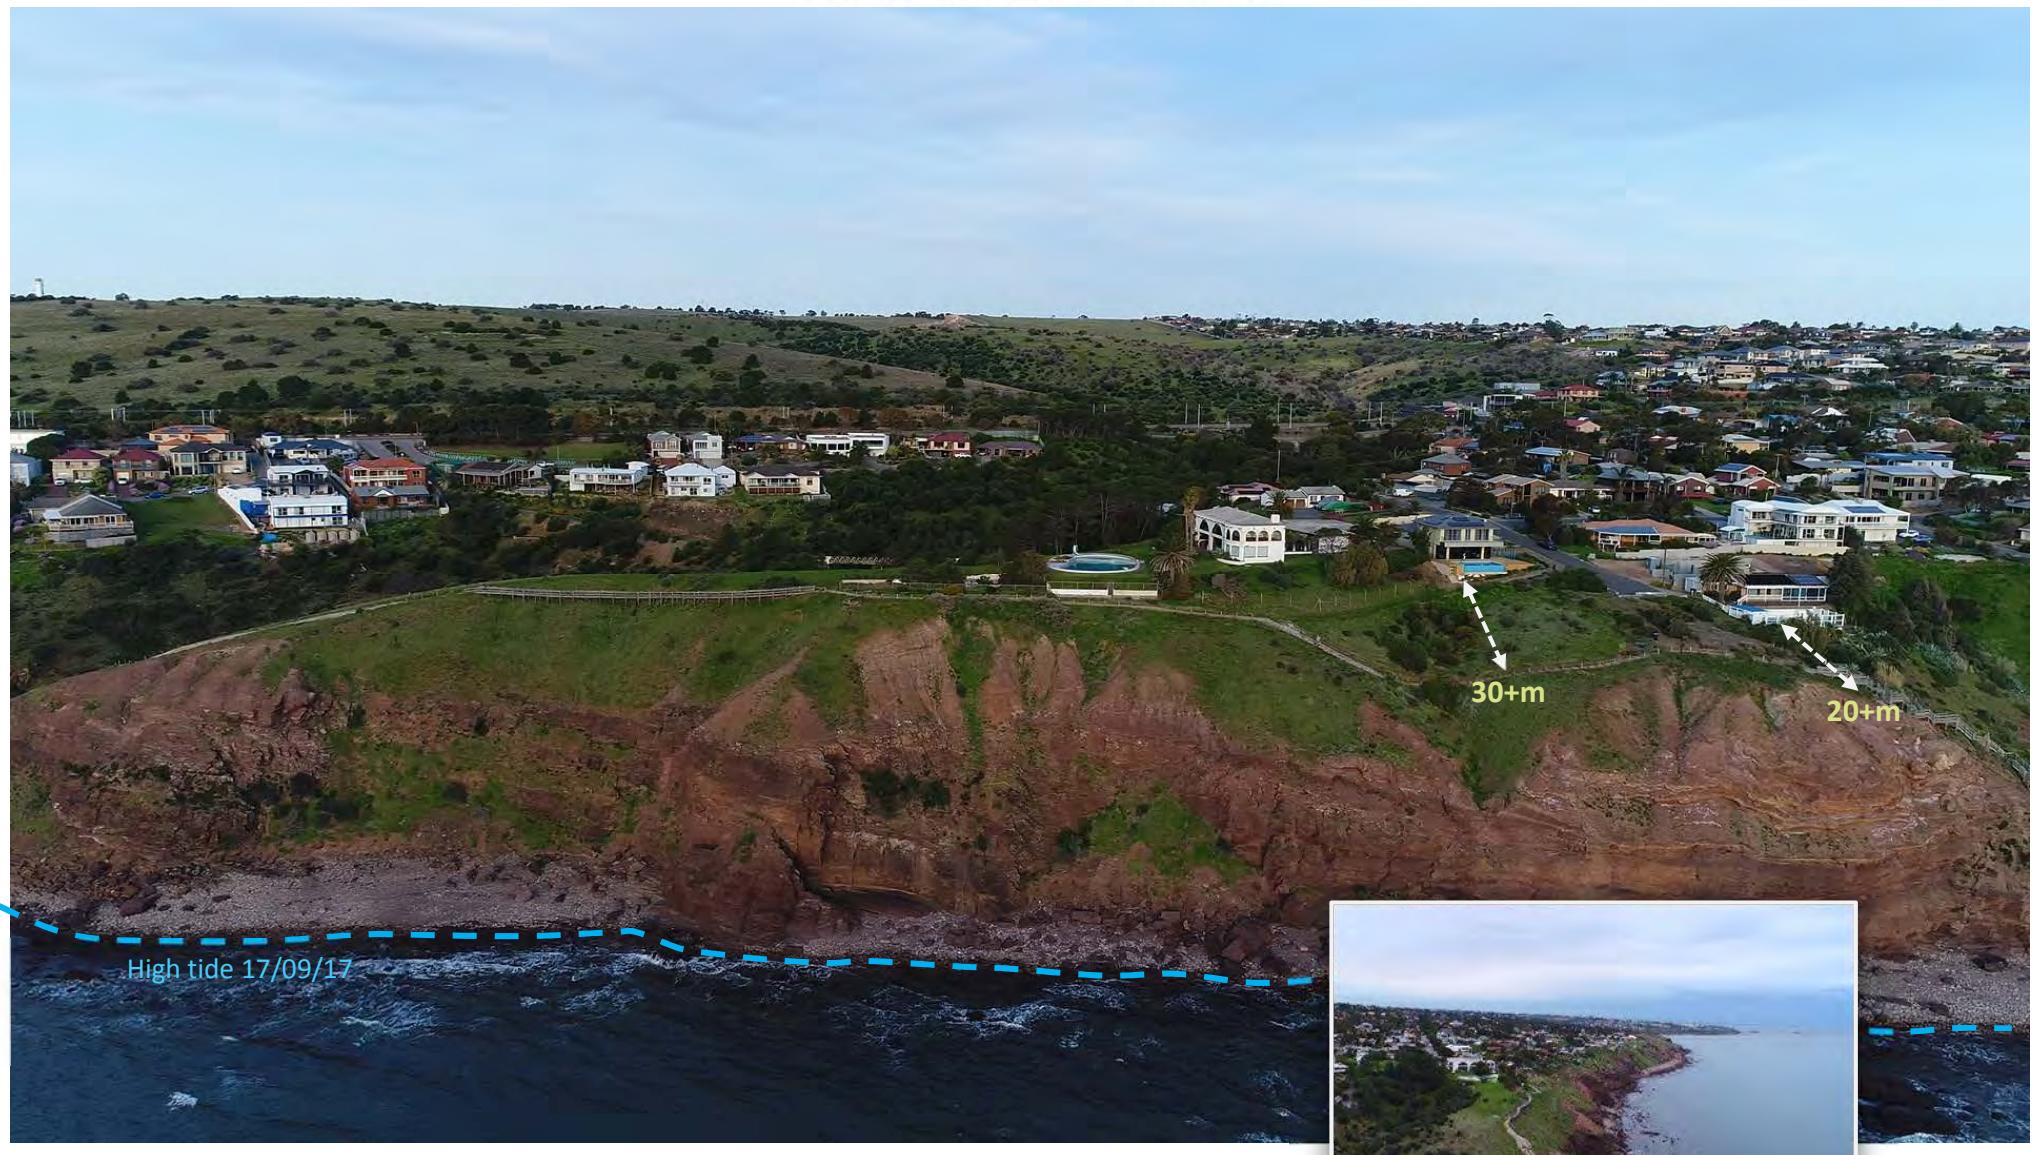
## Cell 2: Hallett Cliffs (2:2)

High tide was 2.03CD (high tides can be 2.30 to 2.50). It is likely that some sections of this cliff base is receiving constant wave action. Houses are set well back from the escarpment which is much more vertical in this location. (Check house on south side)

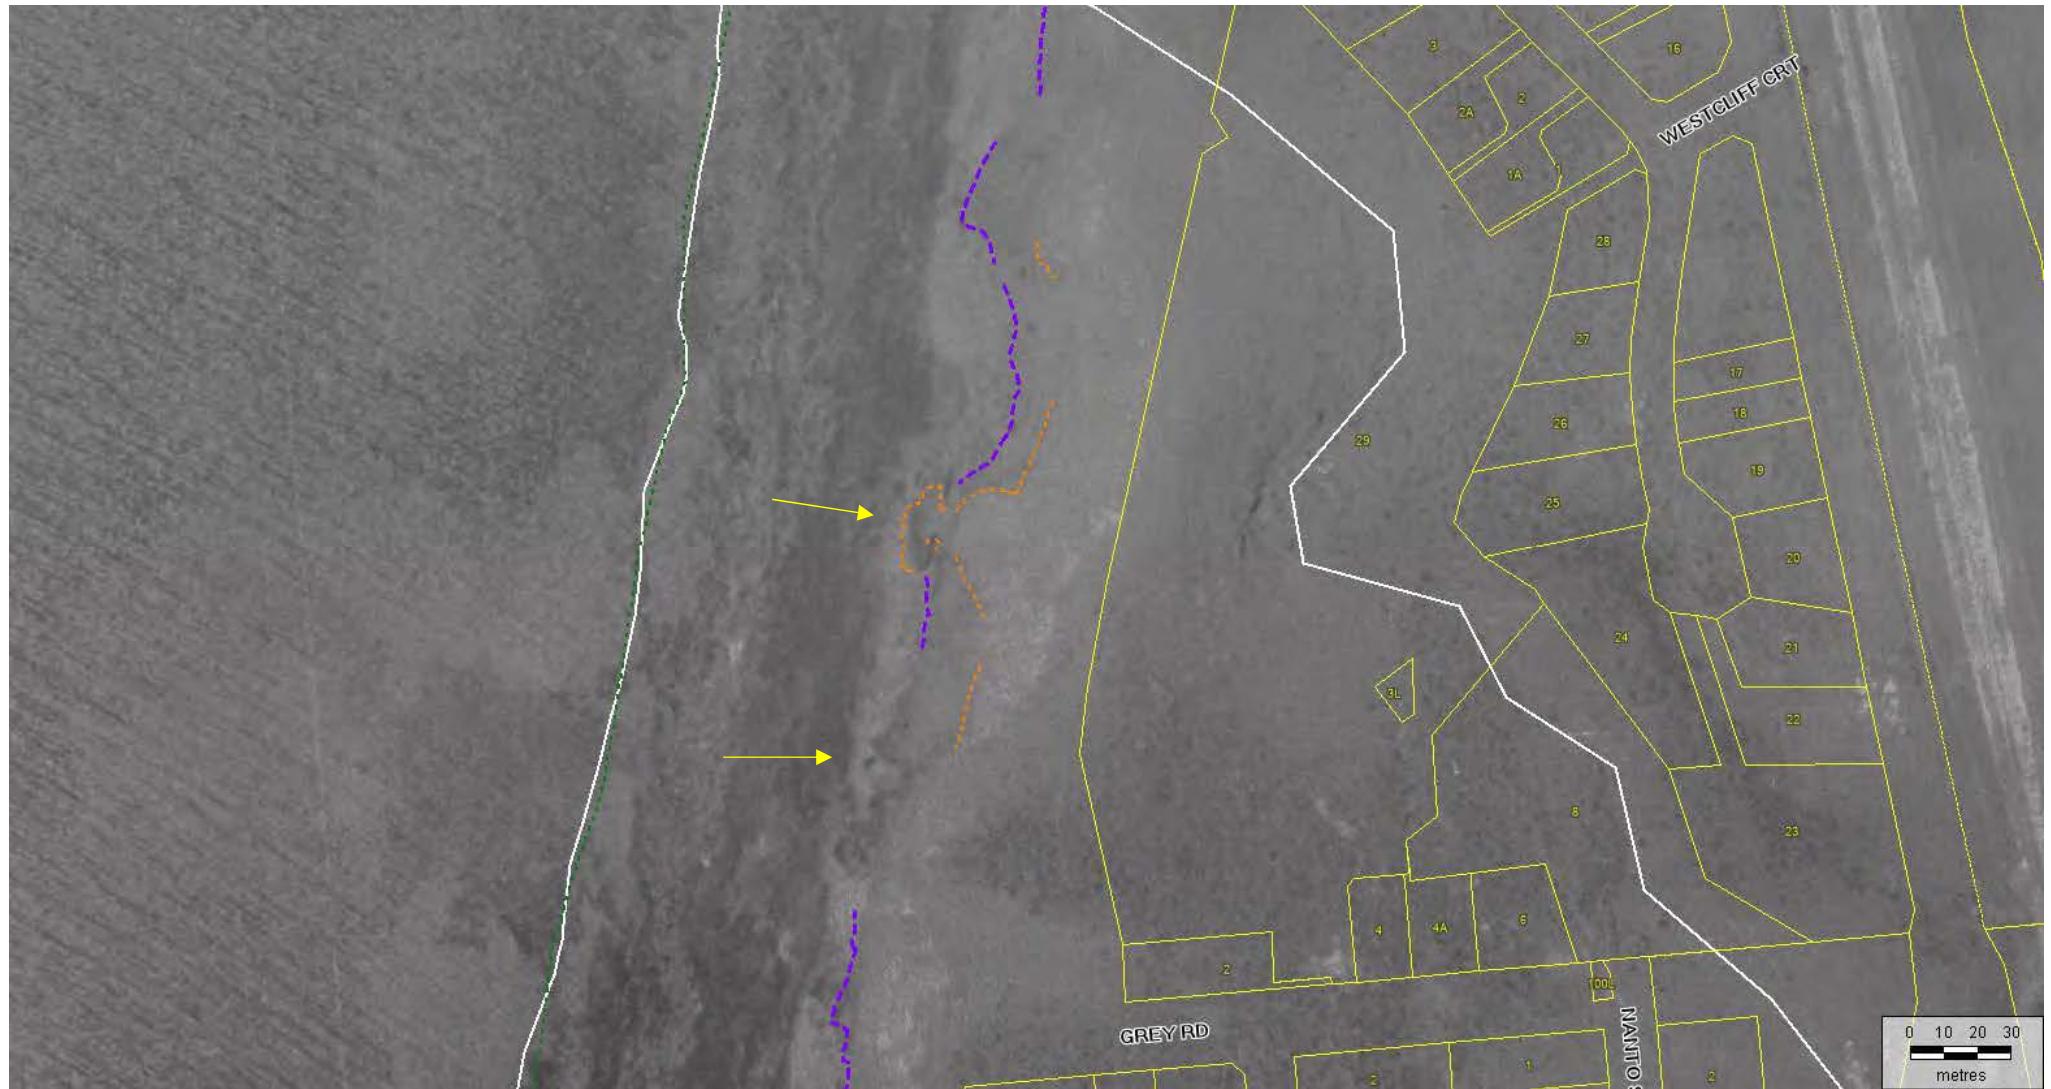
**Hallett Cliffs 2:2**  
**Erosion assessment**  
Event: 2002  
Risk: Shoreline recession  
Date: 12 May 2018

The location of the bottom of the escarpment appears to be in the same location as 1949. Analysis indicates that rock has broken away from the escarpment (top arrow), with evidence of visible cracking in 1949. Possible increase of rock on the beach (bottom arrow) may indicate loss of cliff.

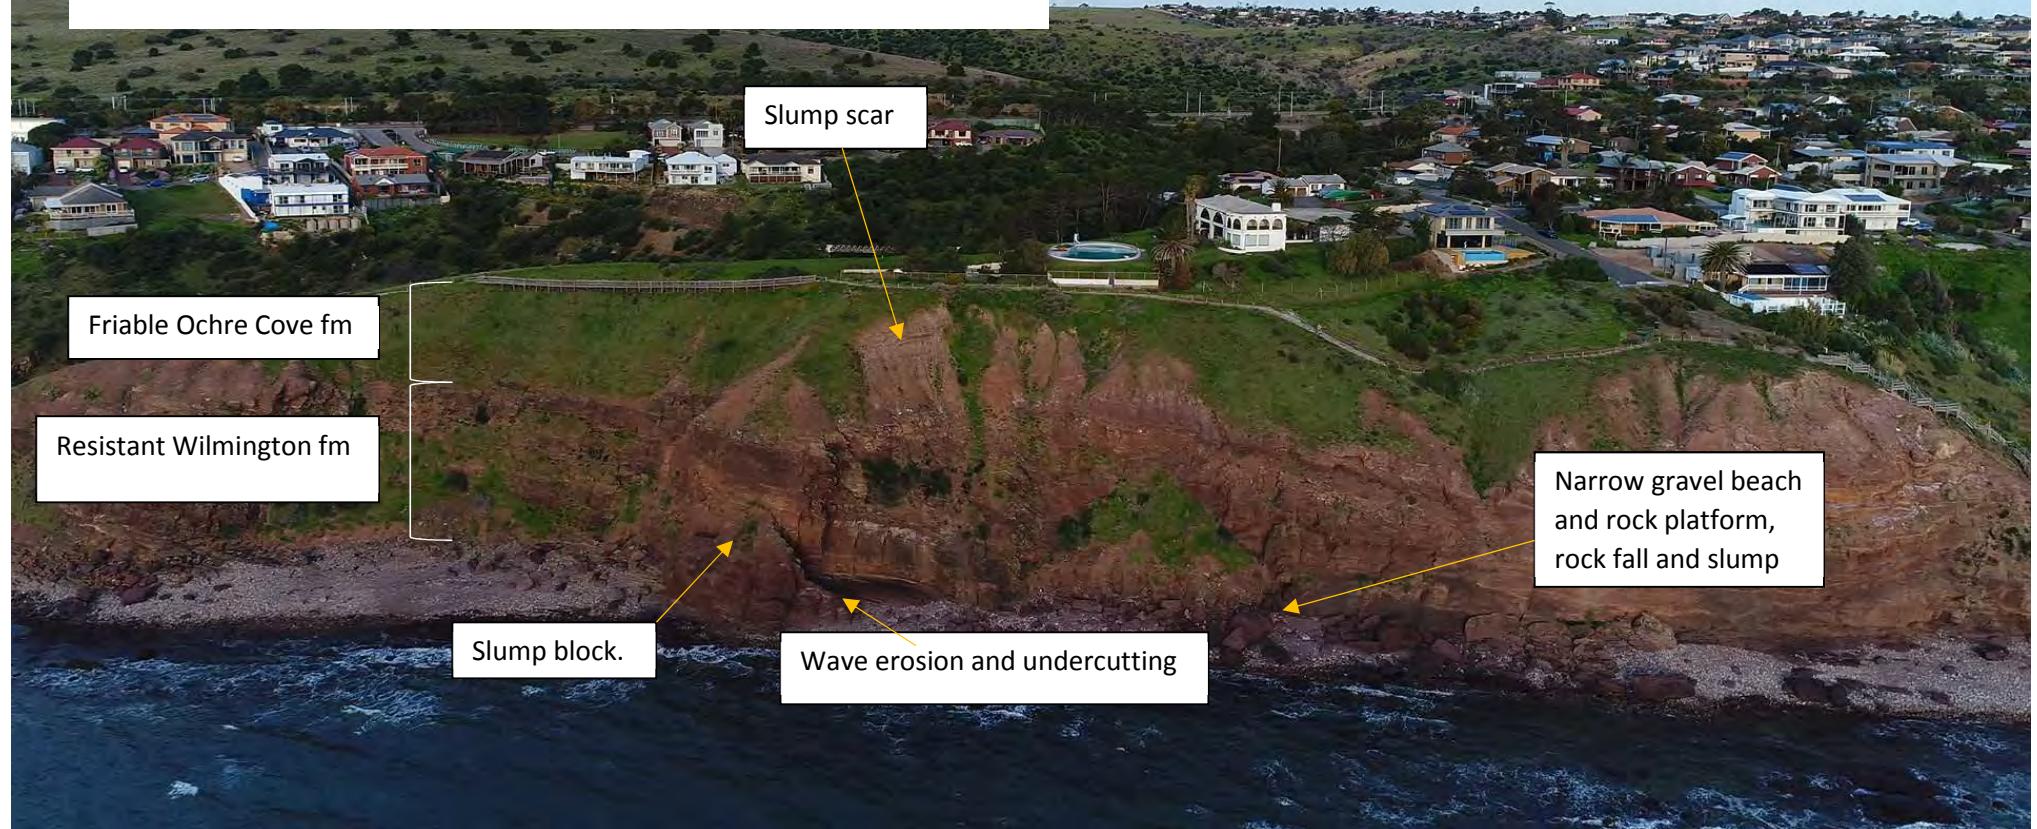
**Hallett Cliffs 2:2**  
**Erosion assessment**  
Event: 1947  
Risk: Shoreline recession  
Date: 12 May 2018

Heterogeneous cliff with resistant Wilmington fm underlying friable Pleistocene Ochre Cove fm (possibly Pleistocene Hindmarsh clay which is also friable material). Rockfall and slump blocks are present on the cliff base and there is evidence of wave erosion of cliff toe. The gravel beach is narrow, sea-flood 2.47 m will potentially cause significant impact. In a 1-4 erosion resistance scale (1, highly vulnerable; 2, likely vulnerable; 3, likely resistant; 4, highly resistant) this section is 2, likely vulnerable, given the nature of the soft material composing the top of the cliff and evident wave attack on the cliff toe

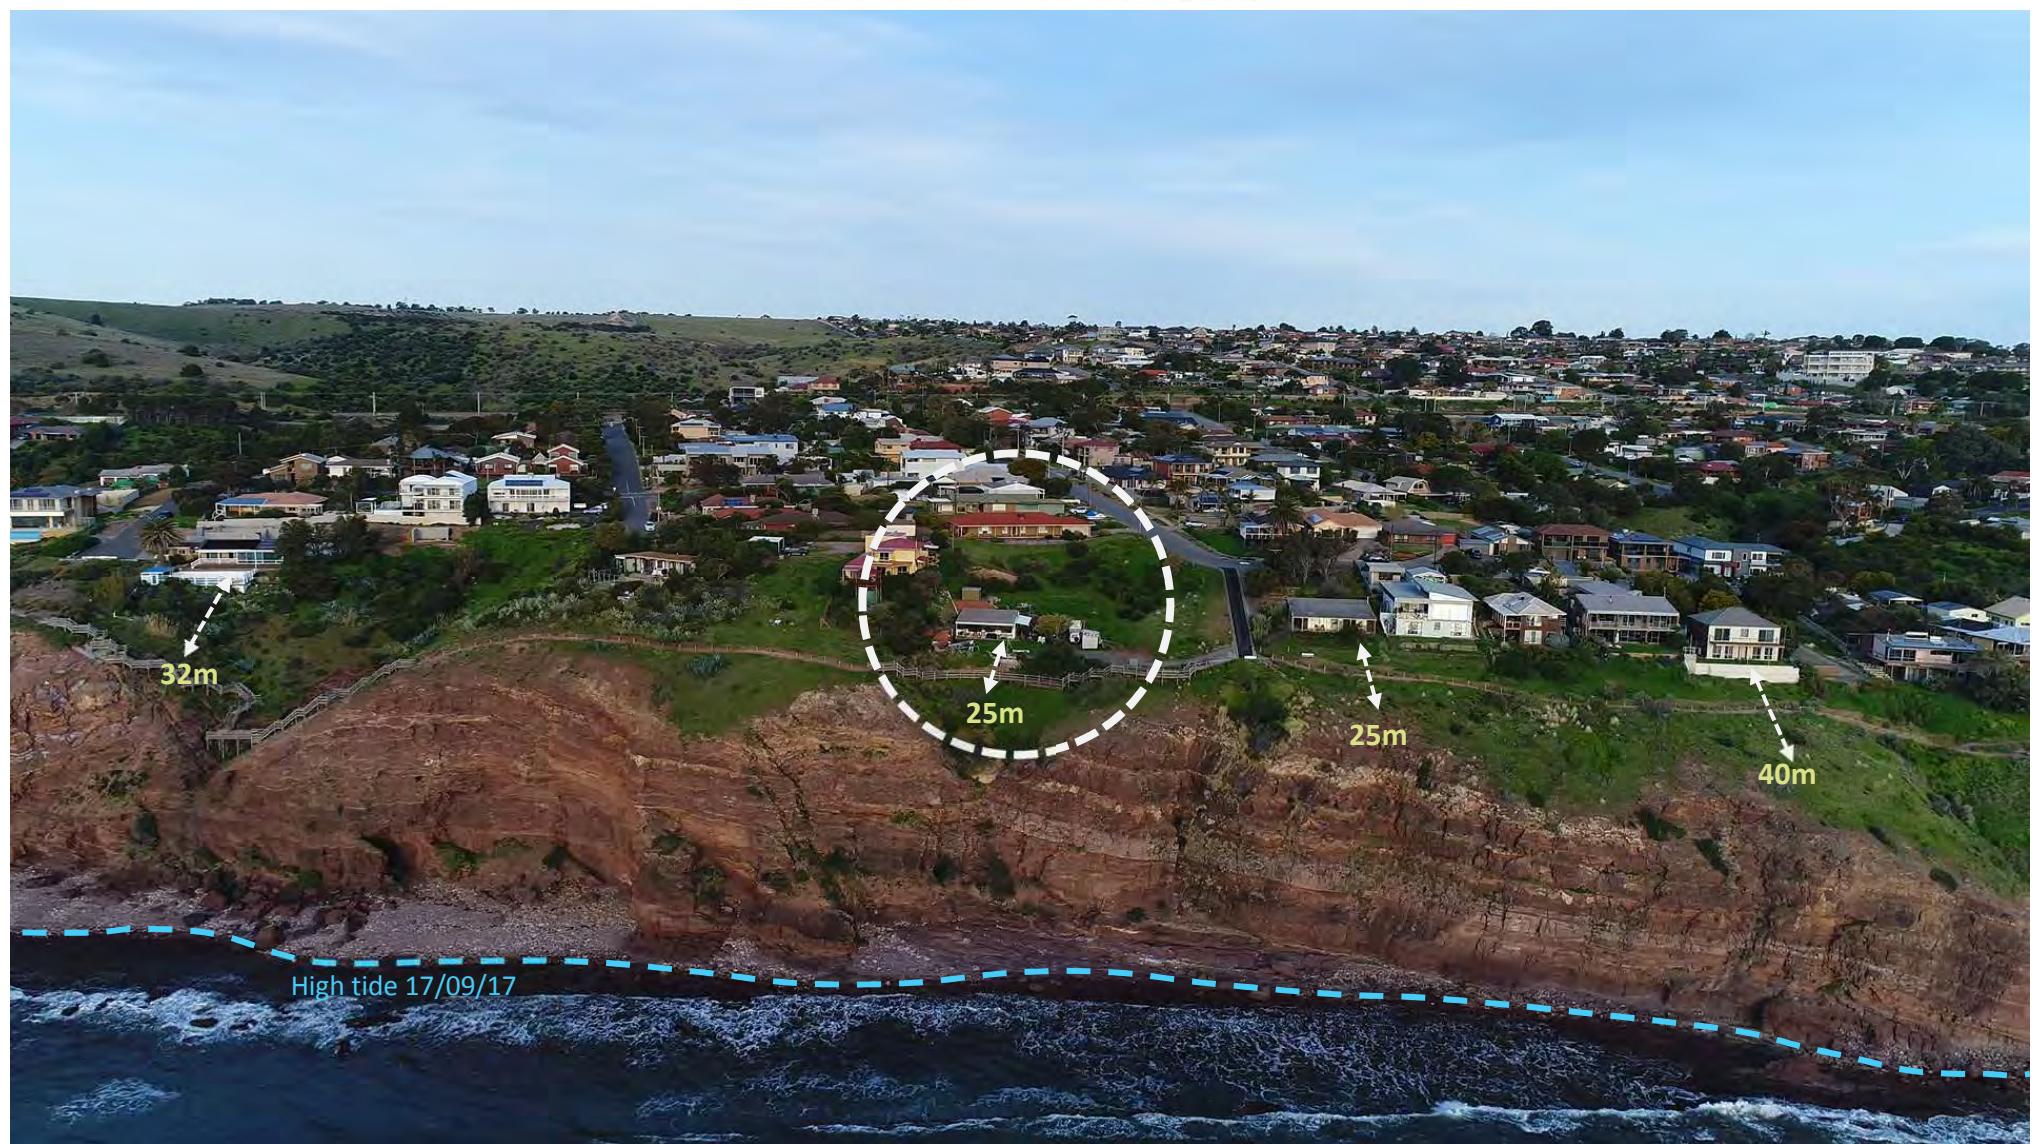
## Cell 2: Hallett Cliffs (2:3)

High tide was 2.03CD (high tides can be 2.30 to 2.50). It is likely that some sections of this cliff base is receiving constant wave action. Houses are set well back from the escarpment in this location which is almost vertical. Note: the house within the circle is situated in a gully between two cliffs. Check to see storm water drainage in the area.

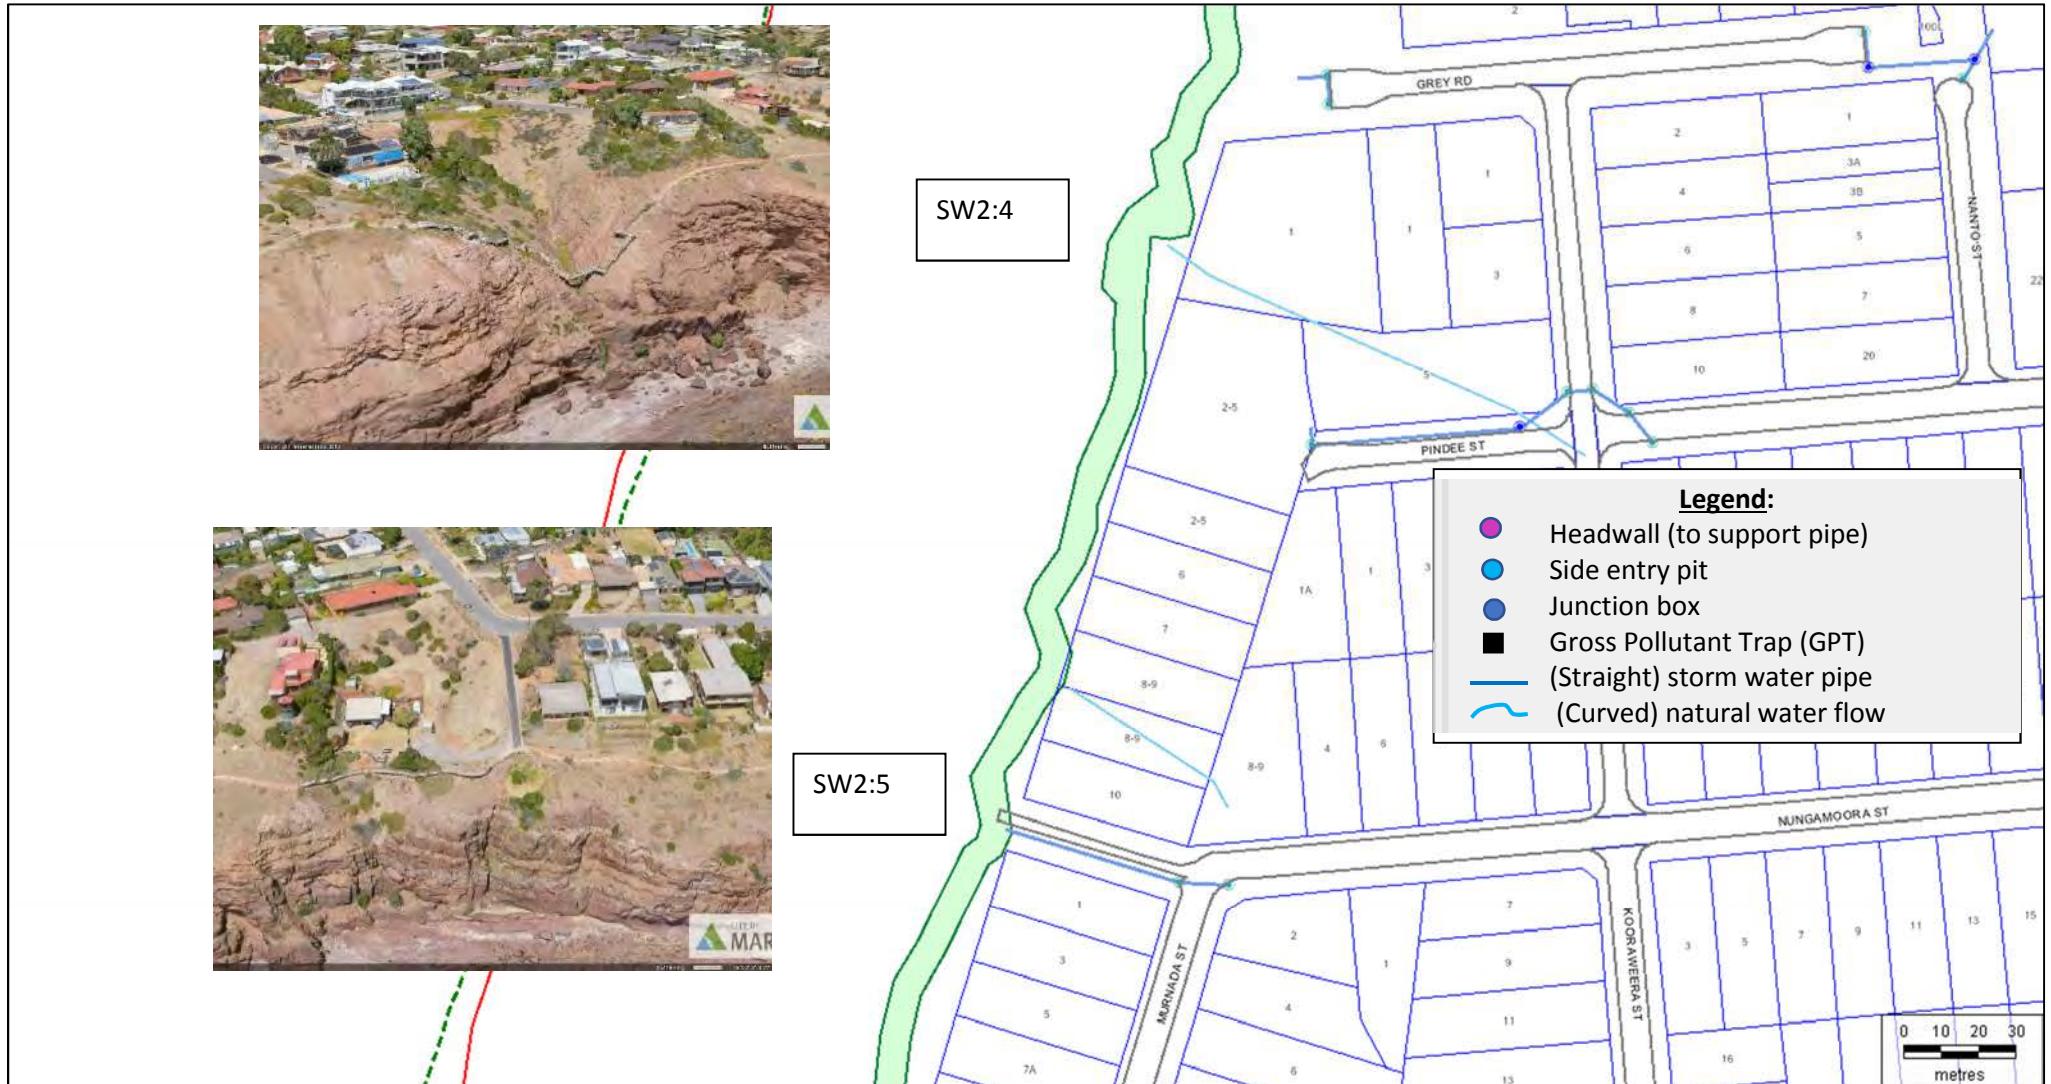
**Hallett Cliffs 2:3**  
**Geological review**  
Event: Ongoing  
Risk: Cliff stability  
Date: 12 May 2018

SW2:4 Open water course (some storm water draining into this)  
SW2:5 Nungamoora Street. Southfront (2012) recommended installation of GPT. CoM has this item as a low priority with possible installation at 2020 (would be elevated if erosion problems became evident).
